HISTORIC DISTRICT COMMISSION
APPLICATION FOR CERTIFICATE OF APPROPRIATENESS

Applicant Town of Durham Phone 860-349-3625 Email hrc@townofdurham.co
Applicant's Address 30 Town House Road
Address of Proposed Work 51 Main Street
Owner Town of Durham Phone same Email same
Agent or Contractor _____ Phone _____ Email _____
Approximate Date of Original Structure 1850

General Description of Proposed Work

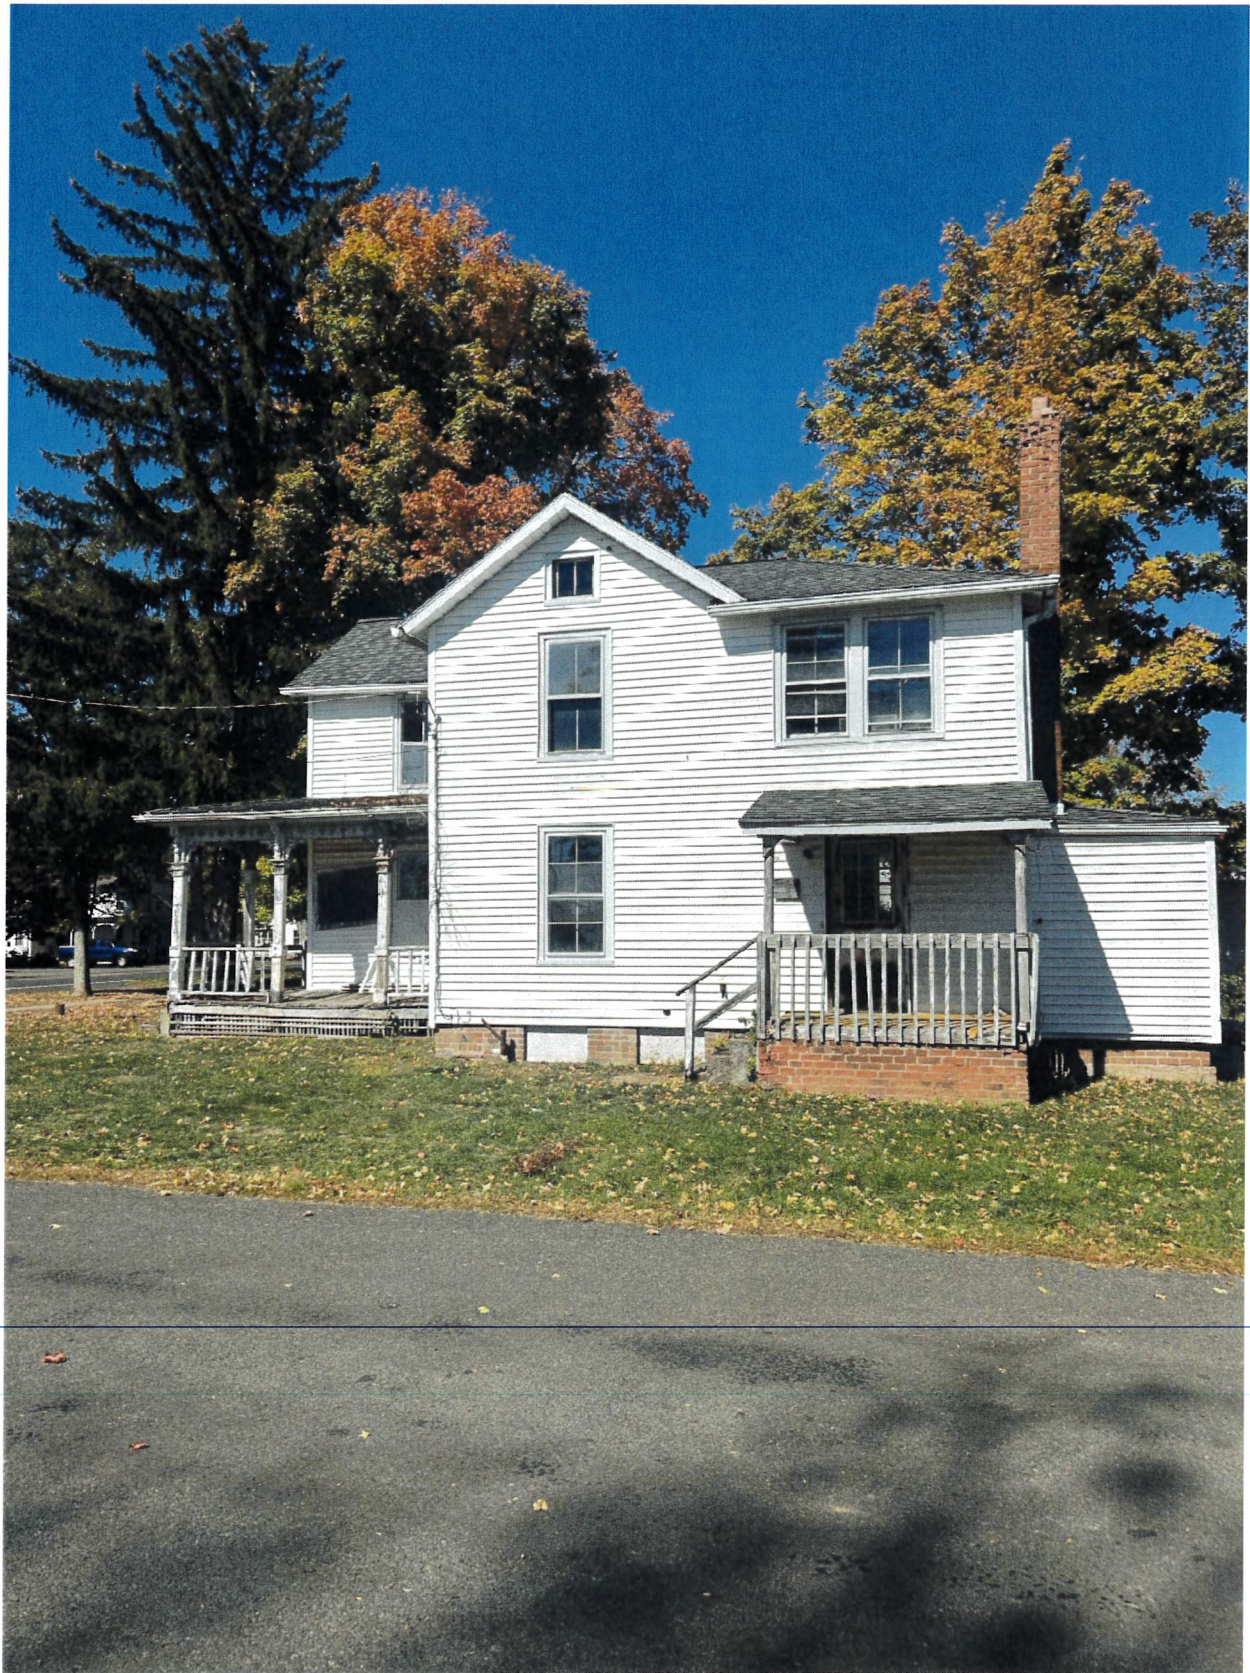
Picture 1: Exterior South Side - Loose masonry and leaning structure pose a collapse hazard.

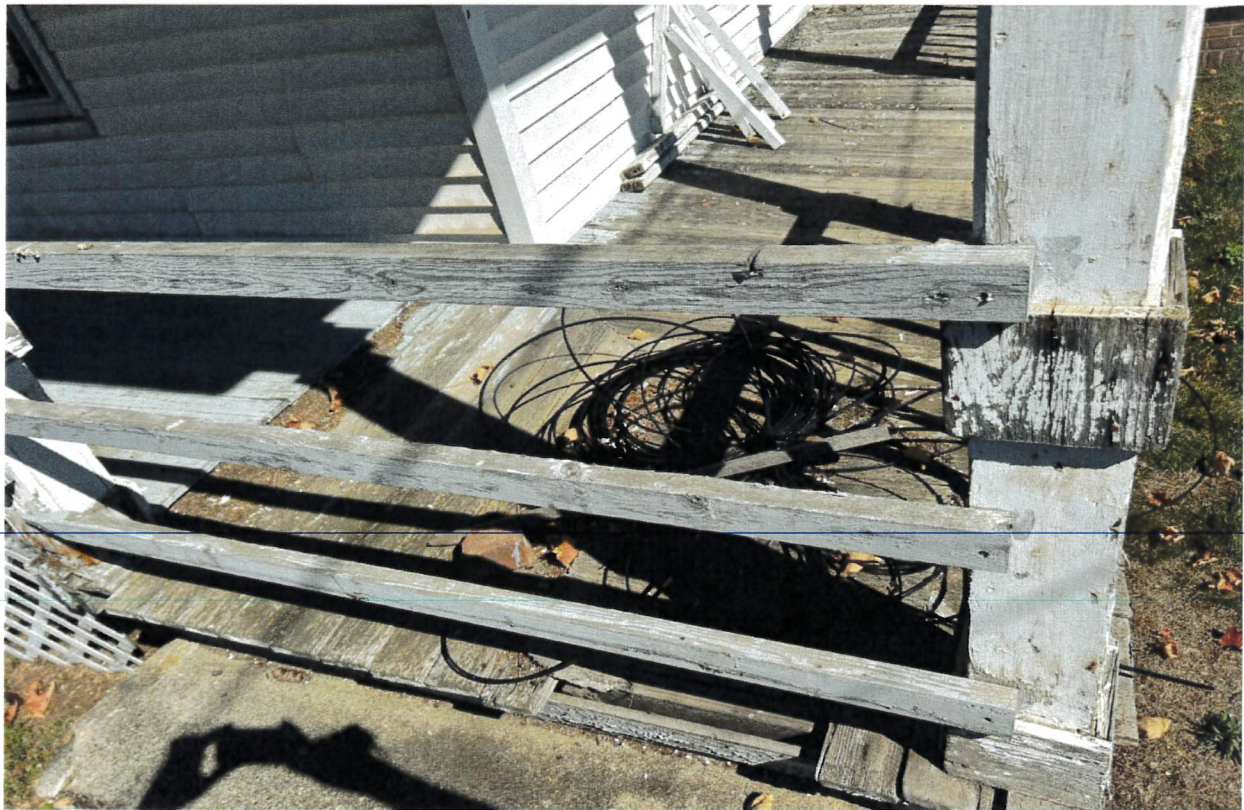
Picture 4 (Bottom Picture): Front Porch - Structural instability and advanced deterioration of support

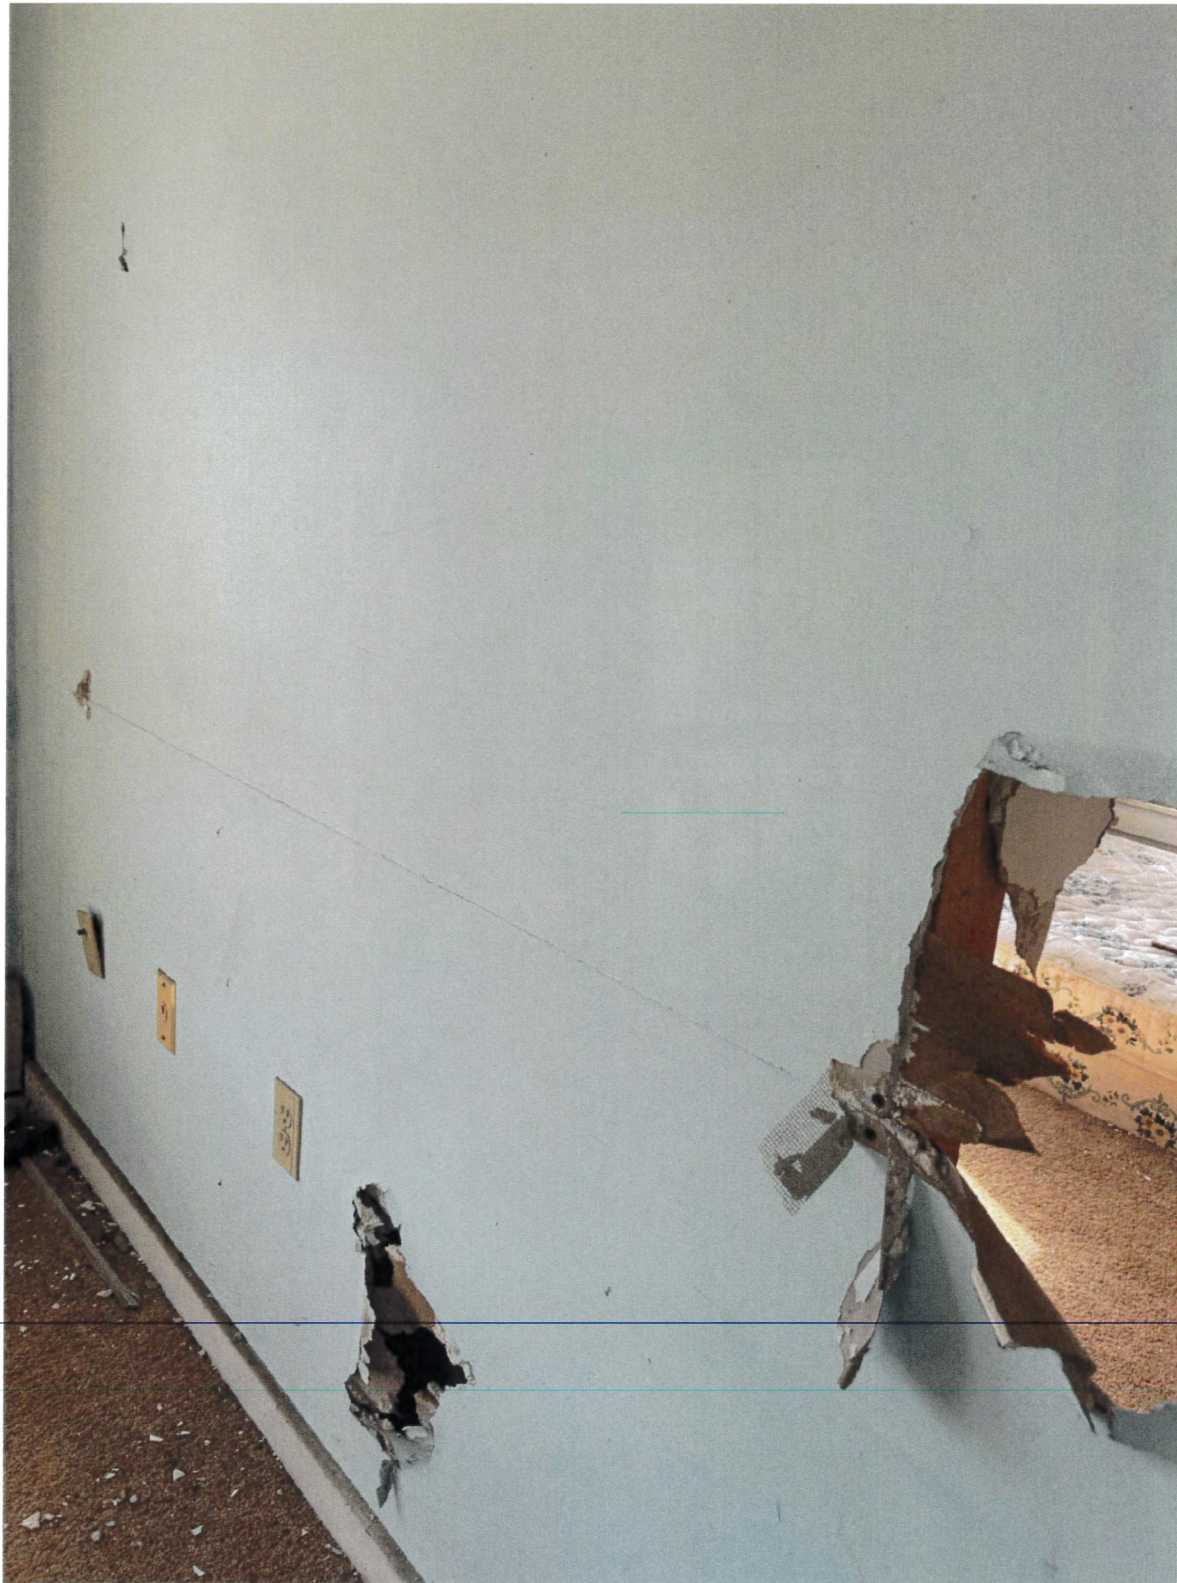
Picture 8: Livingroom wall – Large openings in the walls expose compromised framing and insulation, creating severe energy inefficiency, and structural instability. These gaps also allow moisture intrusion and pest infestation, accelerating deterioration and making restoration impractical.

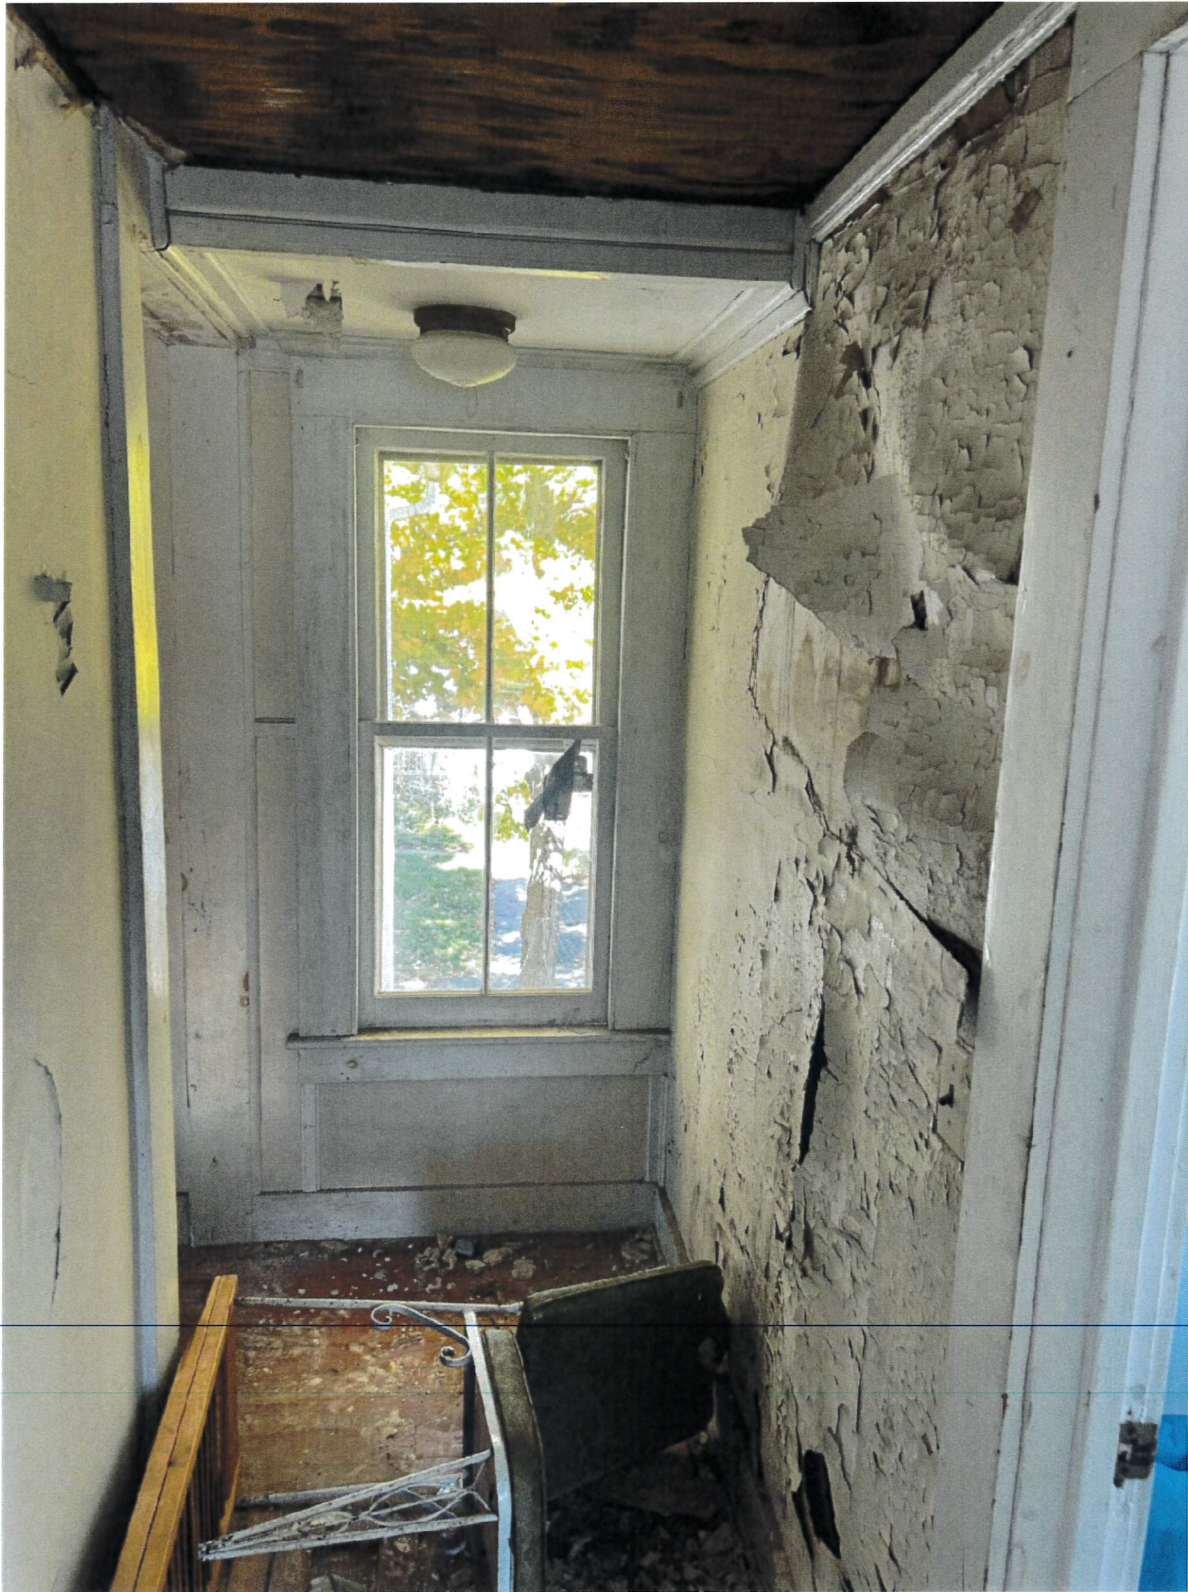
Picture 9: First Floor Hallway – Exterior and interior surfaces show extensive peeling and rotting paint, indicating prolonged moisture exposure and wood decay. This level of deterioration compromises structural integrity and reflects years of neglect.

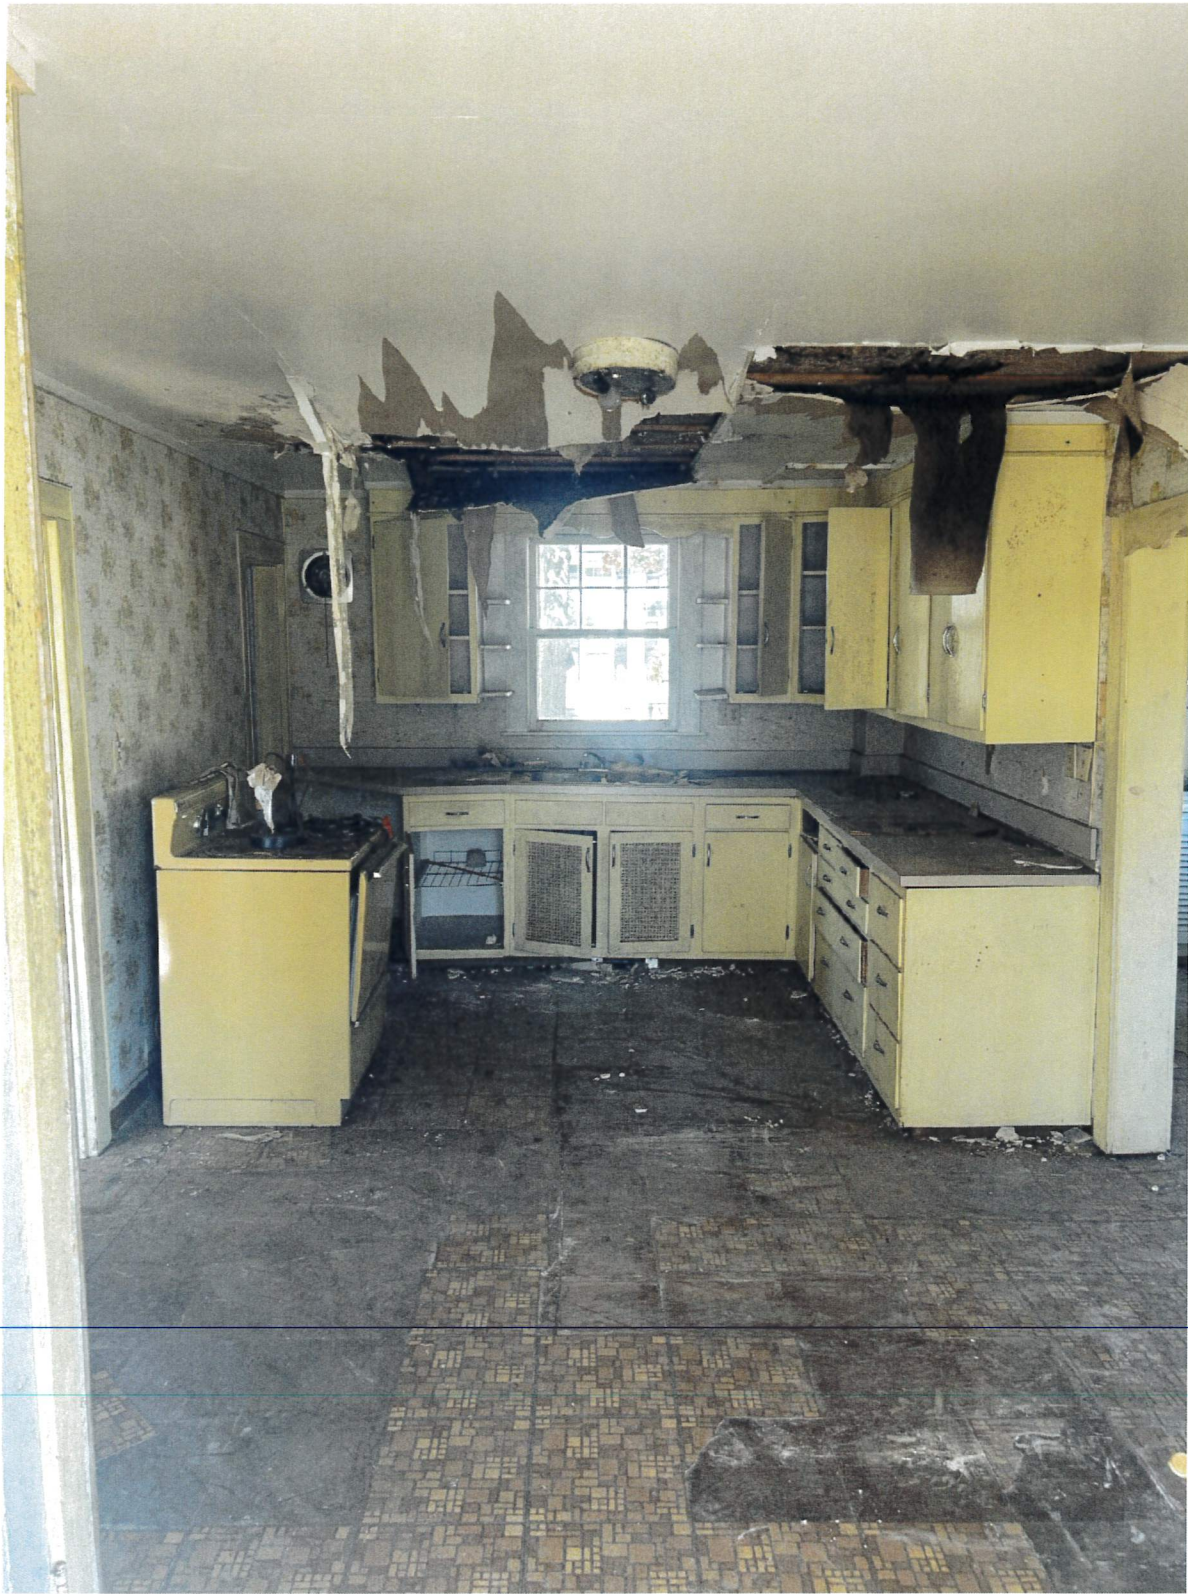
Picture 13: First Floor Kitchen – Ceiling sections are actively collapsing, exposing structural framing and creating an imminent risk of injury. This level of deterioration indicates severe water infiltration and compromised load-bearing integrity.

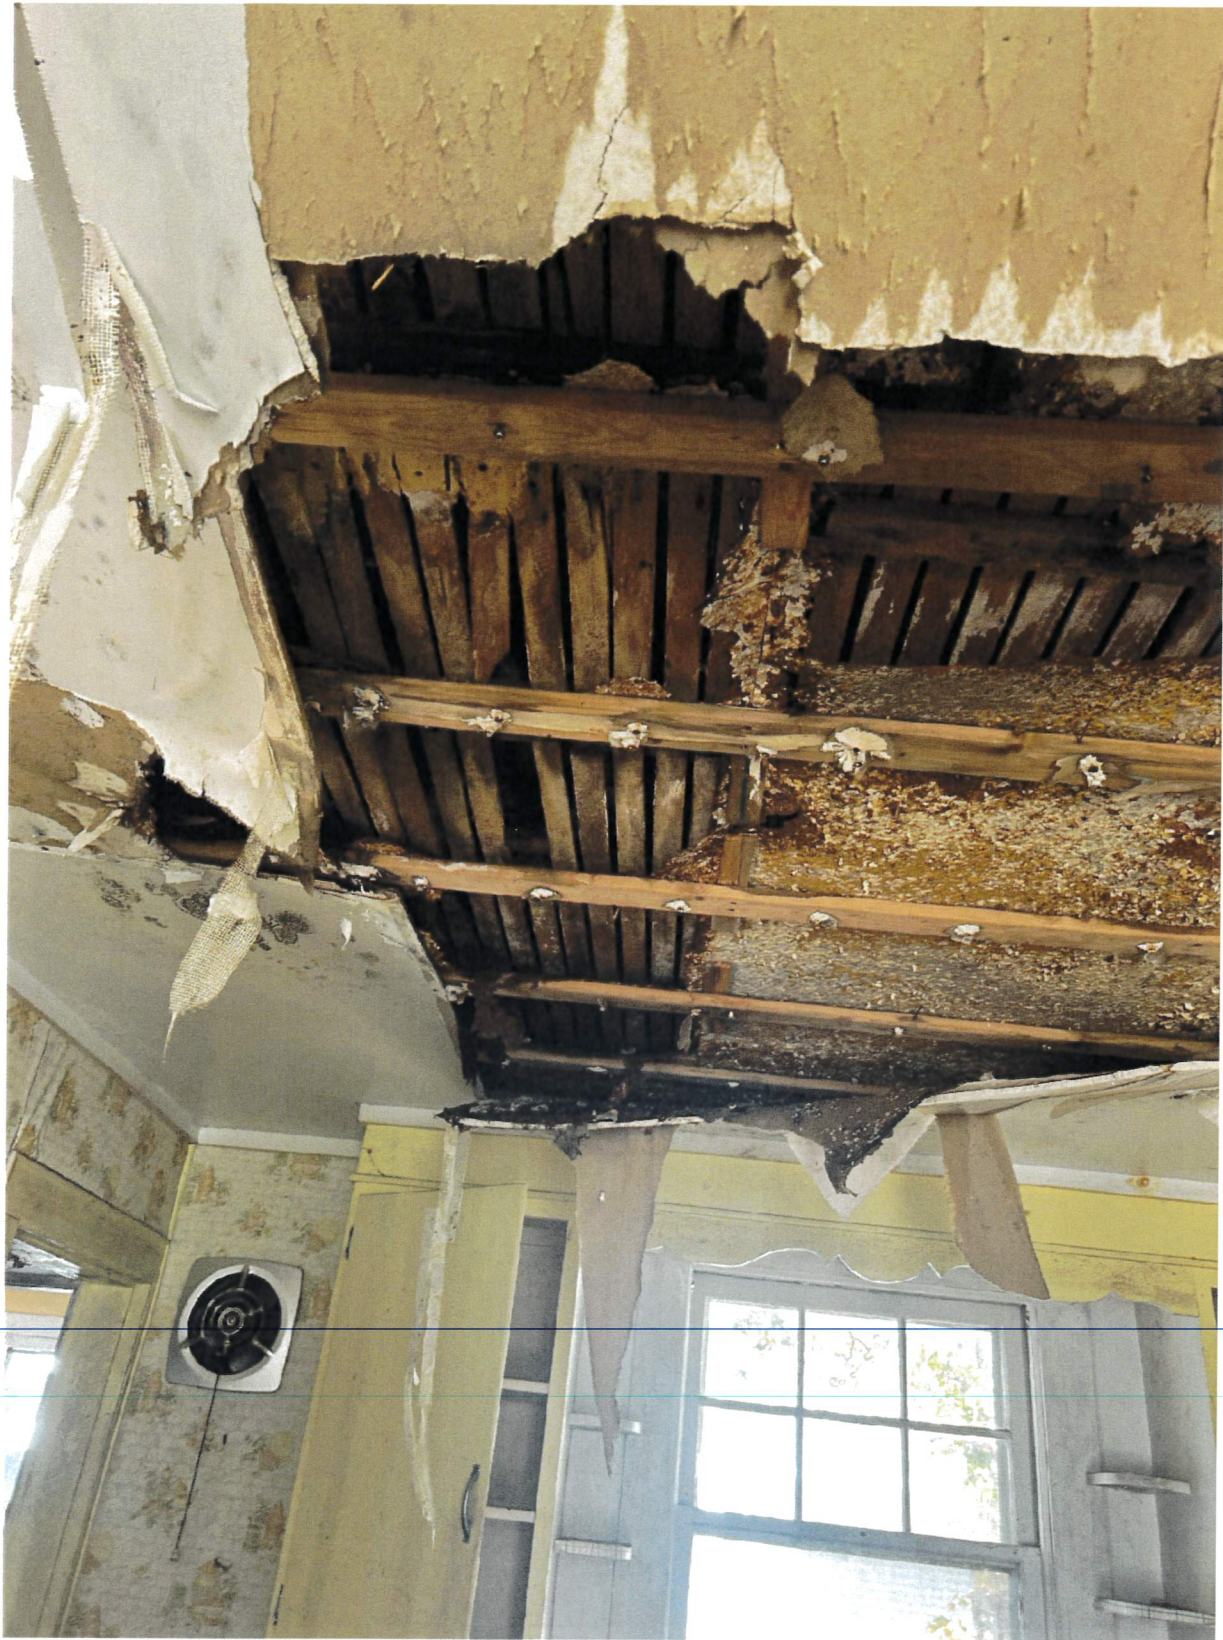
Picture 14: Ceiling of First Floor Kitchen – Large openings in the ceiling reveal more severe structural failure, exposing hazardous conditions and accelerating interior deterioration.

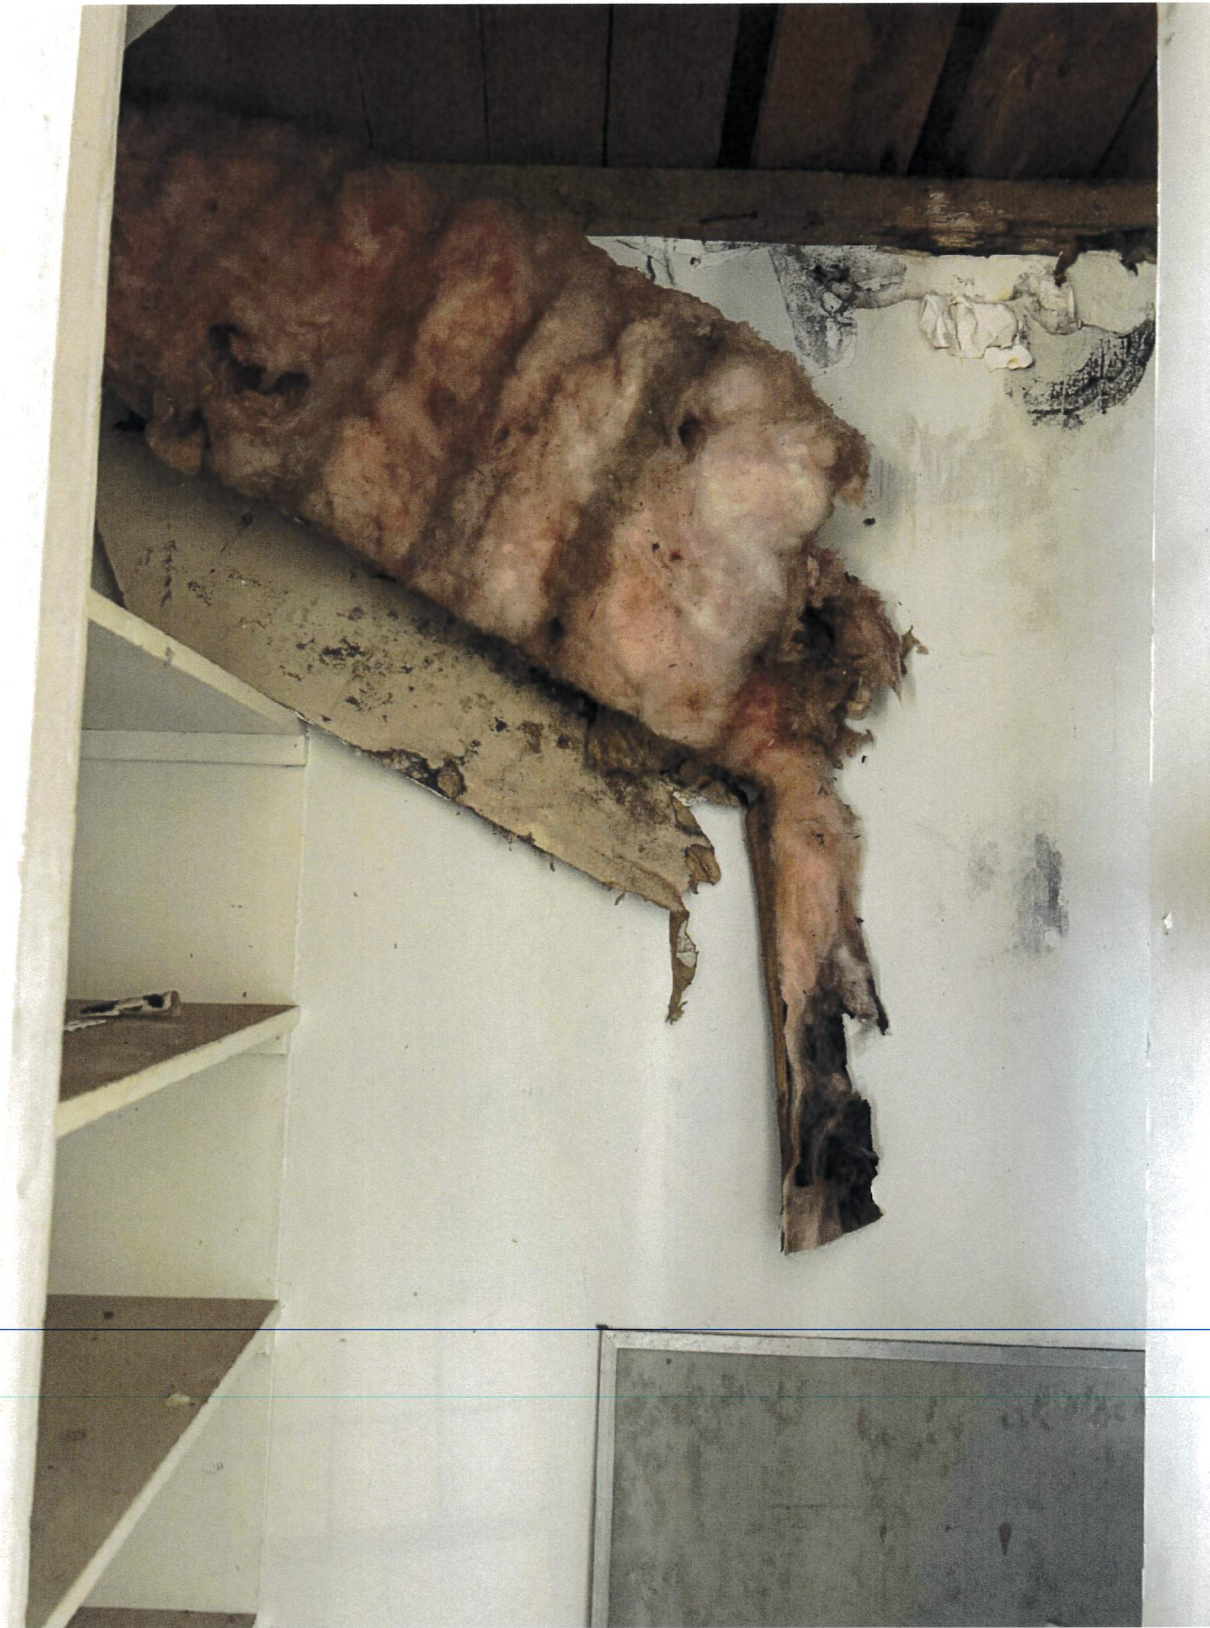
Picture 15: First Floor Closet – Dislodged insulation contaminated with black mold presents severe health hazards and demonstrates prolonged water infiltration and neglect.

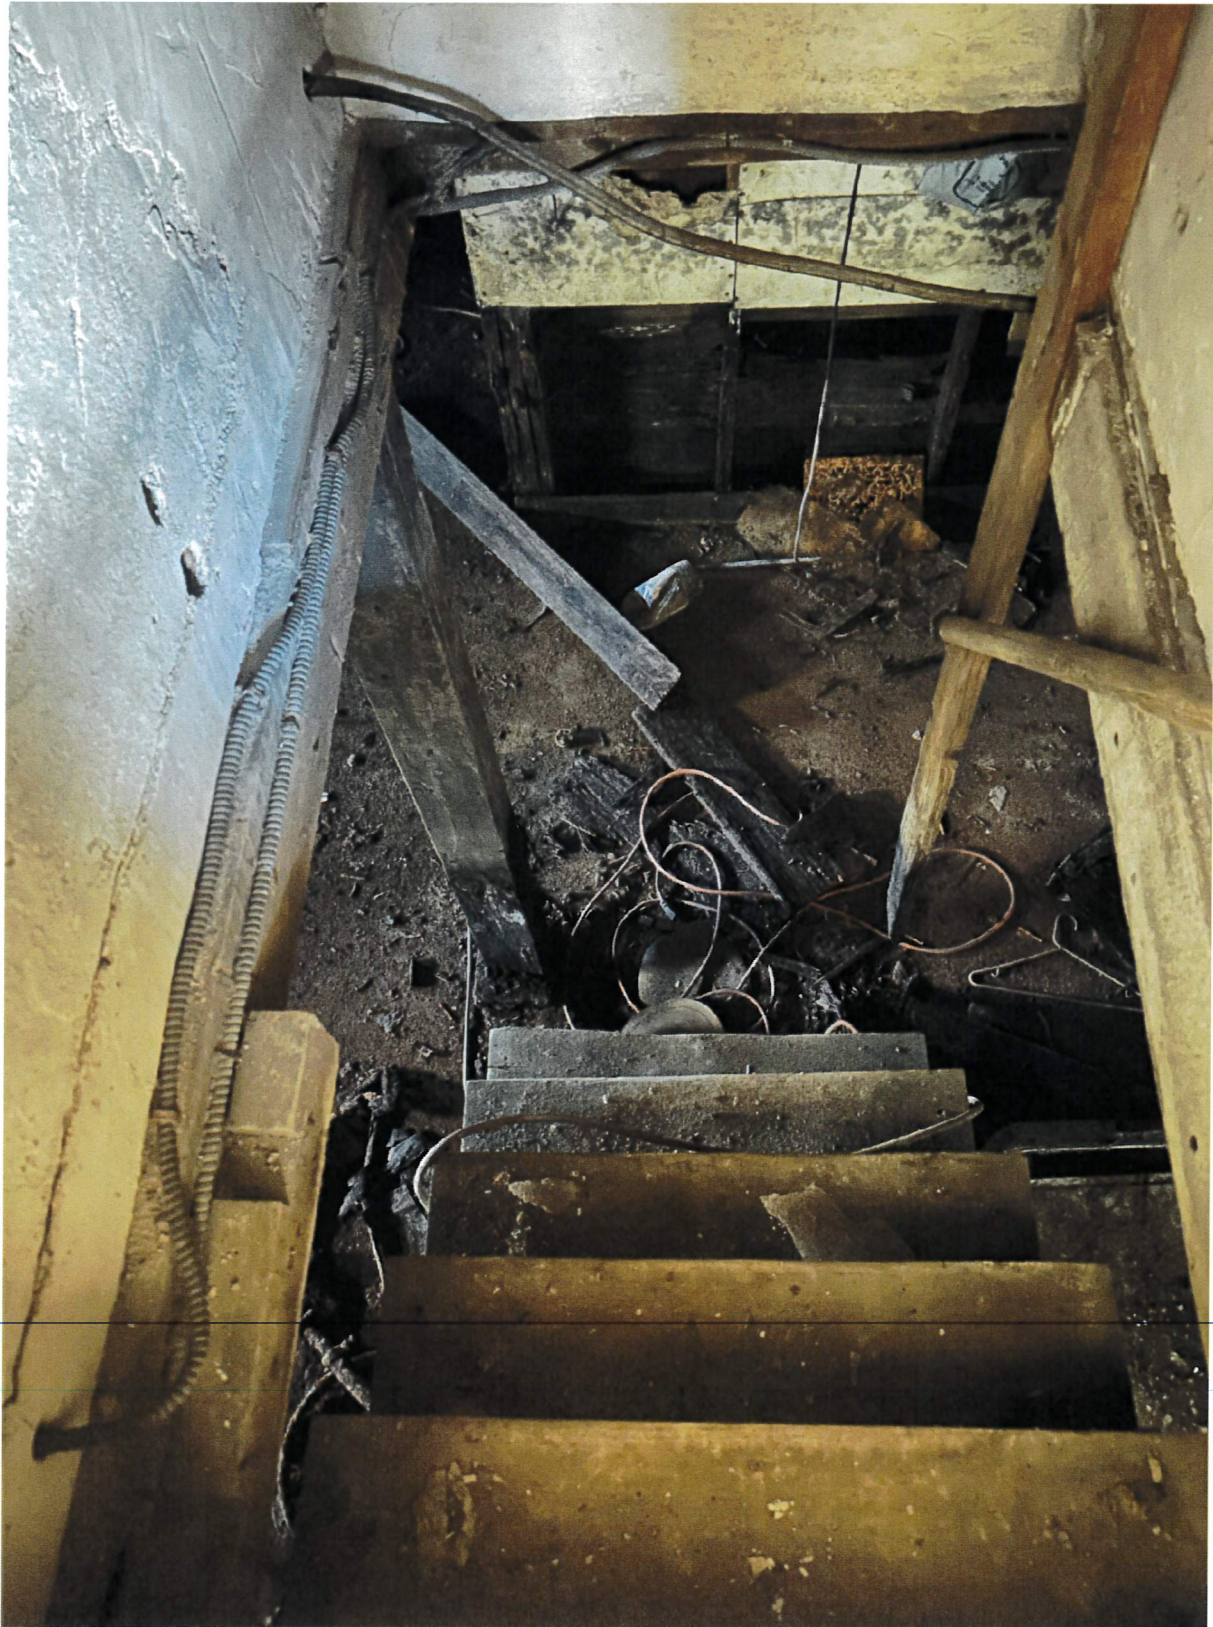
Picture 16: Stairway to Basement – Shows exposed electrical wiring and unsecured plumbing along the descent, creating severe fire and water hazards. Missing steps at the bottom make the staircase unsafe for use.

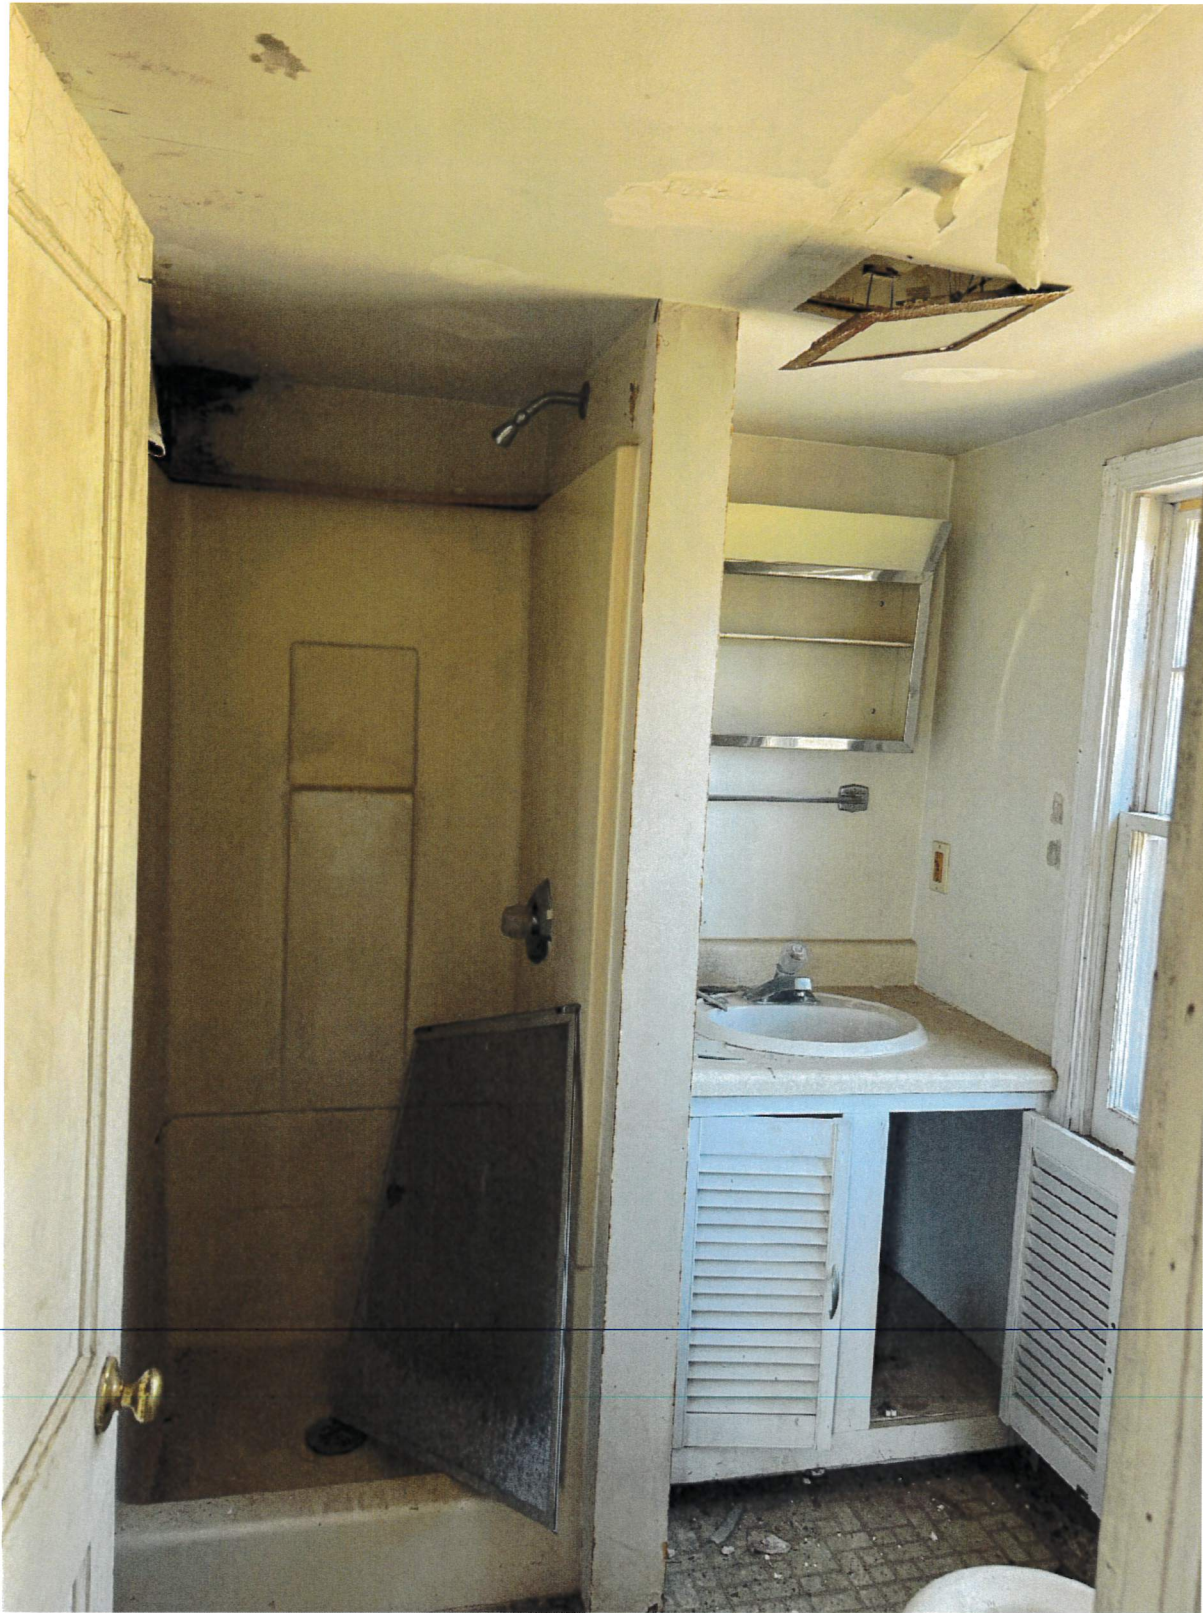
Picture 17: First Floor Bathroom – Damaged and non-functional light fixtures in the bathroom underscore the unsafe electrical system.
