**ASBESTOS PRE-DEMOLITION INSPECTION  
VACANT SINGLE FAMILY RESIDENCE  
51 MAIN STREET, DURHAM CT  
CS# 215-756, 09/15/2026, PAGE 1 OF 6**

Asbestos Pre-Demolition Inspection as directed by Matt Meeker of the Town of Durham. It is our understanding there are plans to demolish the vacant single family residence. You would like all accessible materials tested for asbestos prior to the demolition. Since the house was built in 1850, you would also like the required Lead XRF Inspection prior to demolition as well. No other materials or areas were within the scope of this inspection.

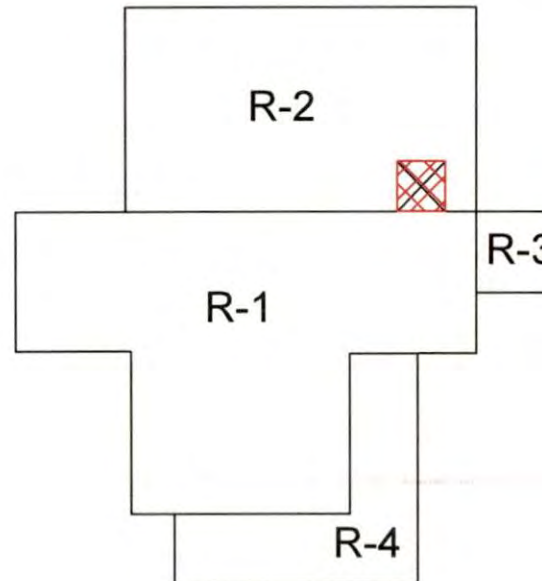
ACM Sample Location Drawing

| <u><b>MATERIAL</b></u> | <u><b>LOCATION</b></u> | <u><b>~*FOOTAGE</b></u> |
|---|---|---|
| Black hard flashing tar (from Chimney) | Exterior – Side C | 5 SF |

Approx. Location of <3 SF of  
ACM Flashing Tar

**For the 5SF of ACM flashing tar:** As long as the roofing materials remain not friable, it may be removed by workers with 8 hour roof training plus a DPH certified supervisor must be on the job. However it would be simpler to stay with a licensed contractor. Also if the roof becomes friable, then the CT DPH must be notified and a licensed asbestos contractor is needed with all certified workers and a certified supervisor.
