Bridge Conditional Assessment

**Bridge No. 123003 in Scotland, CT
Kemp Road over Kimball Pond Brook**

Town of Scotland
Scotland, Connecticut

Issued: January 29, 2021

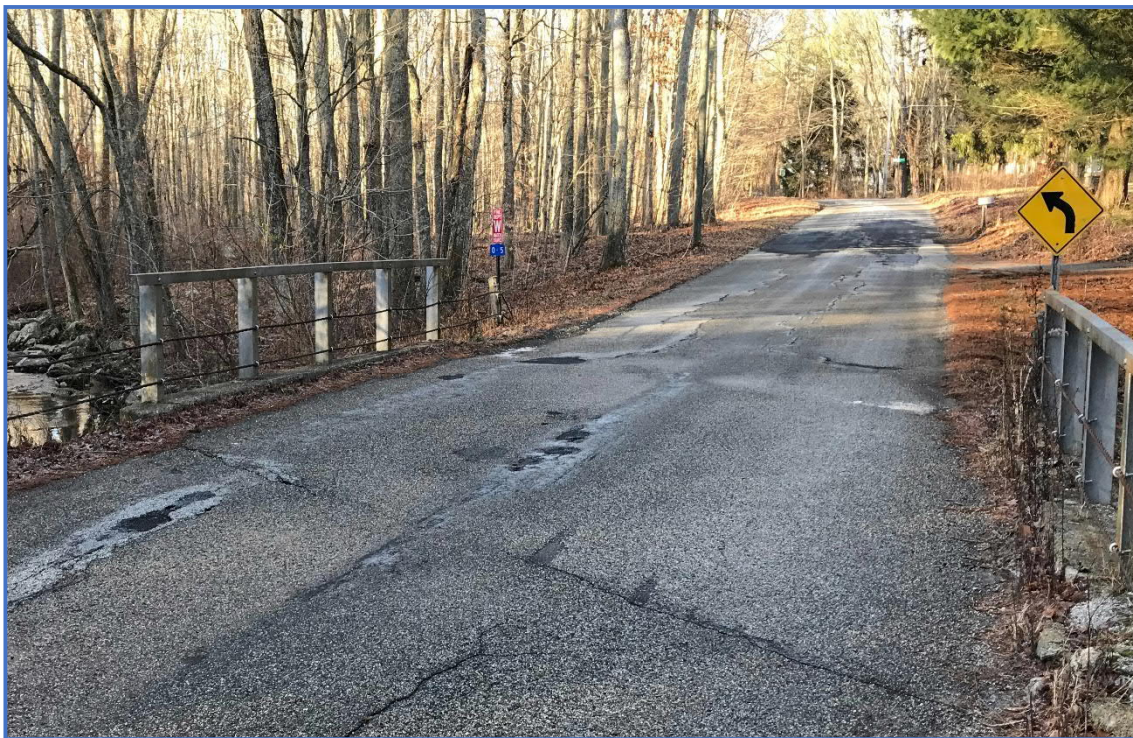
Overlay - The overlay is in poor condition due to the amount of cracking and spalling. Transverse cracking for the full width of the roadway on eastern end of the deck span. There are numerous areas of spalling and patched potholes, especially at center of mid-span. Patched potholes 3'-2" long by 2'-0" wide were observed near the southwest corner of deck. (See photo 7). The potholes suggest a lack of a membrane on top of the deck allowing deleterious de-icing salts to seep into the deck leading to deck cracking and holding water which is cause spalling to the bituminous concrete during the cold weather months.

Photo 7: Typical wearing surface (Note full width transverse cracking on east edge of deck, and spalling with patchwork near midspan)

It is recommended to replace the existing pavement on the bridge and at the approaches. A waterproofing membrane should be added to the top of the bare concrete bridge deck before repaving to limit the amount of de-icing salts that can penetrate the concrete. Additional signage should be posted to warn motorists of the potential blunt end hazard condition at the bridge ends.

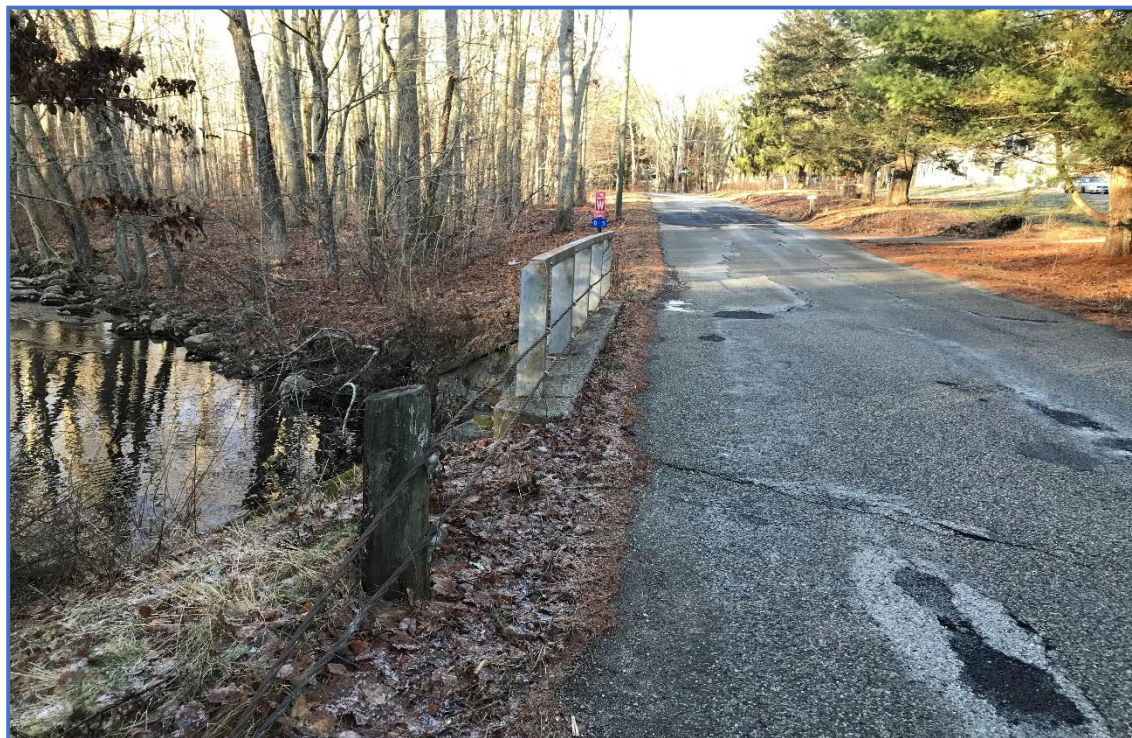
Photo 8: Southern bridge railing connected to wooden approach post (note space between edge of overlay and curb)

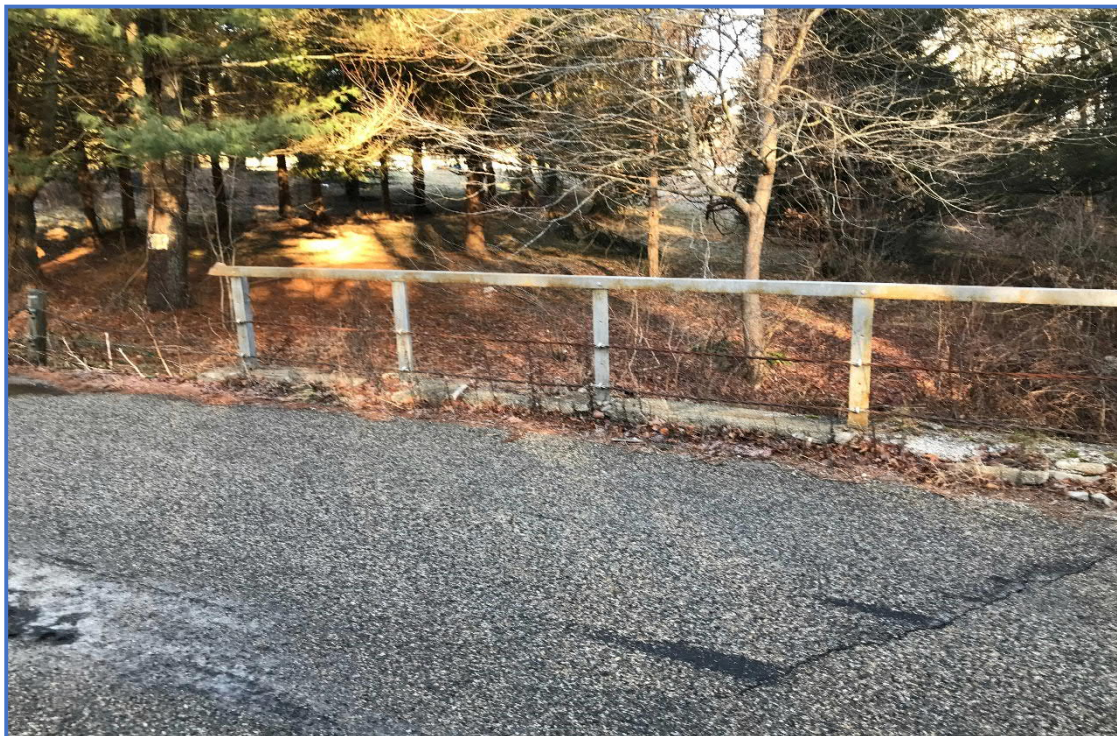
Railing - The railing is in poor condition due to the weak connections between the posts and bridge deck curbs. Visually there is minor surface rust on many of the posts and caps (see photo 9). Concrete around posts appeared loose with heavy crumbling around several posts noted. The railing does not properly transition off the bridge beyond the clear zone, creating a hazard due to blunt end fixed condition. The railing did not exhibit the capacity to withstand a vehicle collision or prevent an errant vehicle from falling off the bridge.

Photo 9: Northern metal railing (note surface rusting)

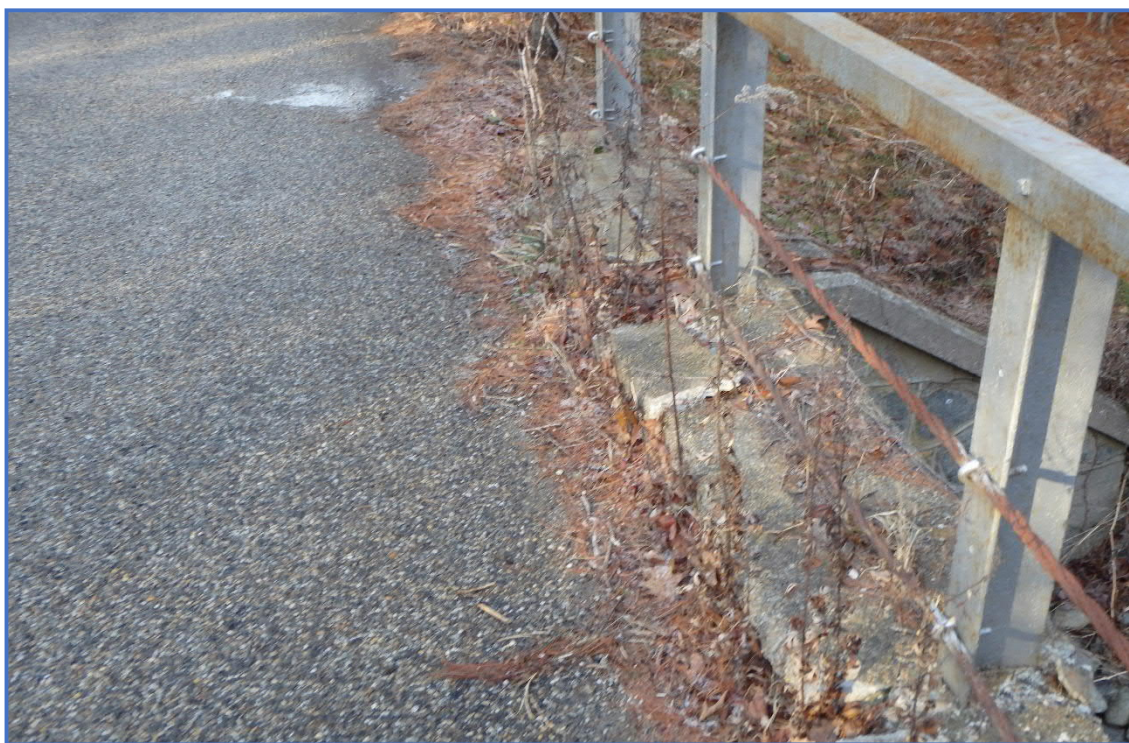
Curbs - The curbs are in poor condition due to advanced deterioration. Cracked and crumbling of concrete is visible along both fasciae (see photo 10). This condition appears to be signs of freeze/ thaw damage to the concrete. The edge of the deck asphalt overlay ends approximately 10" from the curbing (see photo 8). Heavy sediment accumulation was present along the southern gutterline, and vegetation was present on both northern and southern curbs (see photo 10).

Photo 10: Typical crumbling and spalling of concrete curbs (note vegetation along northern curb)

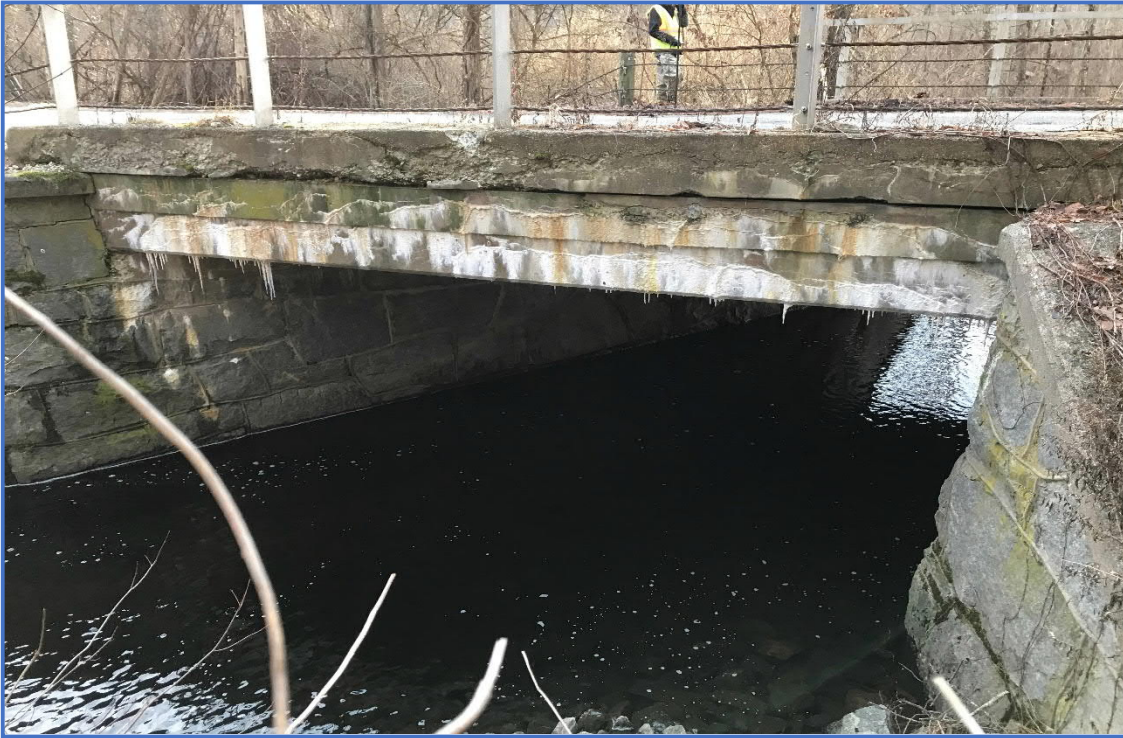
Deck - The concrete slab is in poor condition due to advanced deterioration. Significant cracking with heavy efflorescence and shallow spalls exists for the full length of both outside faces of the fasciae (see photos 11 & 12). At the north fascia, the efflorescence is most prominent at both the east and west edge of deck. Efflorescence noted on northern portion of deck underside (see photo 13). Severe cracking with heavy efflorescence, throughout the span is prevalent on the southern portion of the underside of deck (about 25% of the deck surface area) (see photo 14).

Photo 11: Heavy efflorescence and spalling on northern fascia of concrete deck

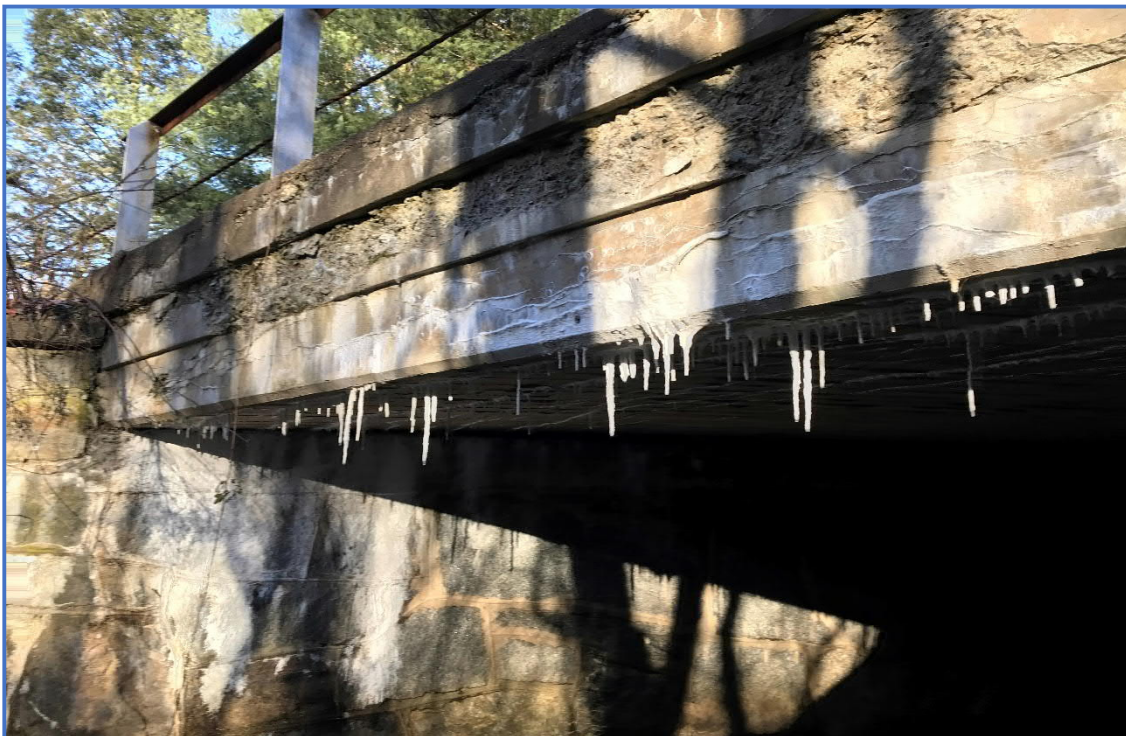
Photo 12: Heavy efflorescence and spalling on southern fascia of concrete deck

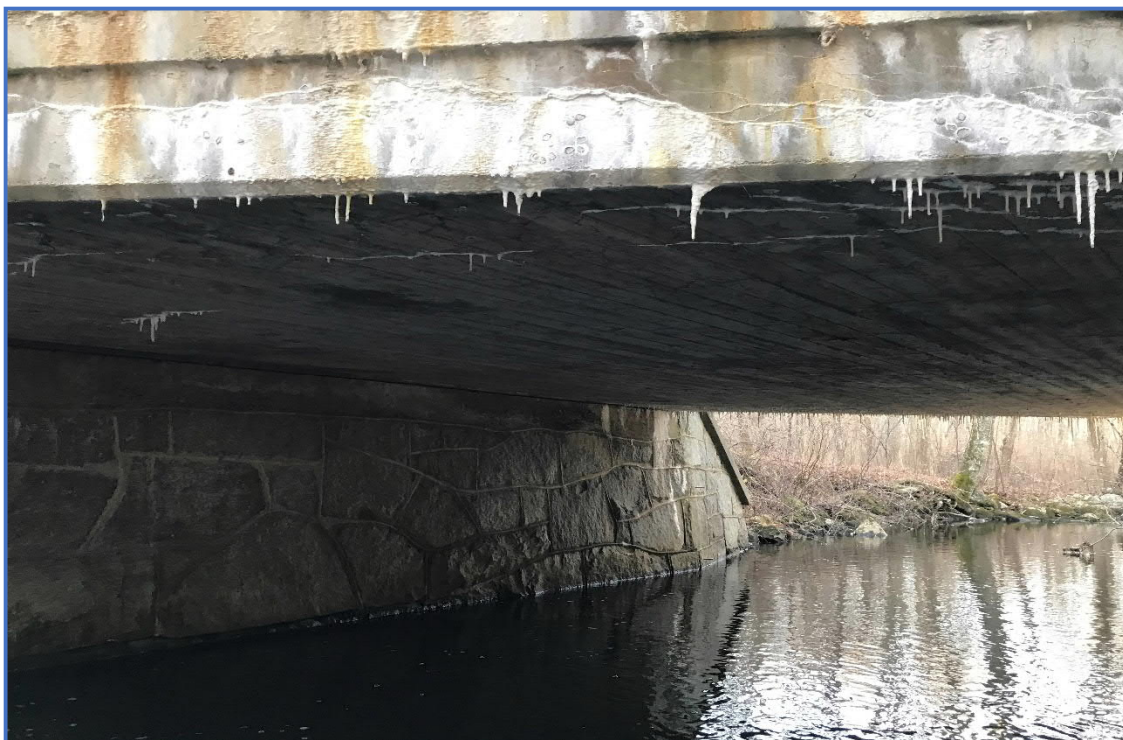
Photo 13: Underside of deck from north fascia (note efflorescence on underside)

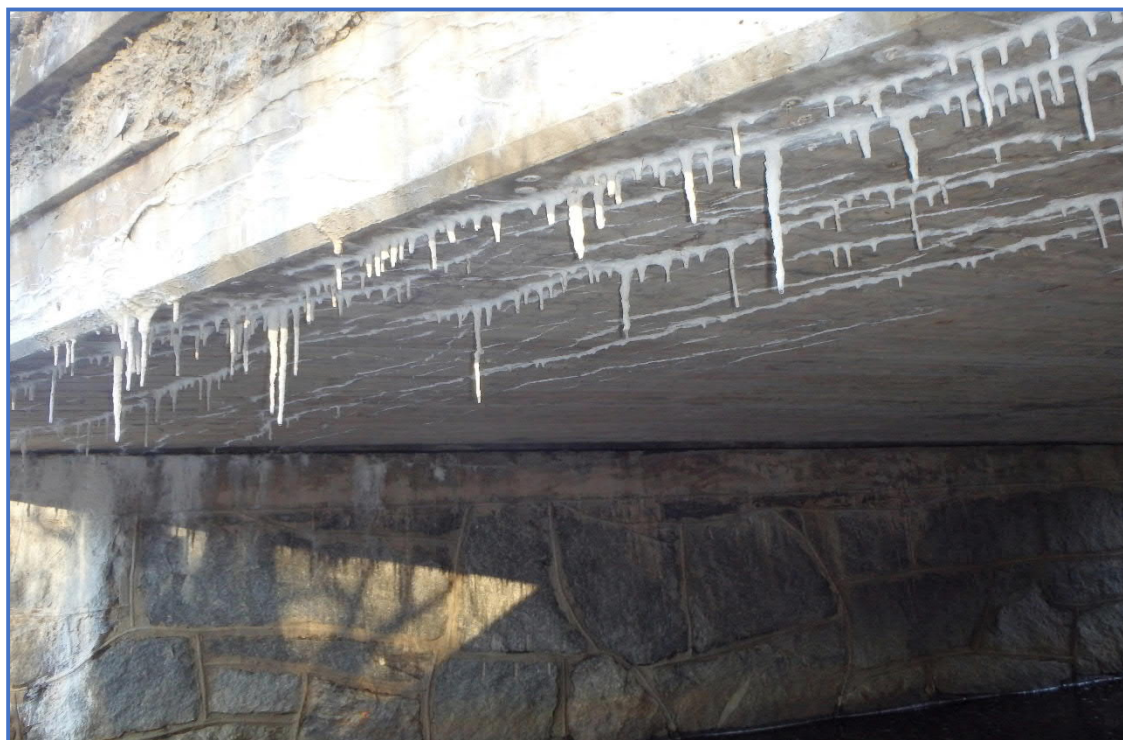
Photo 14: Underside of deck from southern fascia (note heavy efflorescence full span length on underside)

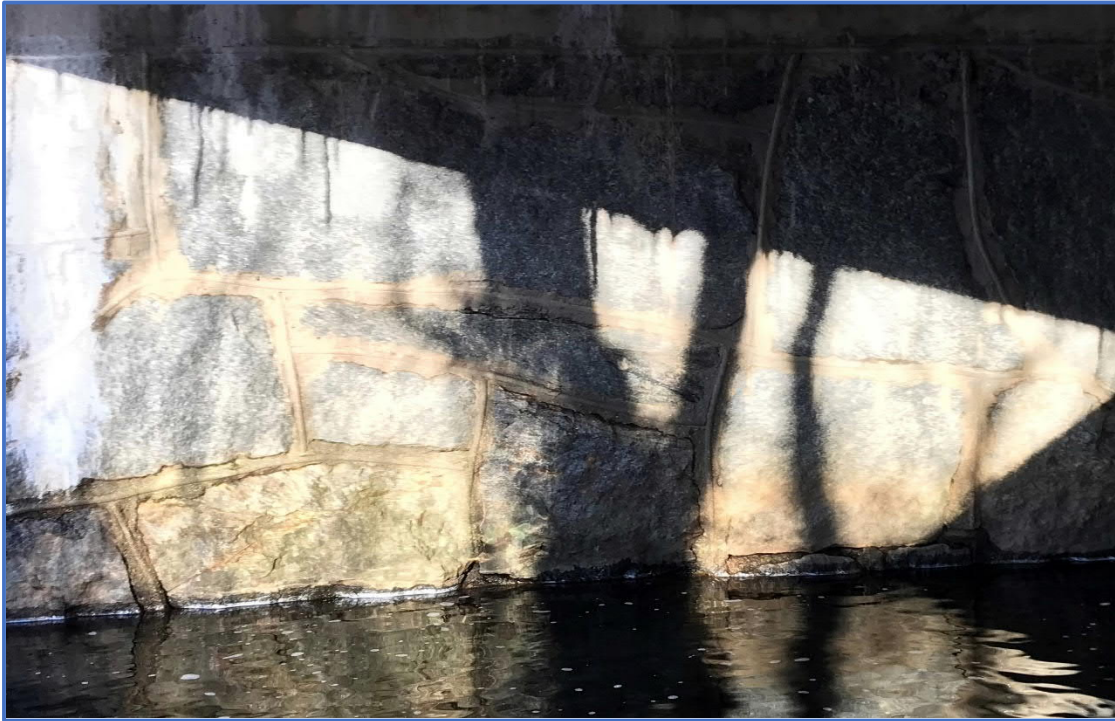
Abutments (Stem) - The abutments are in fair condition with minor deterioration. Minor cracking at mortar joints observed on west abutment (see photo 17). Minor cracking at mortar joints observed at northern portion of east abutment, near waterline (see photo 18). The abutment stems appear plumb, with no signs of leaning apparent at the time of the inspection.

Photo 17: Typical cracking at mortar joints at west abutment

Measures should also be taken to seal the cracked stone masonry abutments and wingwalls. If left unaddressed these cracks will grow and cause stone and portions of the walls to become unstable.

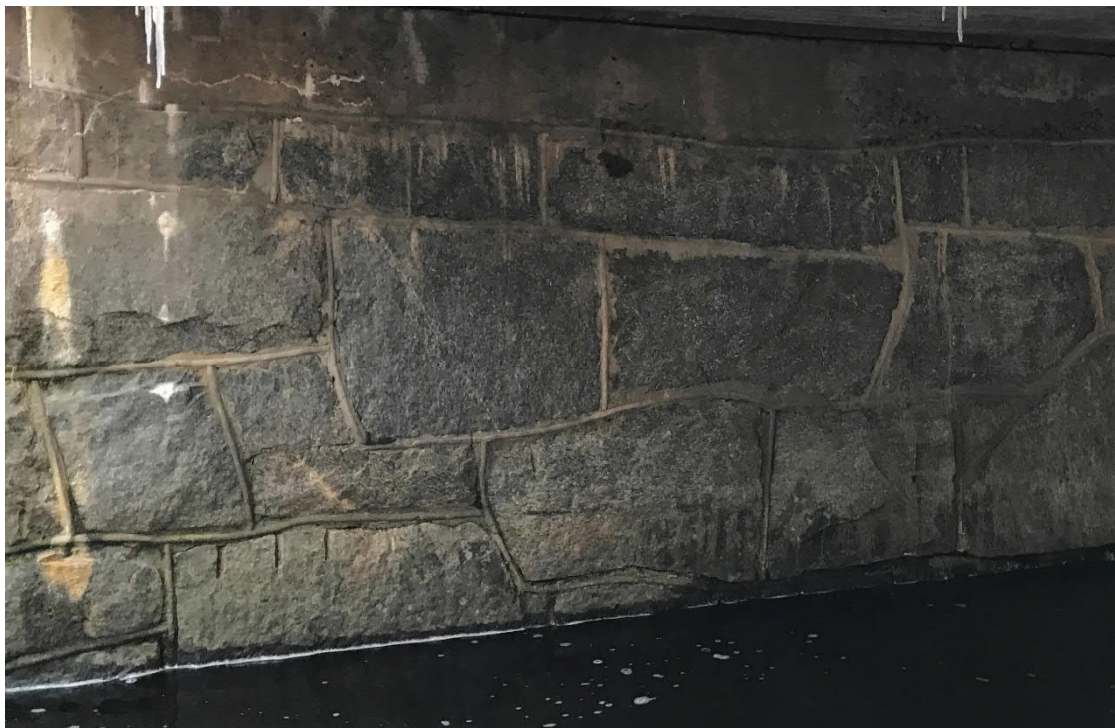
Photo 18: Typical cracking at mortar joints at east abutment

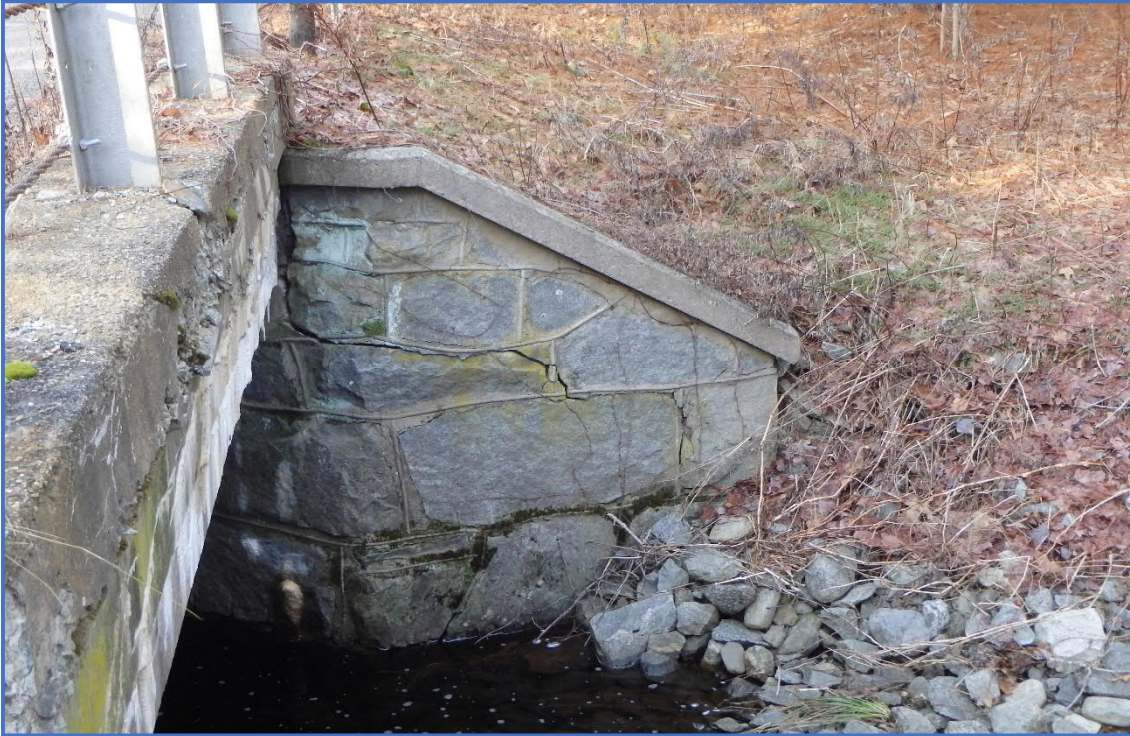
Wingwalls (Stem) - The wingwalls are in poor condition due to advanced cracking at mortar joints. Vertical cracking, up to 2 feet in length, was observed at mortar joints on the northwest wingwall at the base of the stem. A crack along mortar joints that starts horizontal and turns diagonal was noted at an area located at mid-height of the stem (see photo 19). This crack measured approximately 2 feet long by 10" high in total. The width of this crack opening stayed generally consistent throughout. The northeast wingwall exhibited signs of leakage at the time of inspection, and stones were missing from the stem at the waterline (see photo 18). At the waterline of the southeast wingwall, a crumbling mortar joint, approximately 16" long, has led to a loose stone (see photo 22).

Photo 19: Northwest wingwall (note horizontal to diagonal cracking along mortar joints at mid-height of stem)

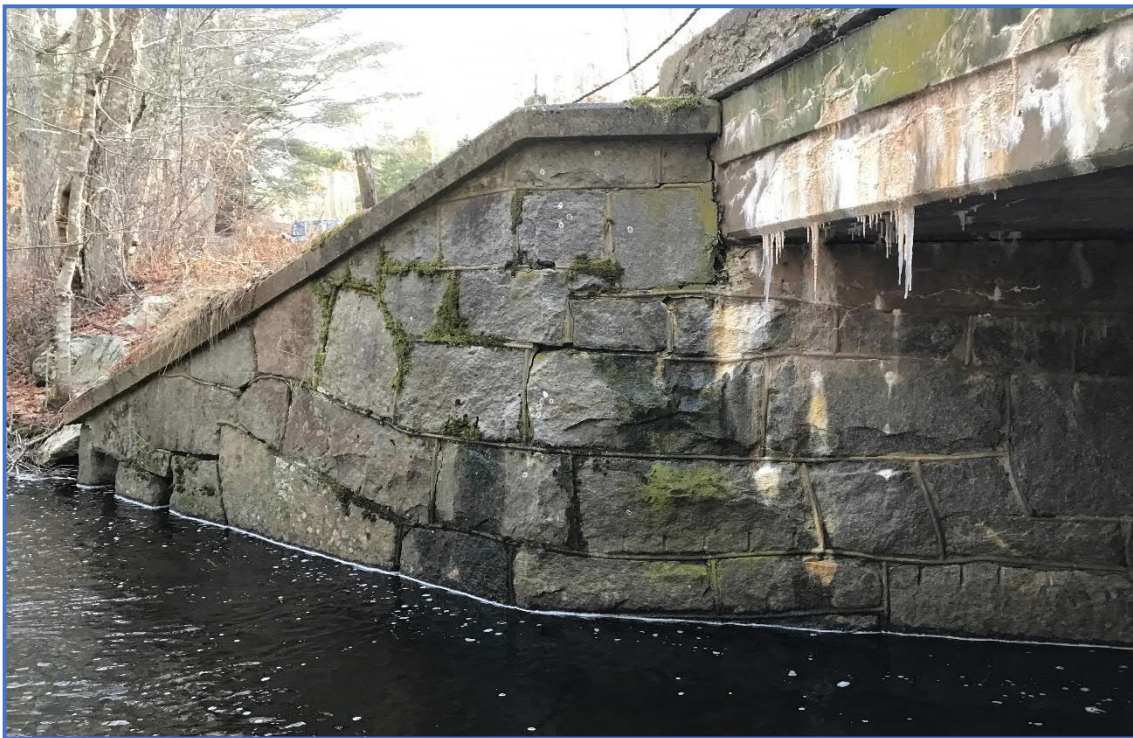
Photo 20: Northeast wingwall (note signs of leakage and missing stones at tip of wingwall near waterline)

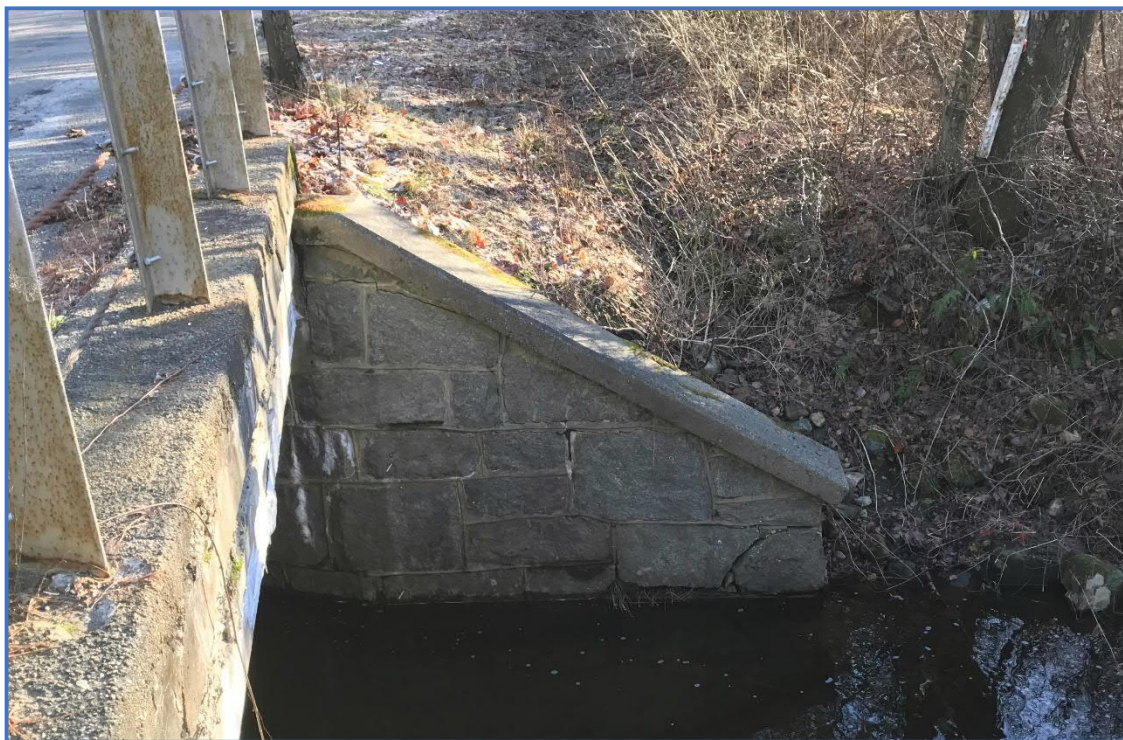
Photo 22: Southeast wingwall (note loss of mortar near tip of wingwall at waterline)

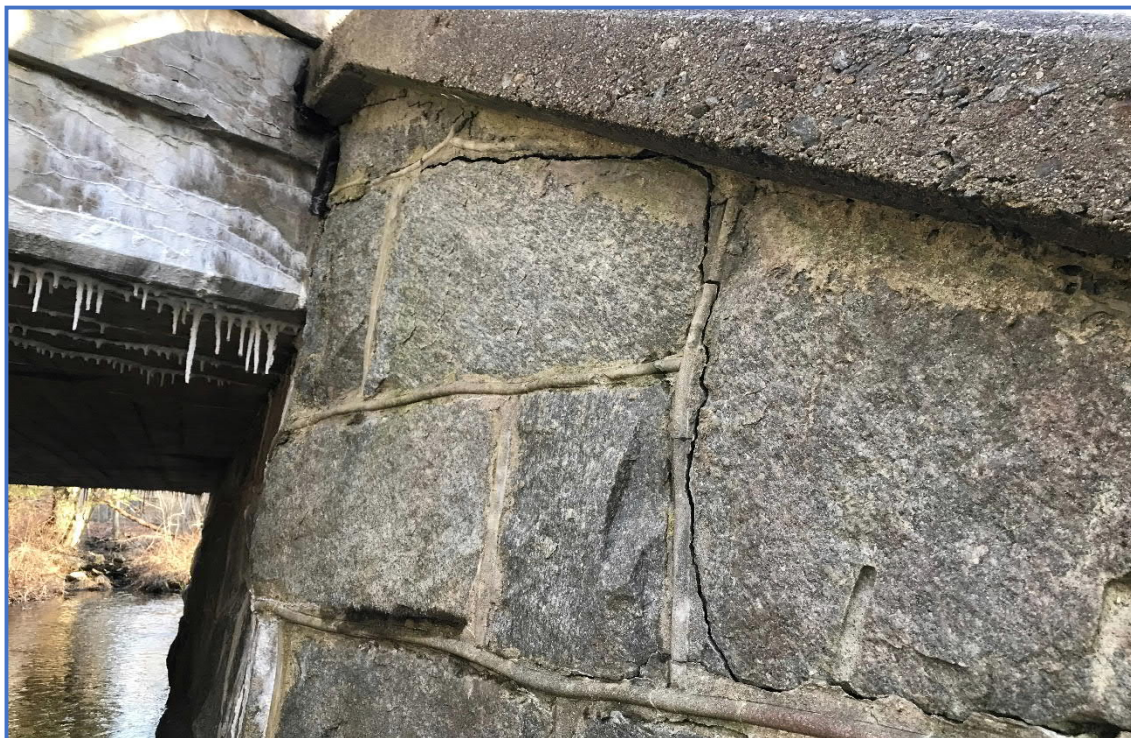
Vertical and horizontal cracking at mortar joints was also observed at the top of the southeast wingwall (see photo 23). No protective fences are present at any of the wingwalls.

Photo 23: Vertical and horizontal cracking at top of southeast wingwall

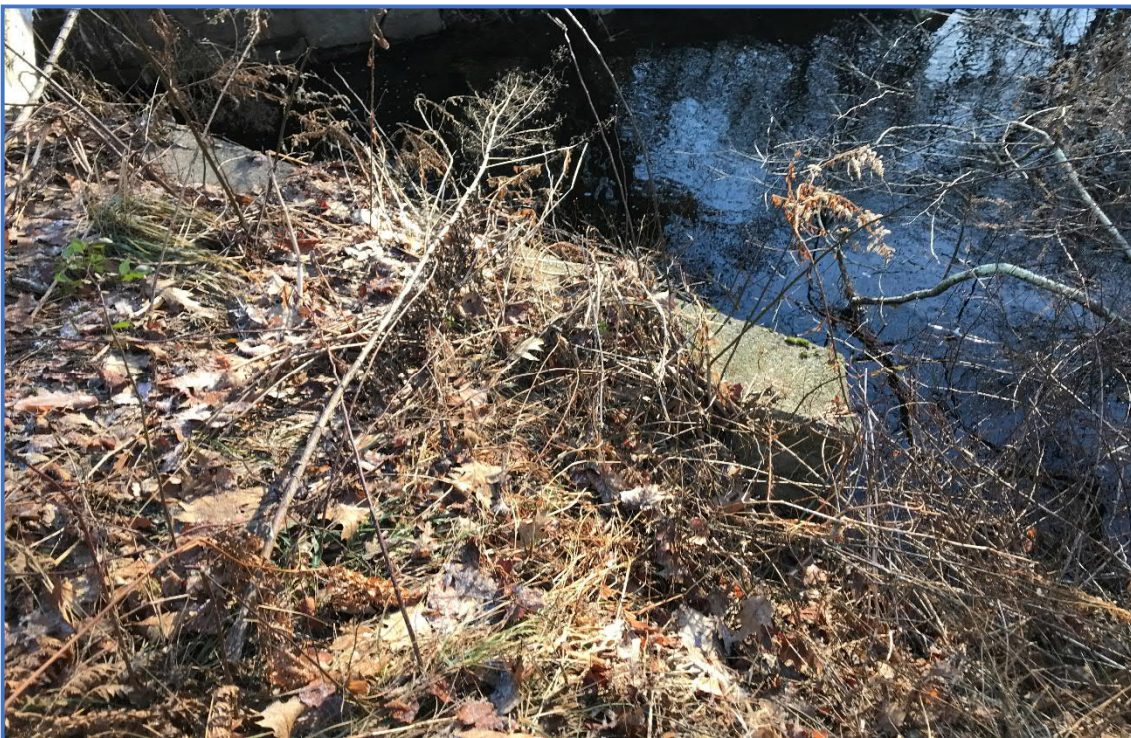
Photo 24: Minor erosion at southwest wingwall
