Bridge Conditional Assessment

**Bridge No. 04769 in Scotland, CT
Brooklyn Turnpike over Merrick Brook**

Town of Scotland
Scotland, Connecticut

Issued: January 29, 2021

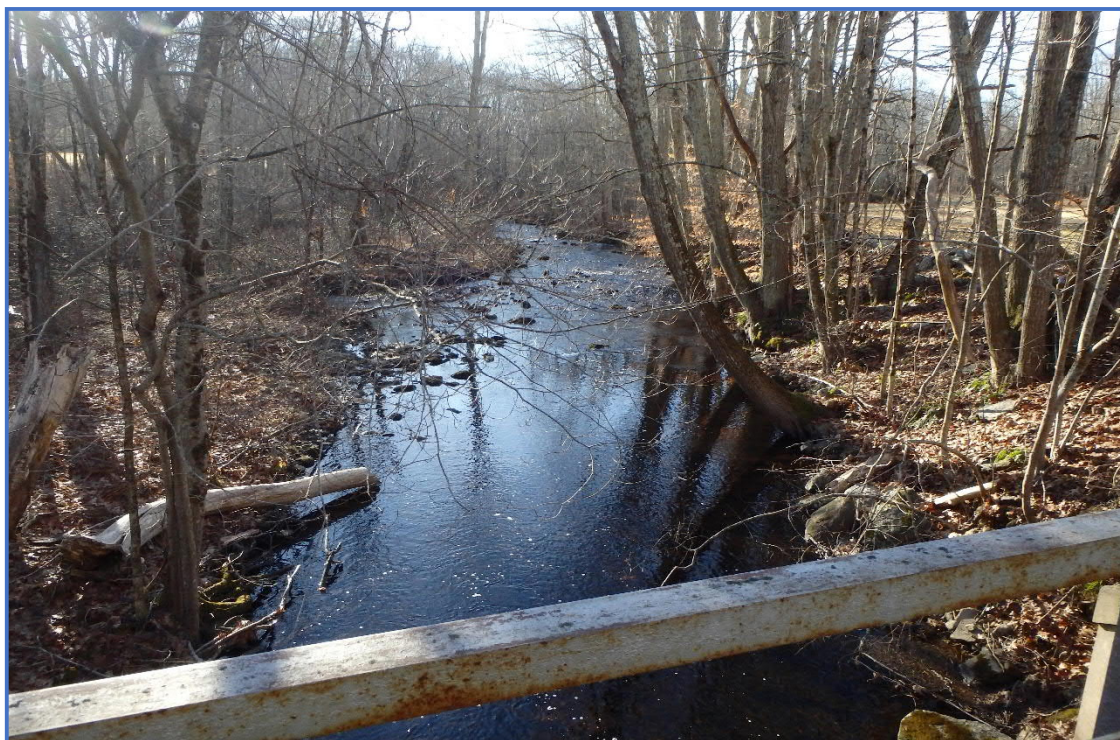
Approach embankment – The approach embankments appear to be eroding. The channel flow is favoring the west side where embankment undercutting exists both upstream and downstream causing exposed root systems and leaning trees (see photo 6). The approach embankments consist mostly of brush and vegetation.

Photo 6: Channel looking downstream (South) from bridge

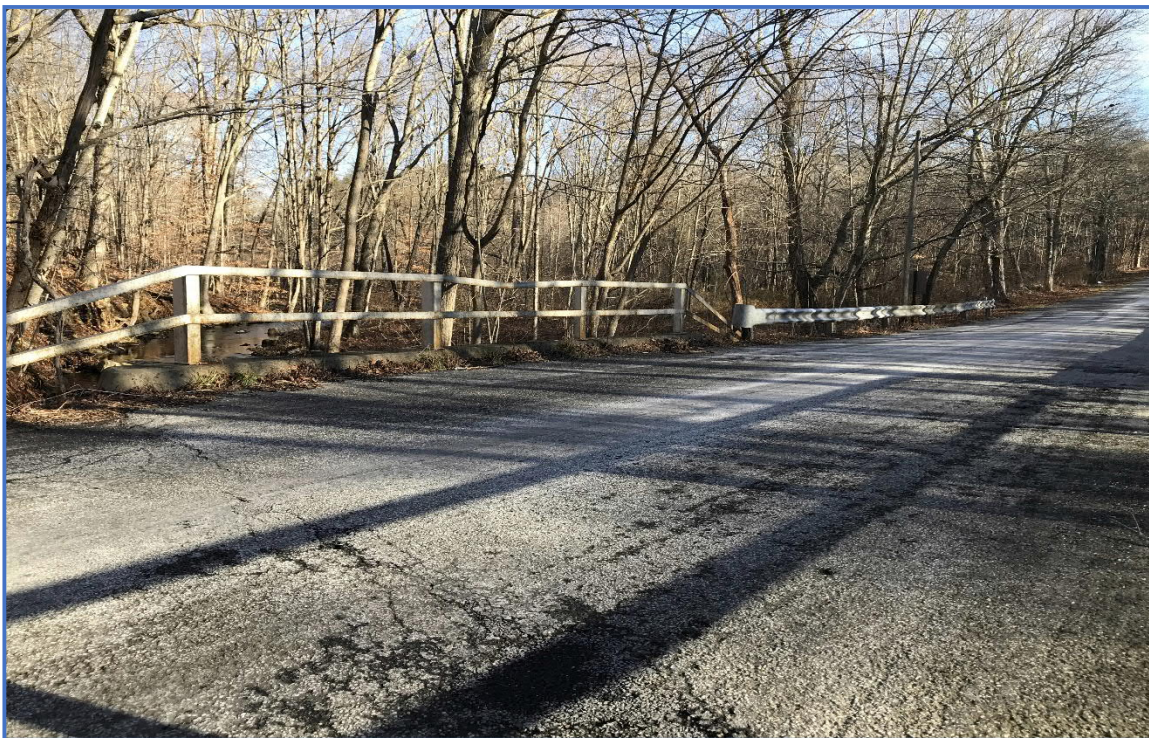
Overlay – The overlay is in fair condition due to deterioration and delamination. Transverse cracking for the full width of the roadway exists at each edge of deck. Delamination along railbases full length x 30" wide. Heavy sediment accumulation and vegetation was present at each gutterline (see photo 12).

Photo 7: Typical wearing surface overlay. Note full width transverse cracking at deck ends.

Based on the findings from the field inspection, several recommendations can be made in order to preserve the structural integrity of the bridge in the short term. It is recommended to remove and replace the existing pavement on the bridge. A membrane should be added to the top of the deck to limit the amount of deleterious de-icing salts that can penetrate the concrete. Cleaning and painting of the existing railing and the addition of fencing on the wingwalls should be included. Action should also be taken to prevent further scour to the west abutment and the west wingwalls. The scour countermeasure should be designed to re-align the channel towards the center of the bridge span, and be installed to protect the existing substructure from further scour which eventually will lead to undermining and ultimately structural instability. Potential construction cost estimate: \$100,000 (see Appendix B: Cost Estimate for the estimate breakdown).

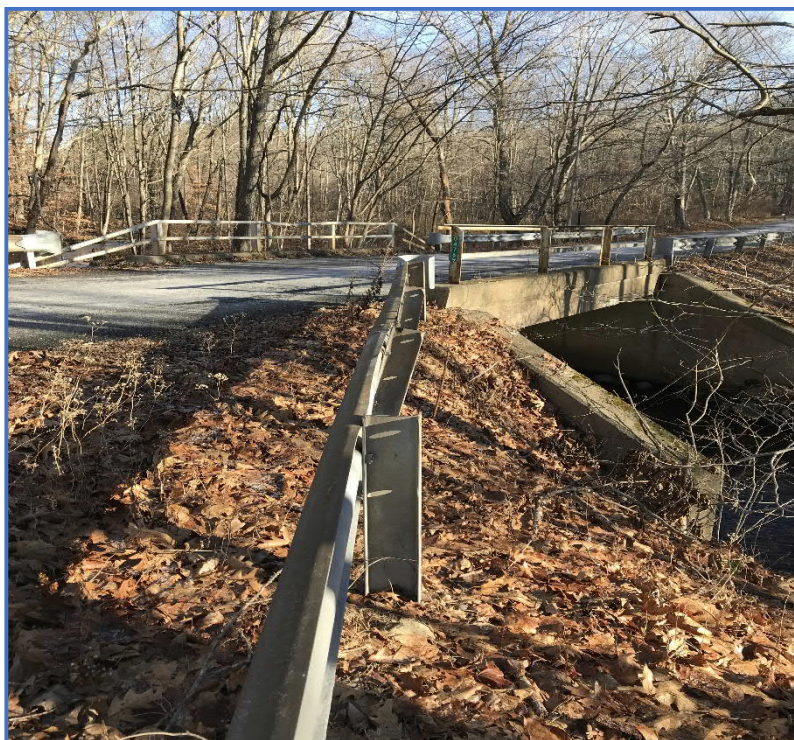
Approach guiderail – The approach guiderail appears to be in fair condition. There is metal beam rail on steel posts on all approaches. There are minor scrapes and dents evident at the guiderails, as well as leaning posts (see photo 8). There is a bridge rail transition at the approaches on the north side, but no railing transition on the south.

Photo 8: Southwest approach corner and bridge rail, leaning posts

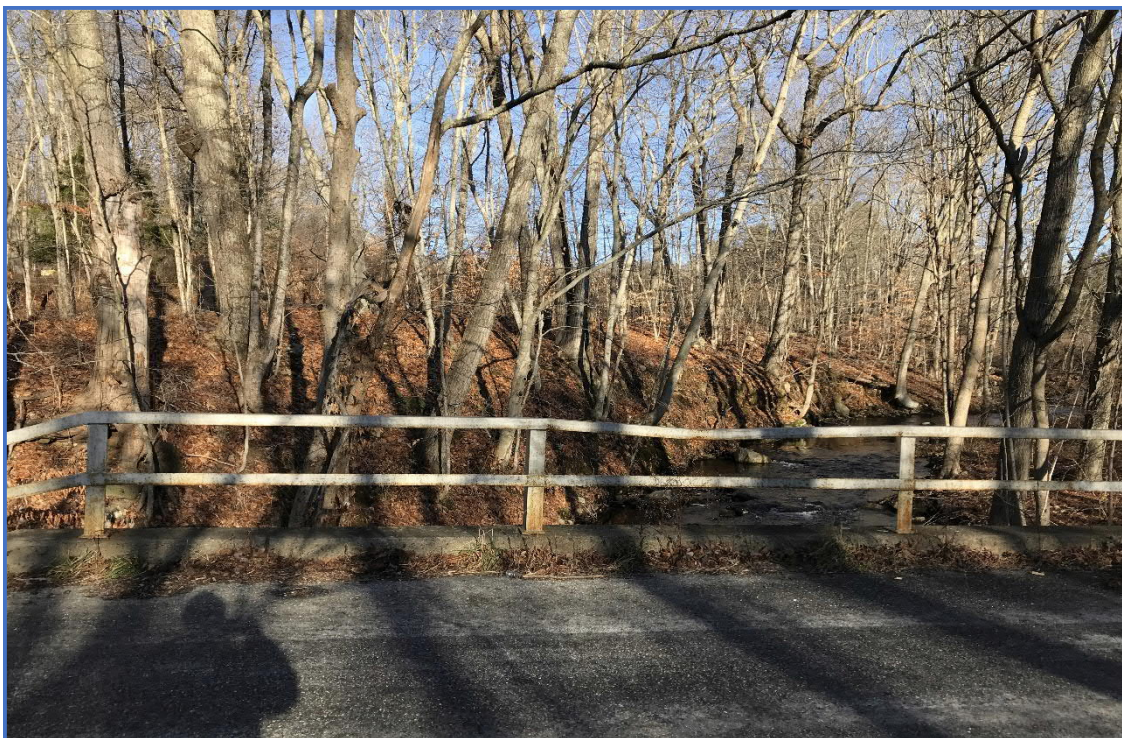
Railing – The railing is in fair condition. The painted angle steel railing and angle steel posts exhibit light surface rust throughout. The north side top rail is bent approximately 3 inches down near midspan. There is a bridge rail transition at the approaches on the north side, but no railing transition on the south.

Photo 12: Bent rail north side of bridge (note typical surface rust)

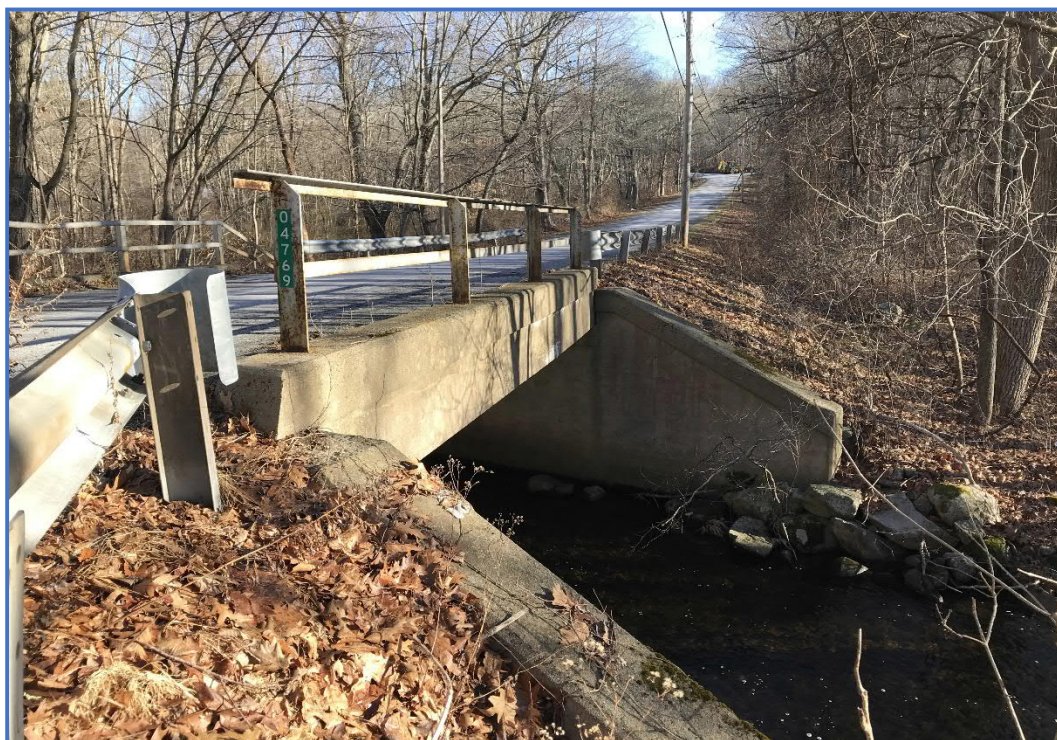
Photo 14: Southeast corner wingwall, rip rap at outlet side

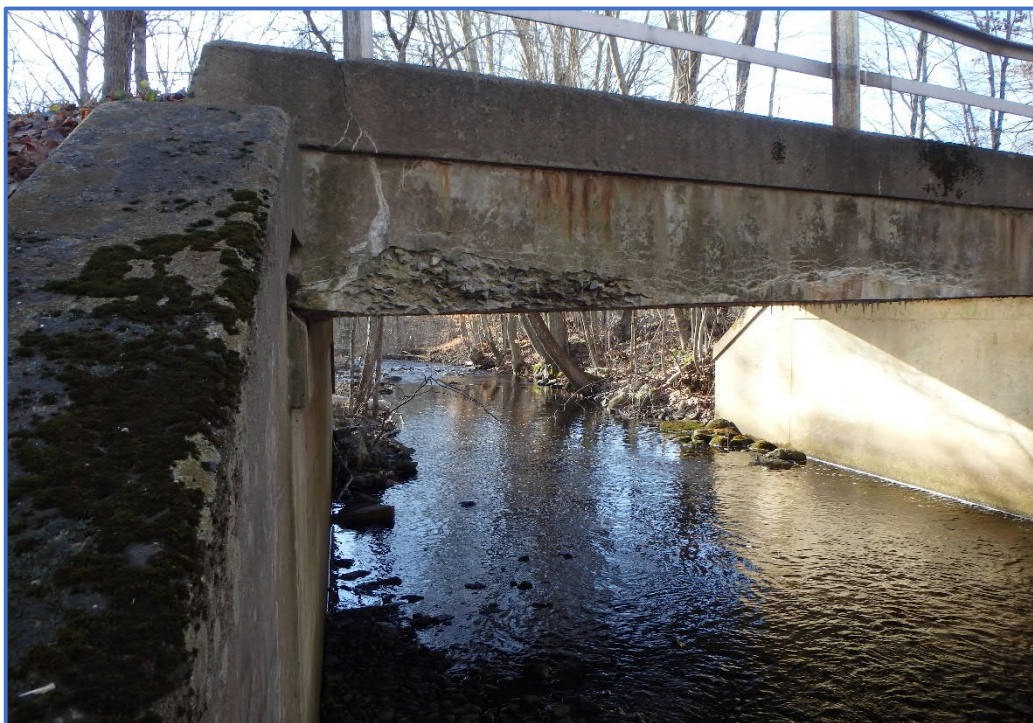
Deck – The reinforced concrete deck remains in fair condition. Hairline cracking and longitudinal cracks with efflorescence exist in random locations on the underside of deck towards the inlet side end face of deck. At the end face of deck, there are areas of severe spalling approximately 4'-0" long x 1'-0" high x 3" deep (see photo 17). The surrounding concrete is also hollow. There is another location on the same face of deck with hairline longitudinal and diagonal cracking with heavy efflorescence and hollow concrete (see photo 17). Spalling up to 2'-0" and 4" deep exists on the same north face and underside of deck, however there is no exposed rebar (see photo 18). The south face of deck (outlet end) shows a 4'-0" x 2'-6" approximate area of hairline map cracking and efflorescence (see photo 21).

Photo 17: North side of deck, severe spalling and longitudinal hairline cracks with efflorescence. (Inlet end)

While the recommendations above will help to preserve the bridge within the short term, the Town should plan and budget to perform a major rehabilitation of the structure within the next 10 years. The rehabilitation project will involve a superstructure (deck) replacement with substructure repairs and scour countermeasures. Potential construction cost estimate: \$550,000 (see Appendix B: Cost Estimate for the estimate breakdown).

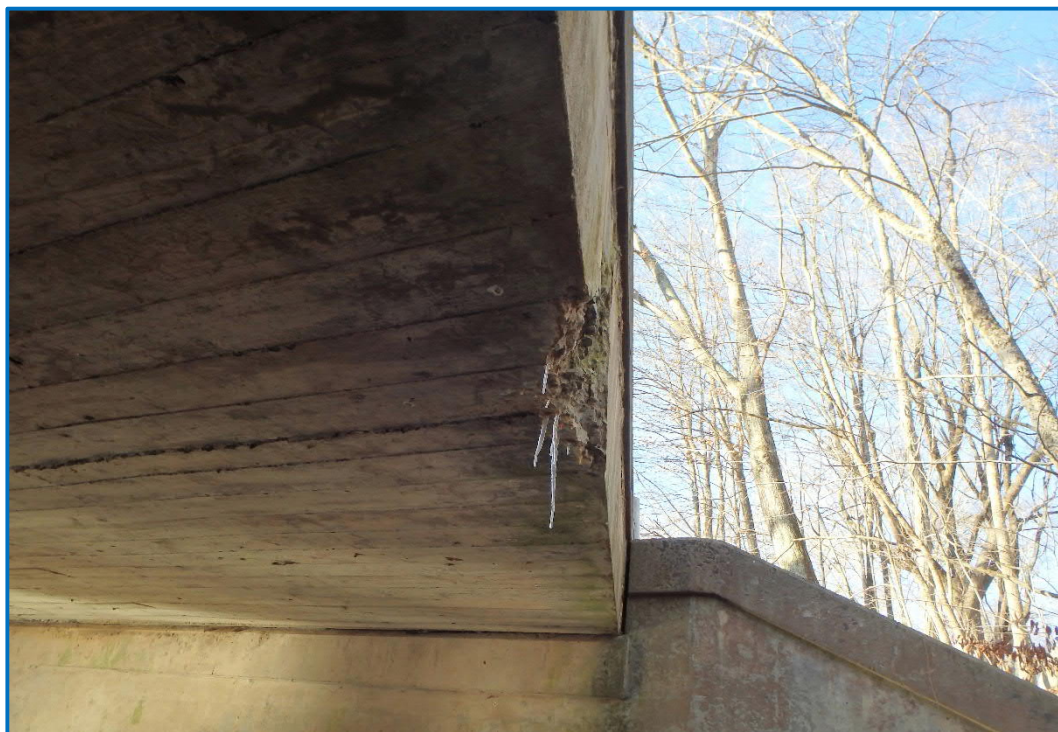
Photo 18: Typical underside and north side of deck severe spalling. (Inlet end)

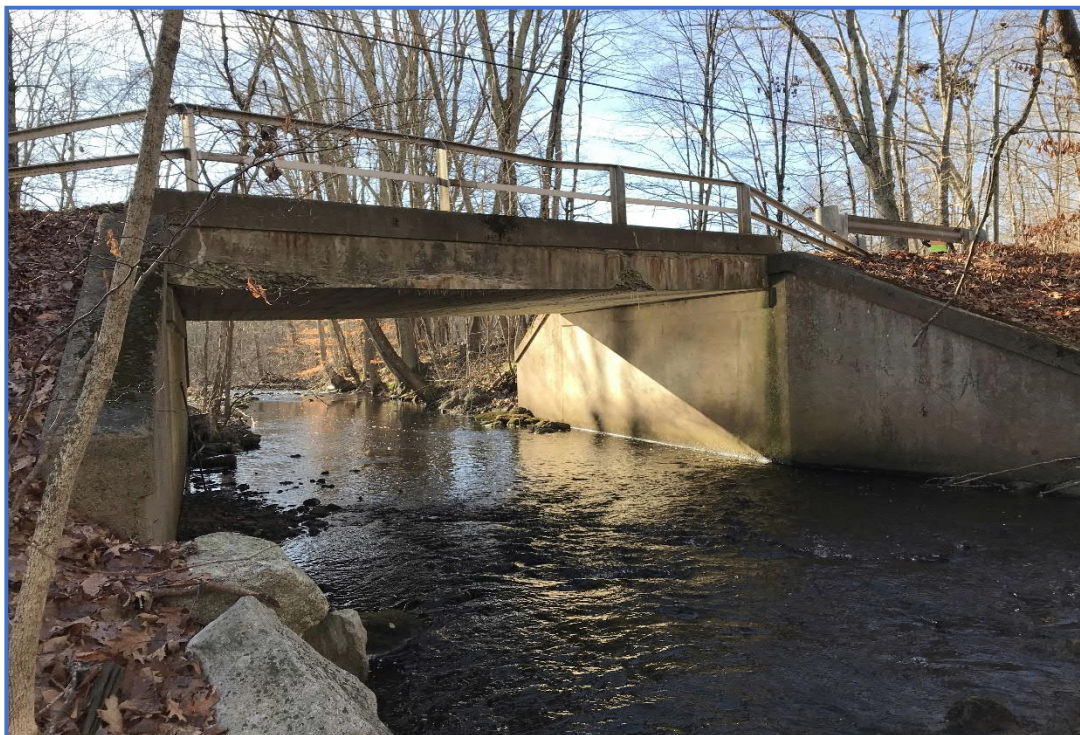
Photo 20: North side of deck, North side of deck, severe scaling and longitudinal hairline cracks with efflorescence. (Inlet end)

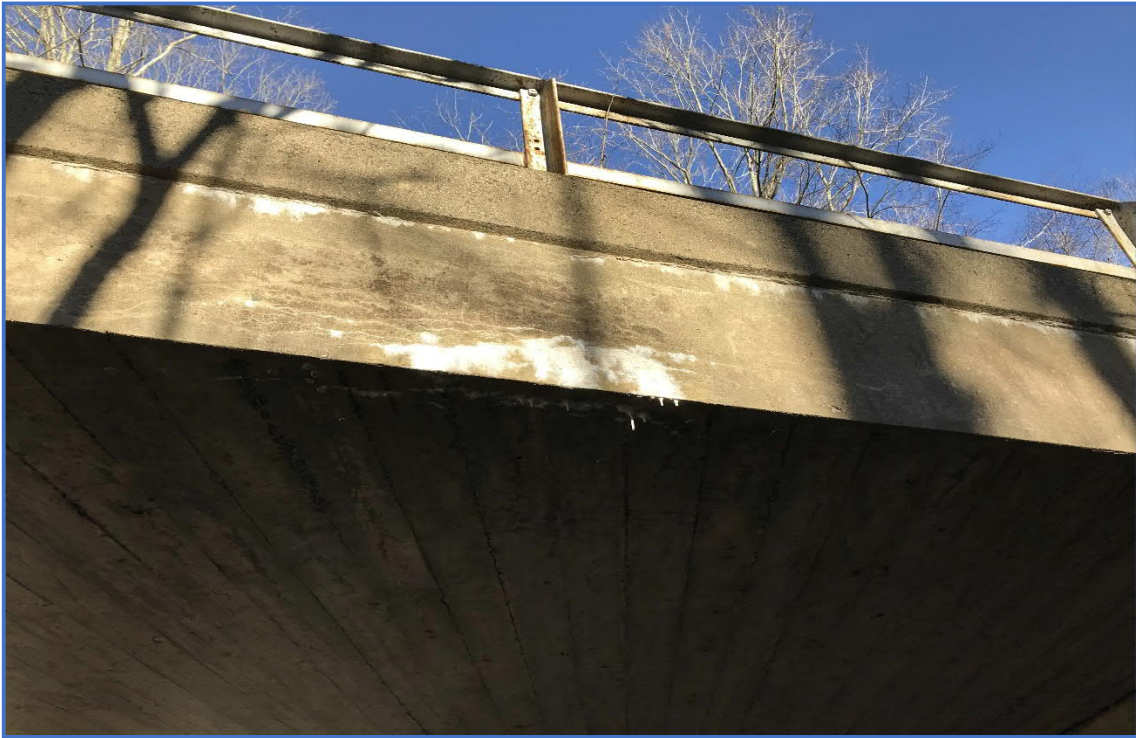
Photo 21: South side deck, longitudinal cracks with efflorescence (outlet side)

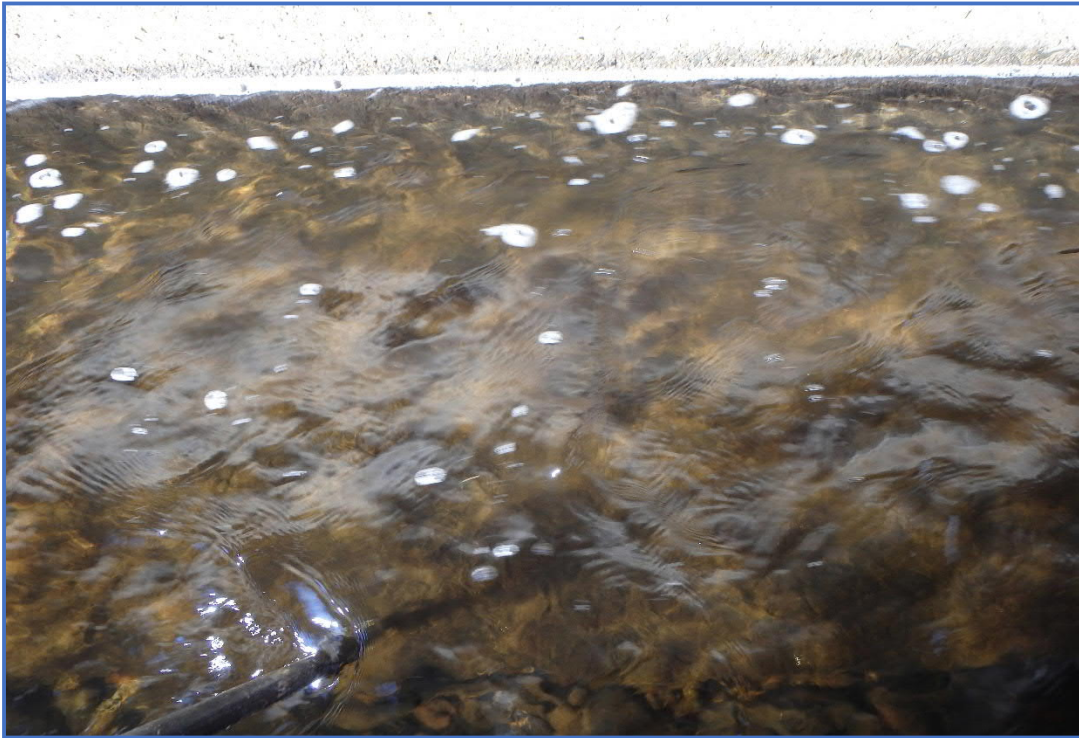
Erosion and scour – The footings in regards to erosion and scour remain in fair condition. The west abutment and northwest footings are exposed full length (see photo 23). The vertical face is exposed up to 12", but no undermining was noted at the time of inspection. There is gravel build up on the east abutment. There is evidence of bedrock upstream and downstream of the bridge. The structure may be founded on bedrock.

Photo 23: West abutment, exposed footing

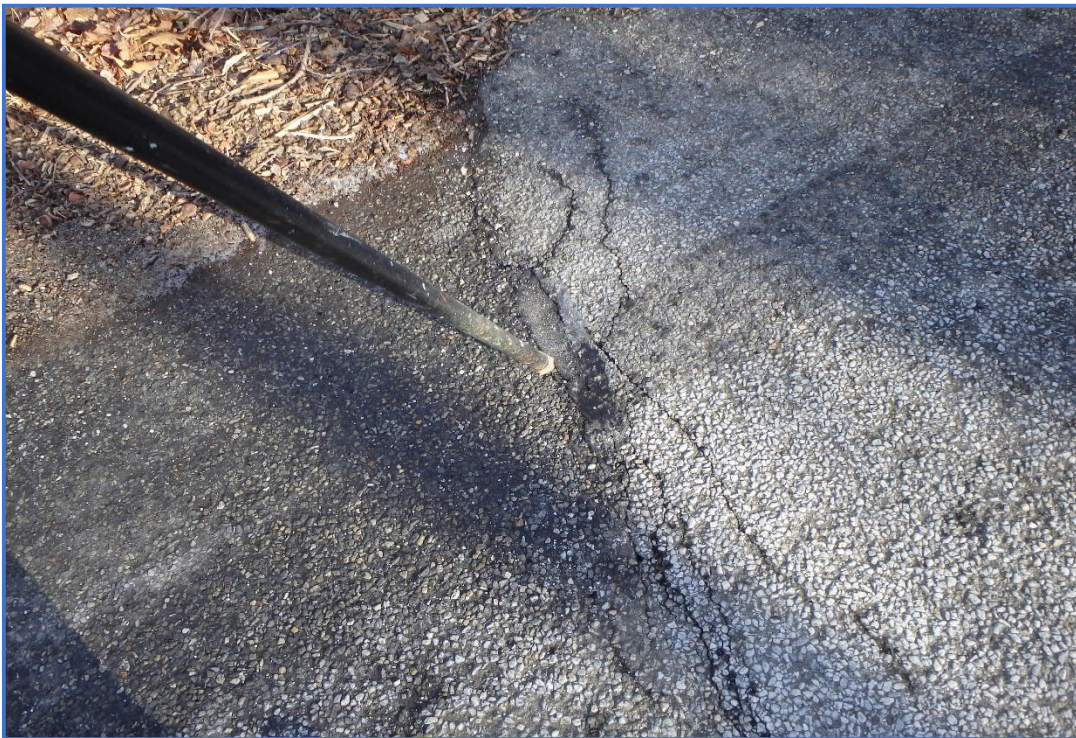
Approach pavement – The approach pavement is in poor condition. There are transverse and longitudinal cracking up to ¼” wide that exists in random locations. There is evidence of previous crack sealing that has failed. Minor wheel rutting exists, as well as settlement up to 1” at the approaches immediately before and after the bridge.

Photo 24: Settlement and transverse cracking at approach west side
