## Bridge Conditional Assessment

**Bridge No. 04771 in Scotland, CT**  
**Brook Road over Merrick Brook**

Issued: January 29, 2021

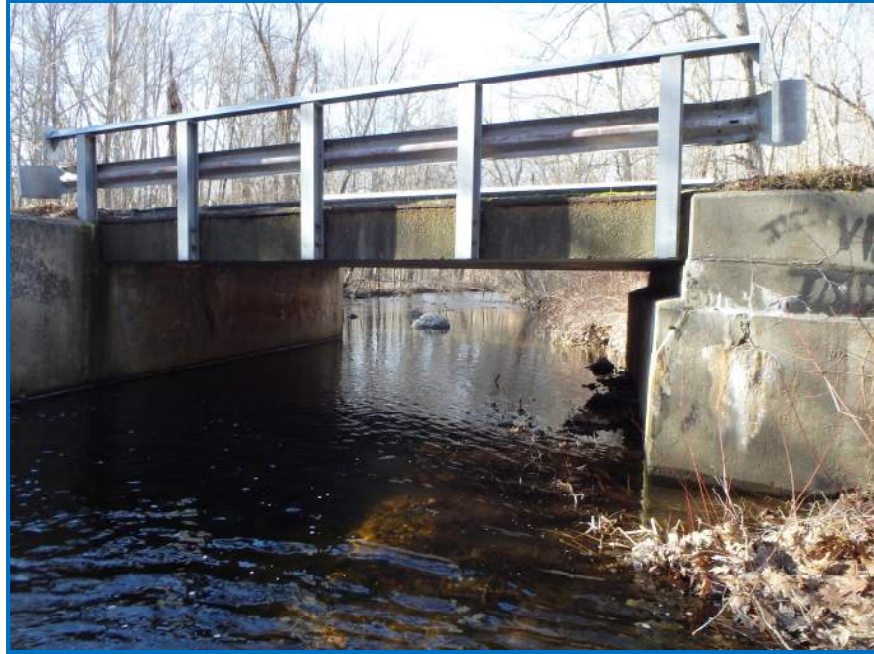
*Photo 1: Elevation*

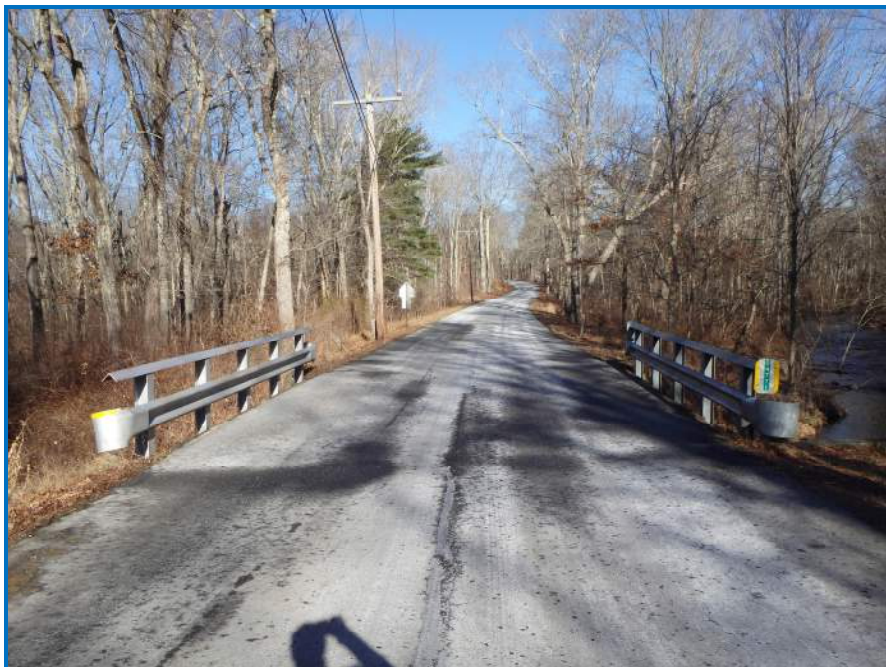
*Photo 2: North Approach*

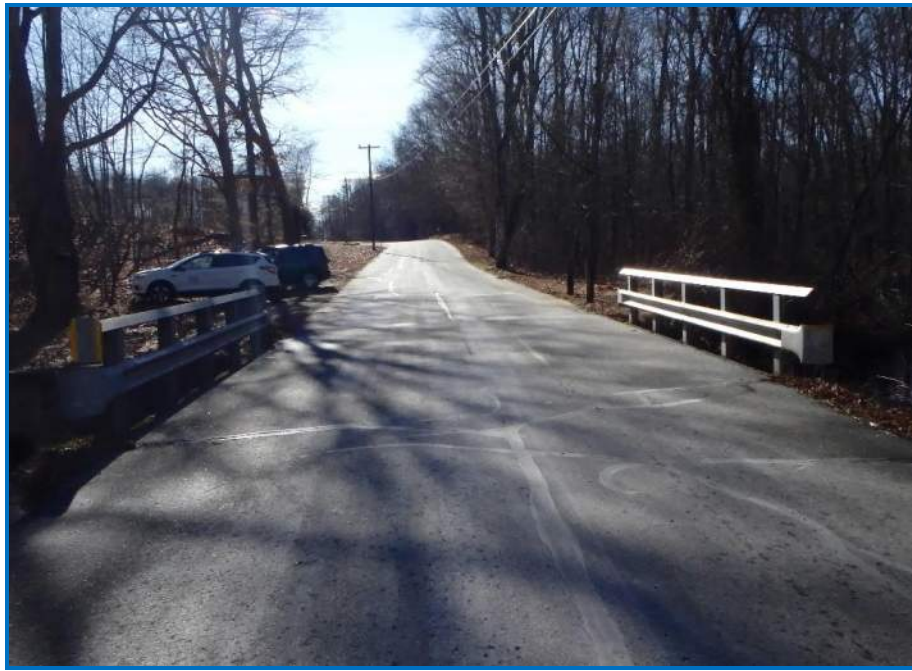
*Photo 3: South Approach*

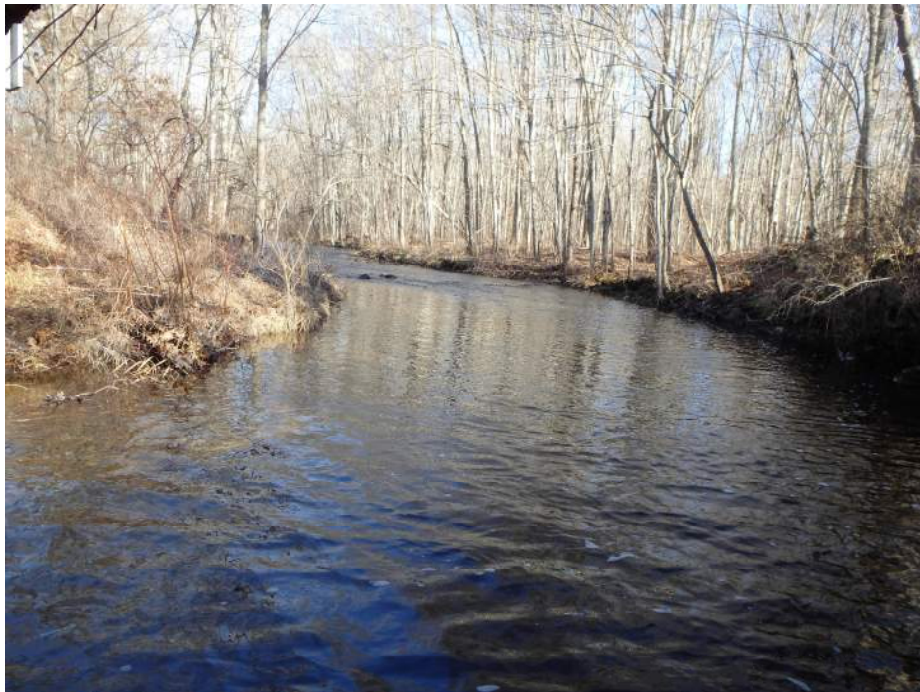
*Photo 4: Channel looking upstream from bridge*

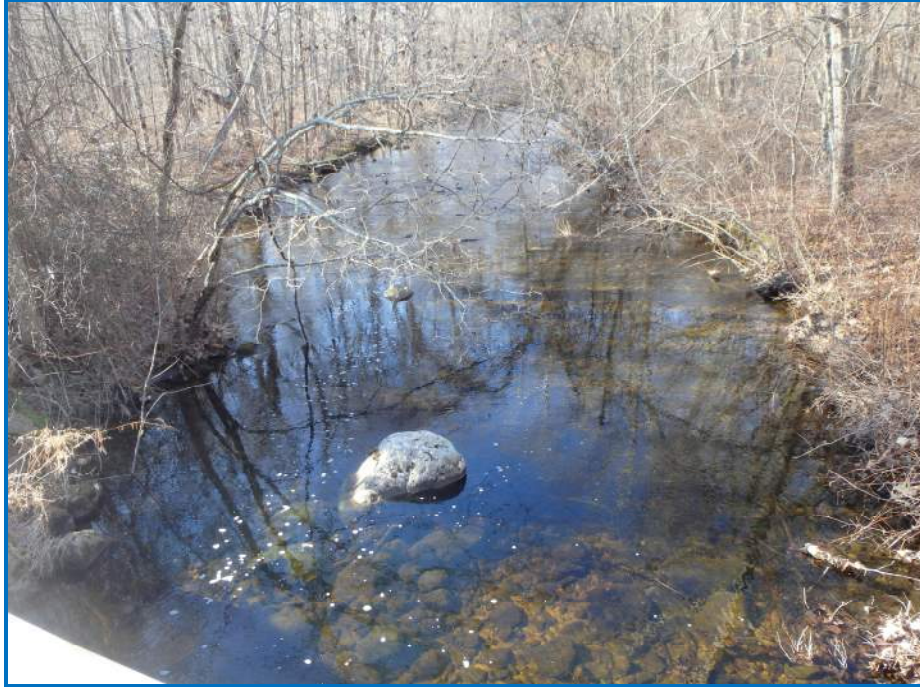
*Photo 5: Channel looking downstream from bridge*

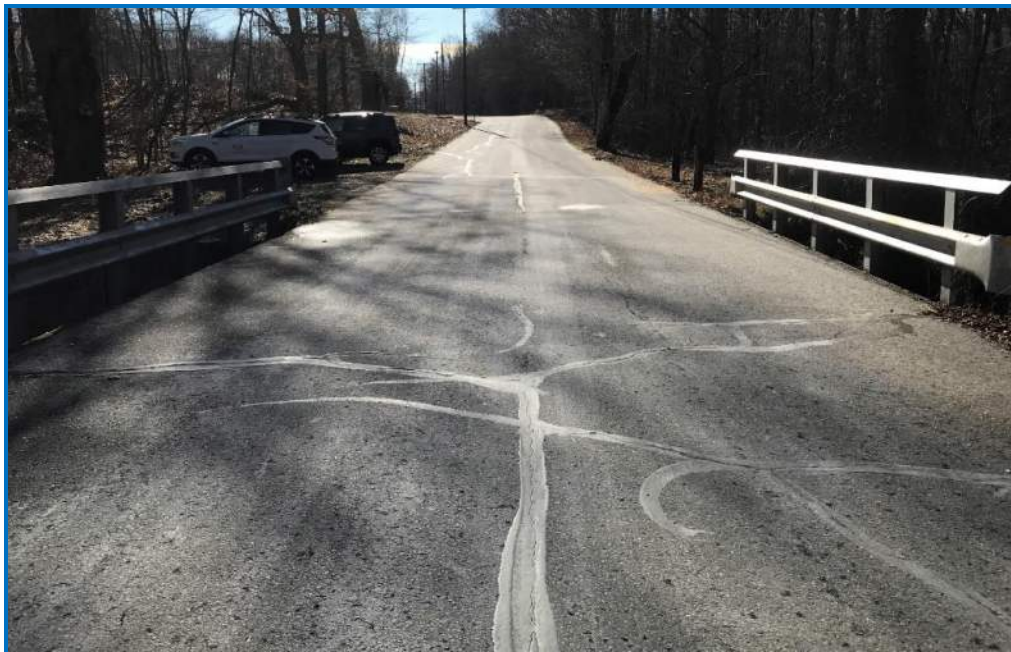
*Photo 6: Overlay cracking & sealing*

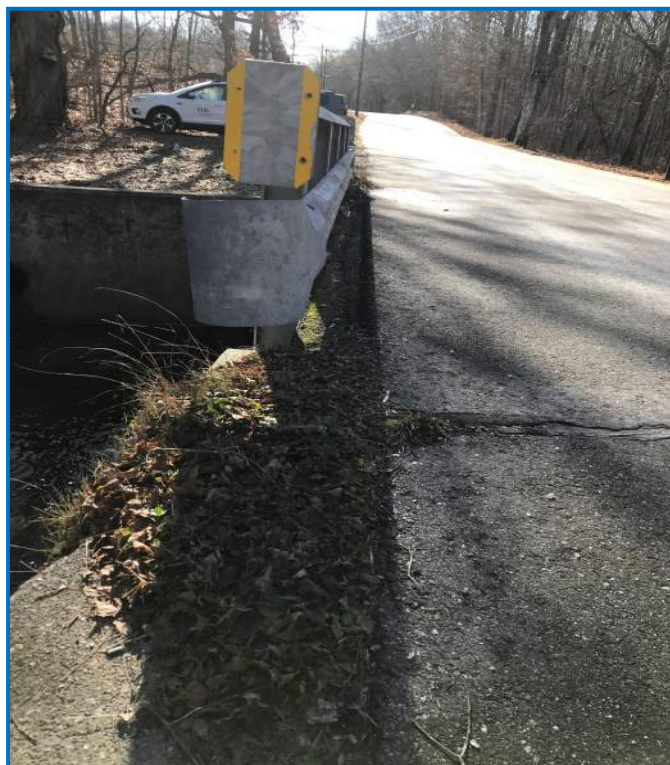
**Overlay** - The overlay of bituminous concrete with no membrane is in good condition. The overlay does not extend to the deck edges (see photo 7). Minor transverse and longitudinal cracks are present. Transverse crack at north end of deck (up to ½" wide) approximately 10' long. Longitudinal cracking appears to run from the CL of south approach through the bridge and into the north approach.

*Photo 7: Typical approach rail*

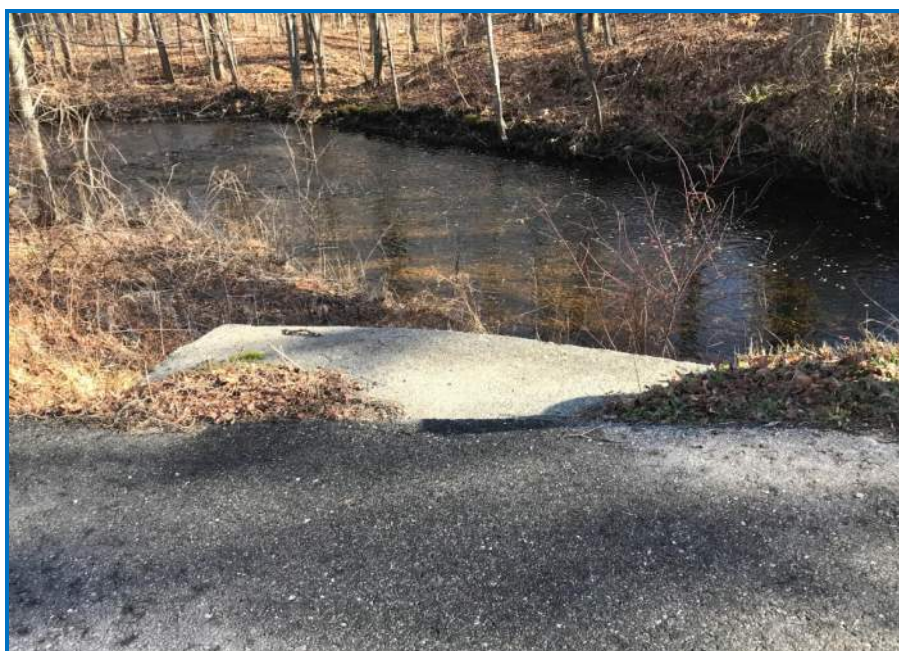
**Curbs** – No curbs are present along either fascia. Previous curbs appear to have been removed at some point. The edge of the deck overlay ends approximately 10” from the railing, leaving a 3” drop off (see photo 8).

*Photo 8: Concrete buildout over NE WW*

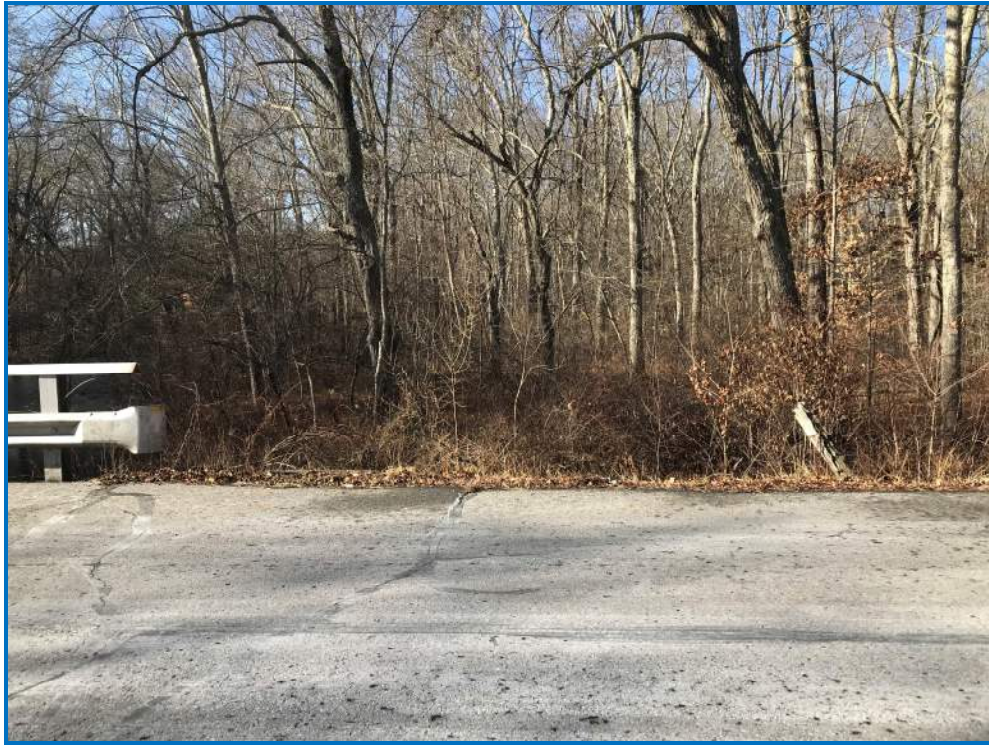
**Deck** – The reinforced concrete deck is in good condition. Moderate efflorescence and scaling exists for the full length of both outside faces of the fascias (see photos 11 & 12). At the north fascia, the efflorescence is heaviest at both the east and west edge of deck. Efflorescence note on northern portion of deck underside (see photo 13). Heavy efflorescence and cracking, up to full span length, is prevalent on the southern portion of the underside of deck (about ¼ of the deck width) (see photo 14).

*Photo 9: Approach rail with abandoned wooden posts*

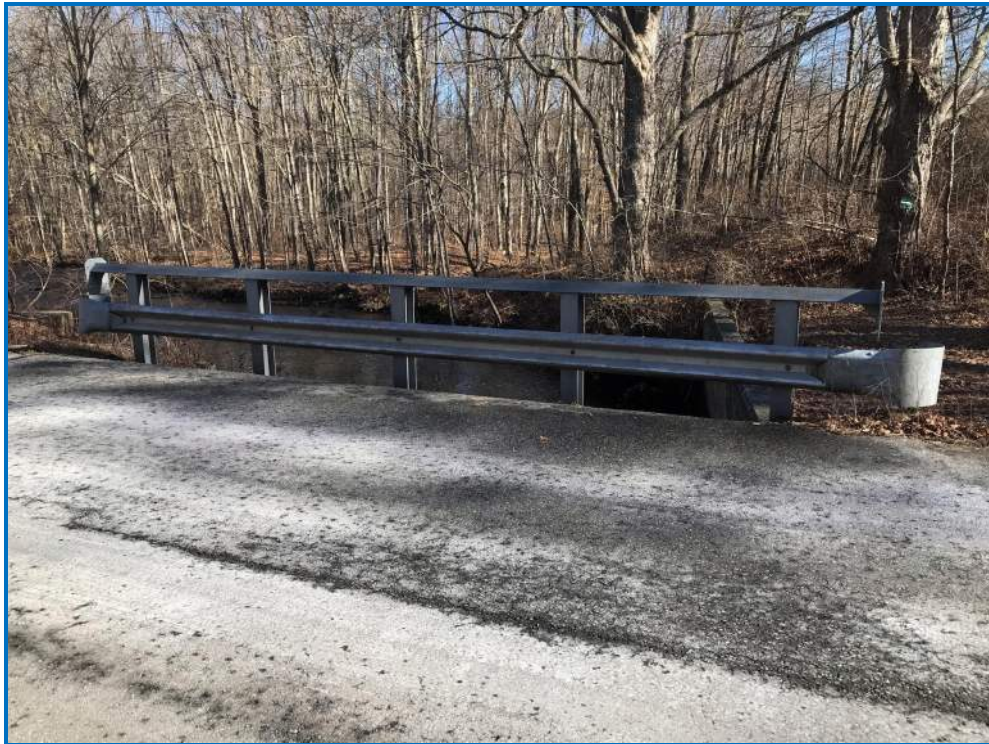
**Wingwalls (Stem)**– The wingwalls are in fair condition (6). There is light scaling at the waterline. Wingwall 1A shows a surface spall (approximately 16”x6”x1.5” deep). The southeast wingwall shows signs of light scaling throughout the wall, with the heavier scaling at the outlet drain pipe. The northwest and northeast wingwalls have moderate mortar voids up to 8” penetration and hairline cracking (see photos 12 & 16).

**Approach Guide Rail** – No approach guiderail is present. There is no protection on the east side of the bridge approaches, with only abandoned wooden posts and no cables at the west side approaches. The bridge railing terminates at each end of the bridge with a blunt end bullnose (see photo 10). The railing does not properly transition off the bridge beyond the clear zone, creating a hazard due to the blunt end fixed condition and allows the ability of an errant vehicle to drive into the brook.

*Photo 10: East rail*

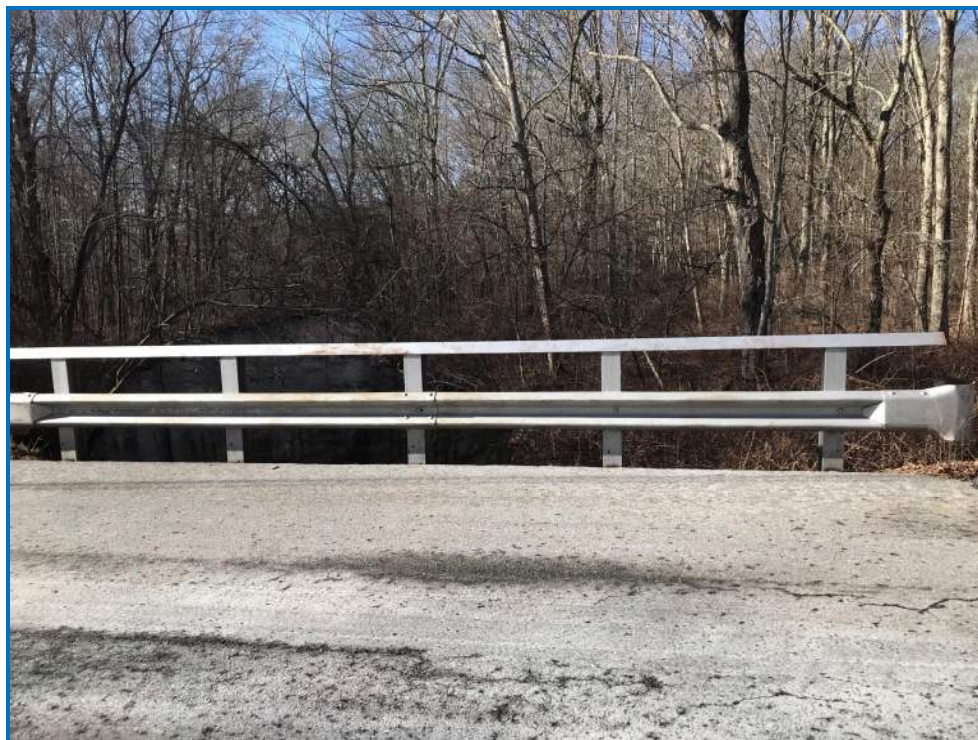
*Photo 11: West rail*

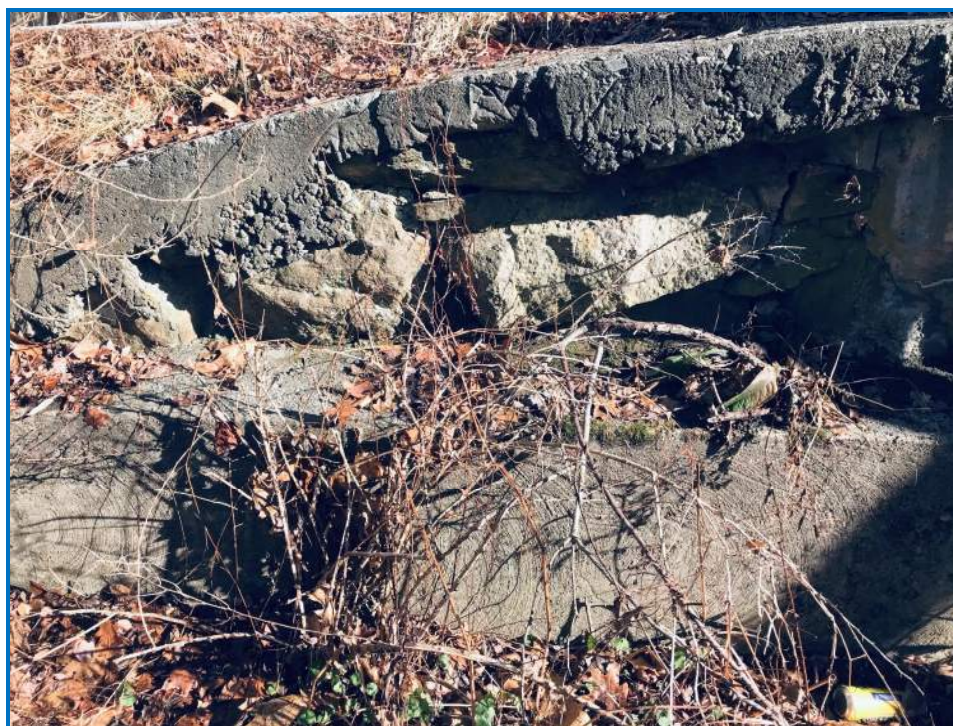
*Photo 12: Wingwall 2A (NW)*

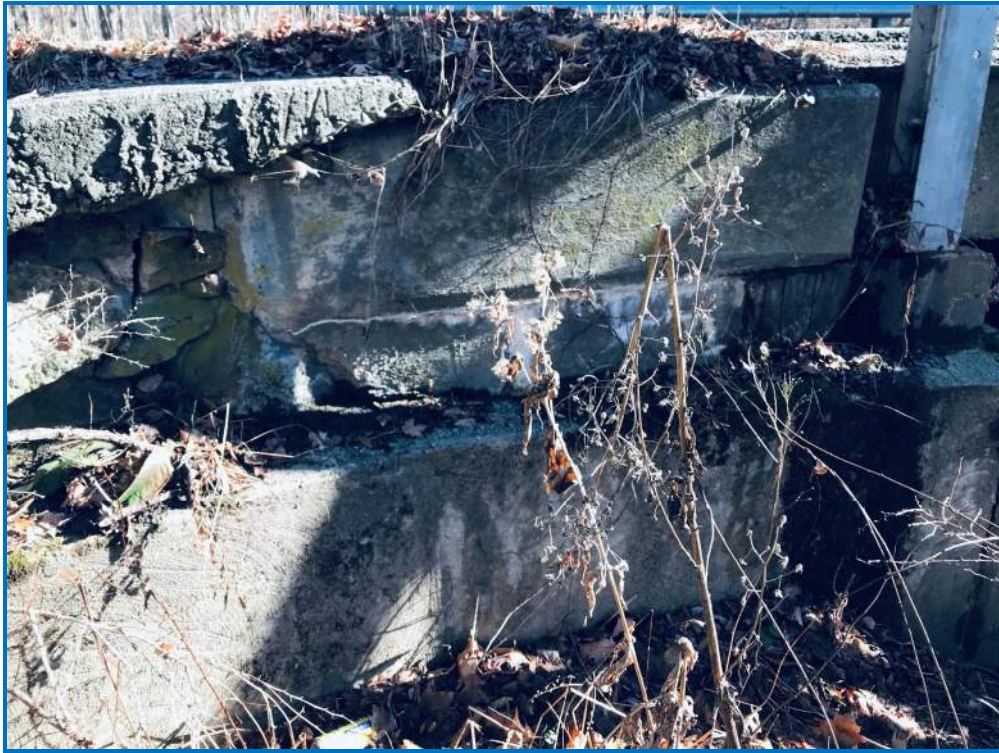
*Photo 13: Wingwall 2A (NW)*

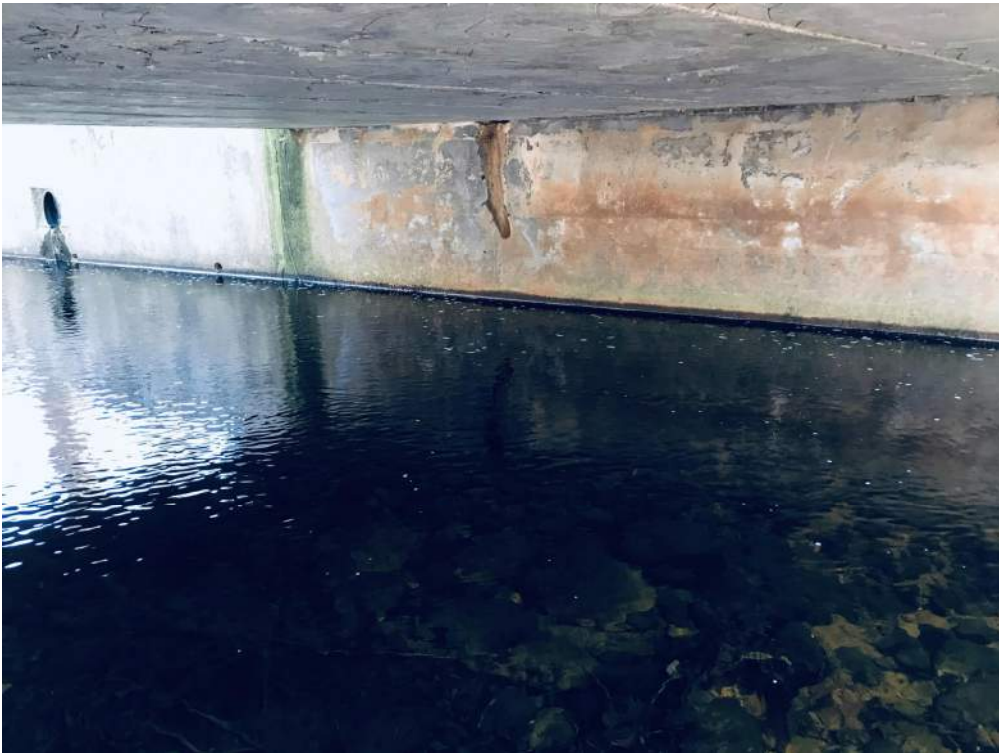
*Photo 14: Abutment #2 (south) elevation*

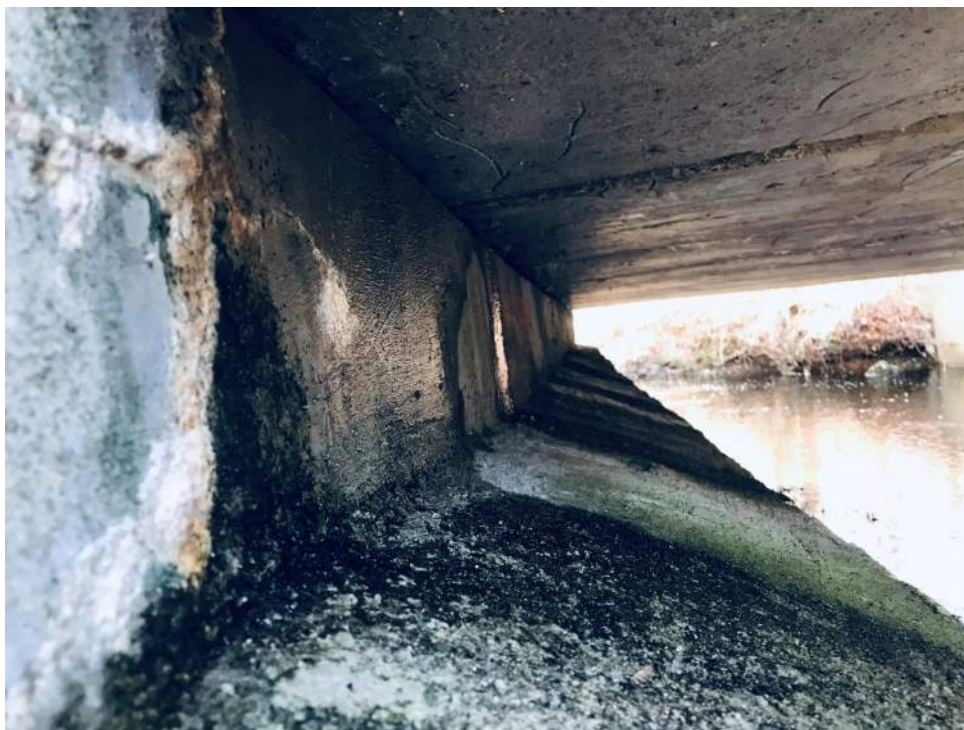
**Abutment (Stem)** – The abutment stems are in fair condition. There are signs of leakage at most joints and efflorescence is evident at mid-height with vertical hairline cracking. There is an 8”x10” hollow area with diagonal crack and efflorescence at the east end of abutment #2.

*Photo 15: Leaking joints at abutments*

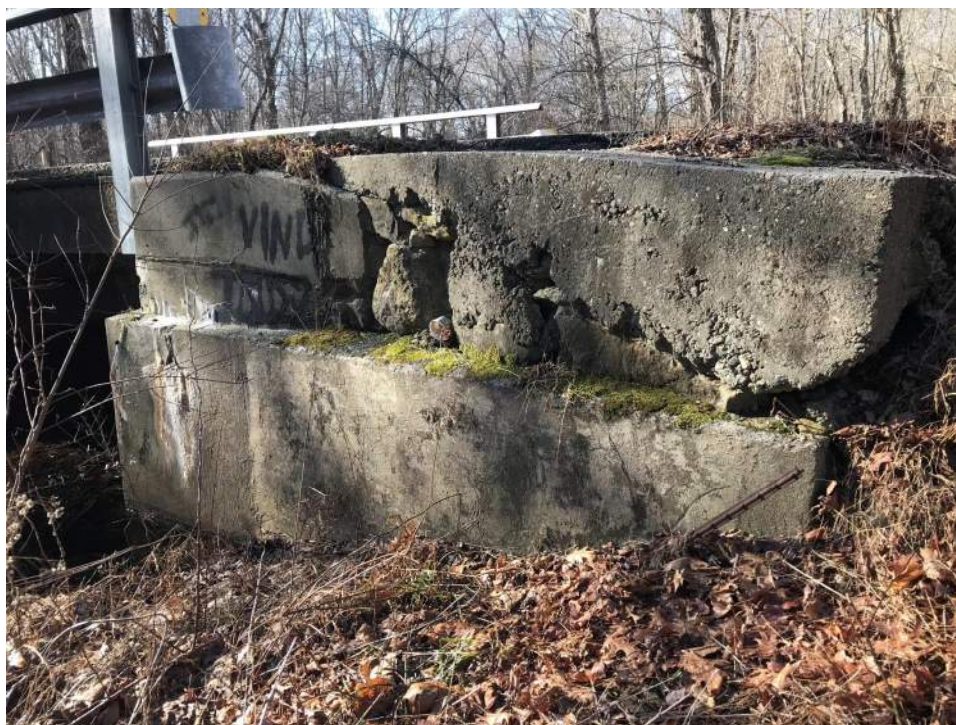
*Photo 16: Wingwall 2B (Northeast) w/ erosion at free end*

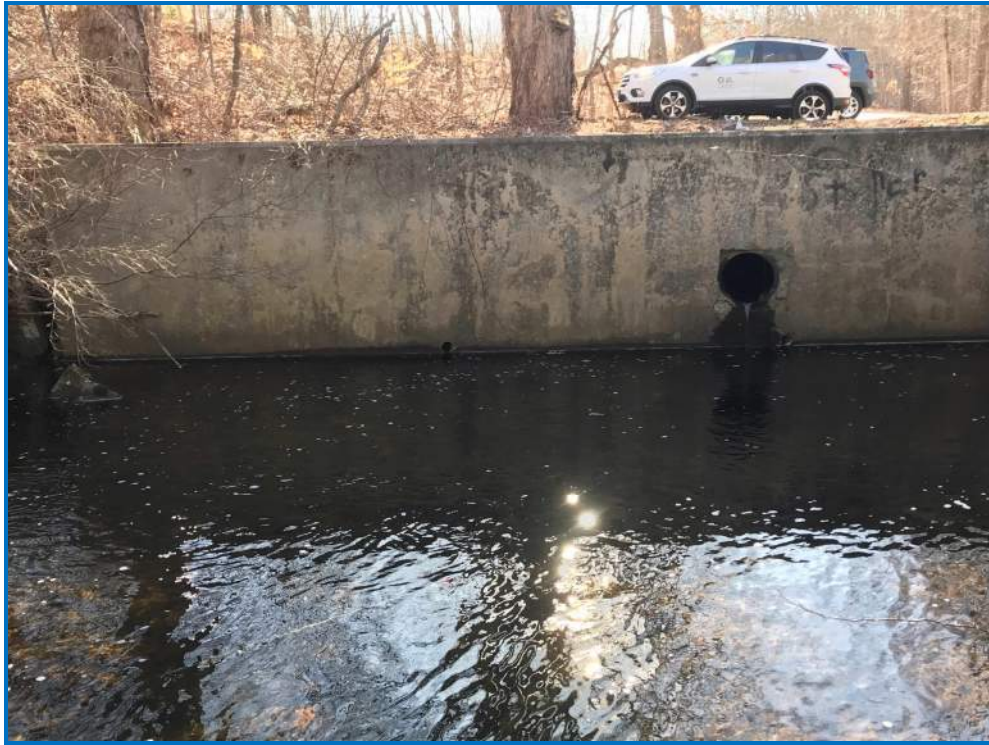
*Photo 17: Wingwall 1B (SE) elevation*

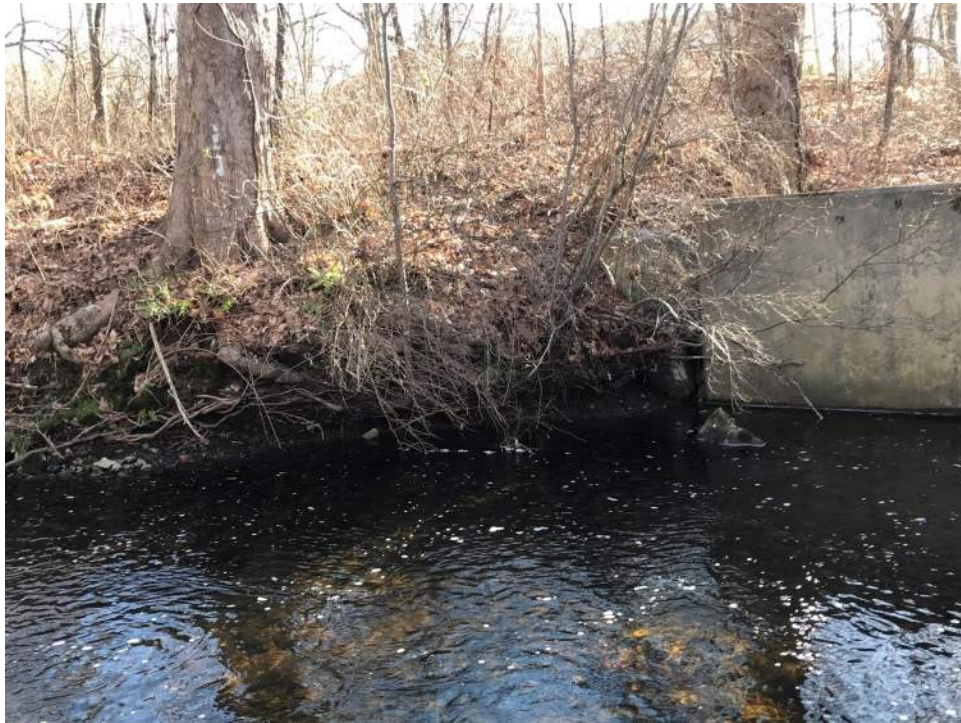
**Approach Embankment** – Approach embankments are in good condition with minor erosion. The channel centerline makes an abrupt turn as it approaches the structure with flow directed towards the southeast wingwall and the south abutment. This change to Merrick Brook’s angle of the attack has led to embankment erosion and scouring of streambed material surrounding the nearby tree root wads (see photo 18). Undercutting upstream and downstream is exposing tree root systems. The approach embankments consist mostly of brush and vegetation.

*Photo 18: Embankment erosion beside WW 1B, undercut/exposed tree root systems*

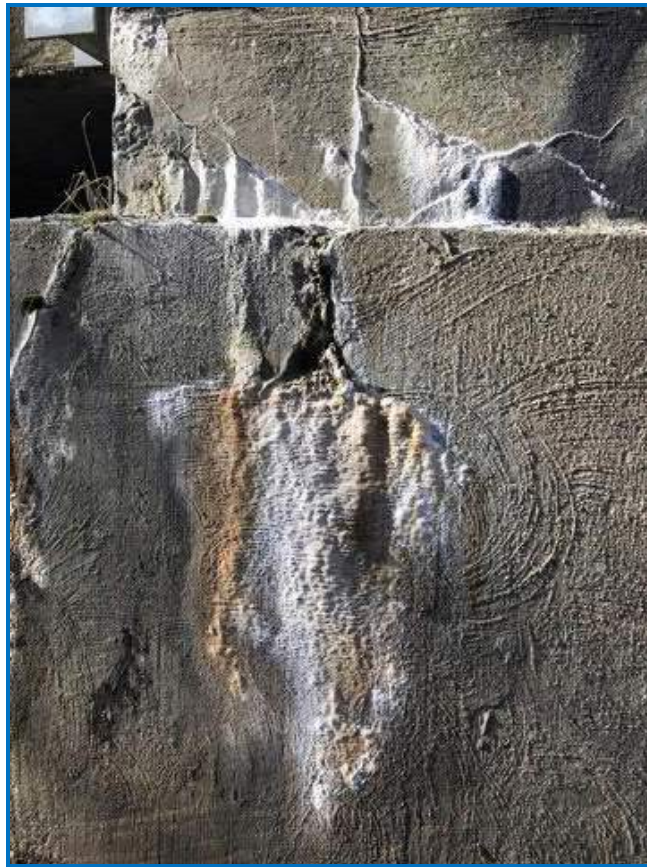
*Photo 19: Efflorescence at WW 2B (Northeast)*

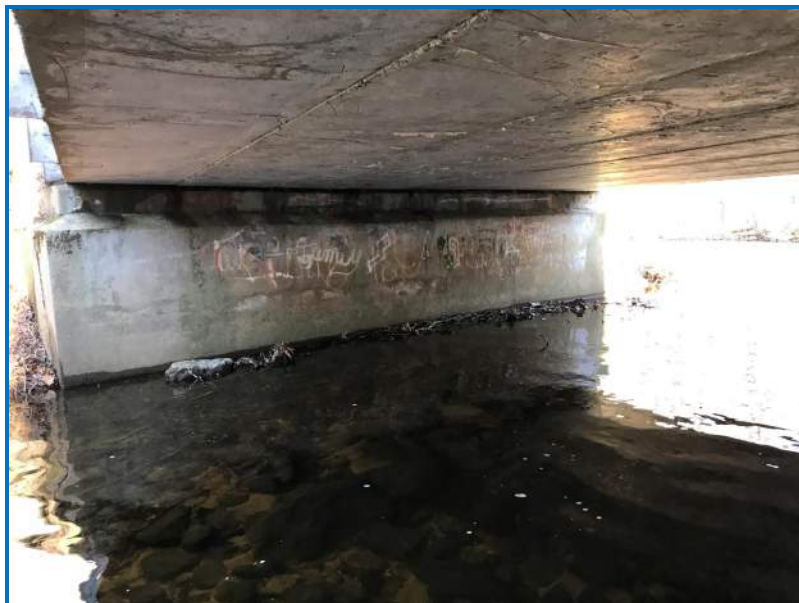
*Photo 20: Abutment #2 (north) elevation*

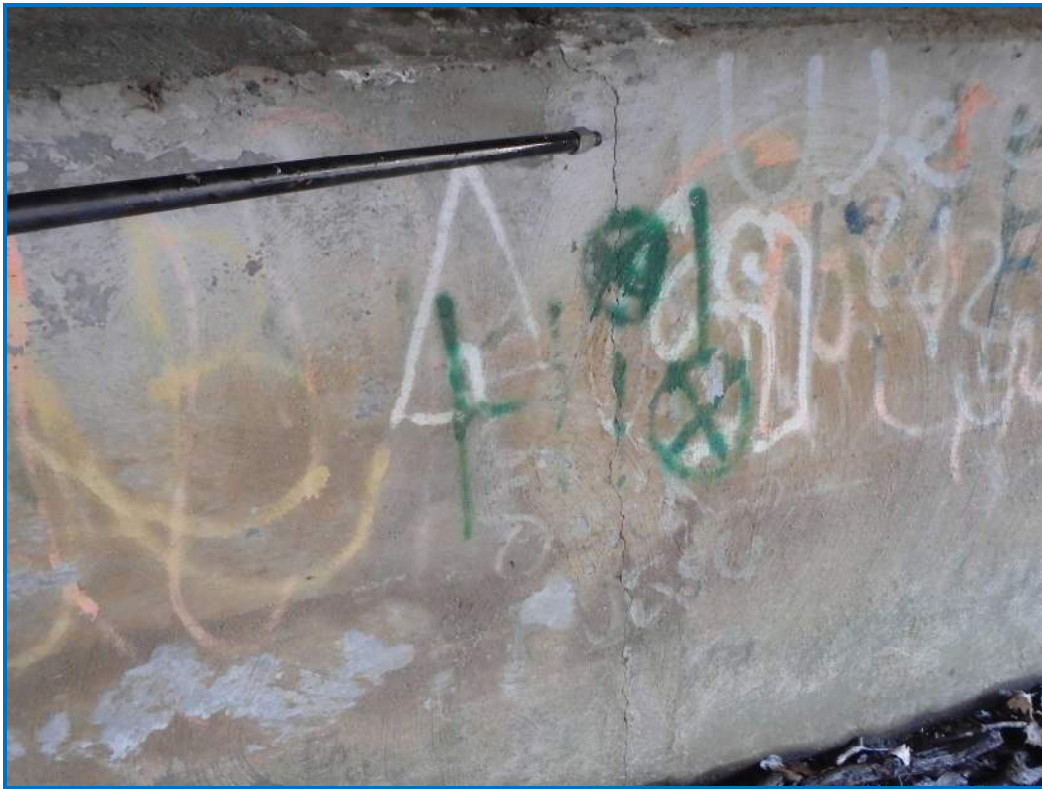
*Photo 21: Vertical hairline cracking at Abutment #2 (North).*

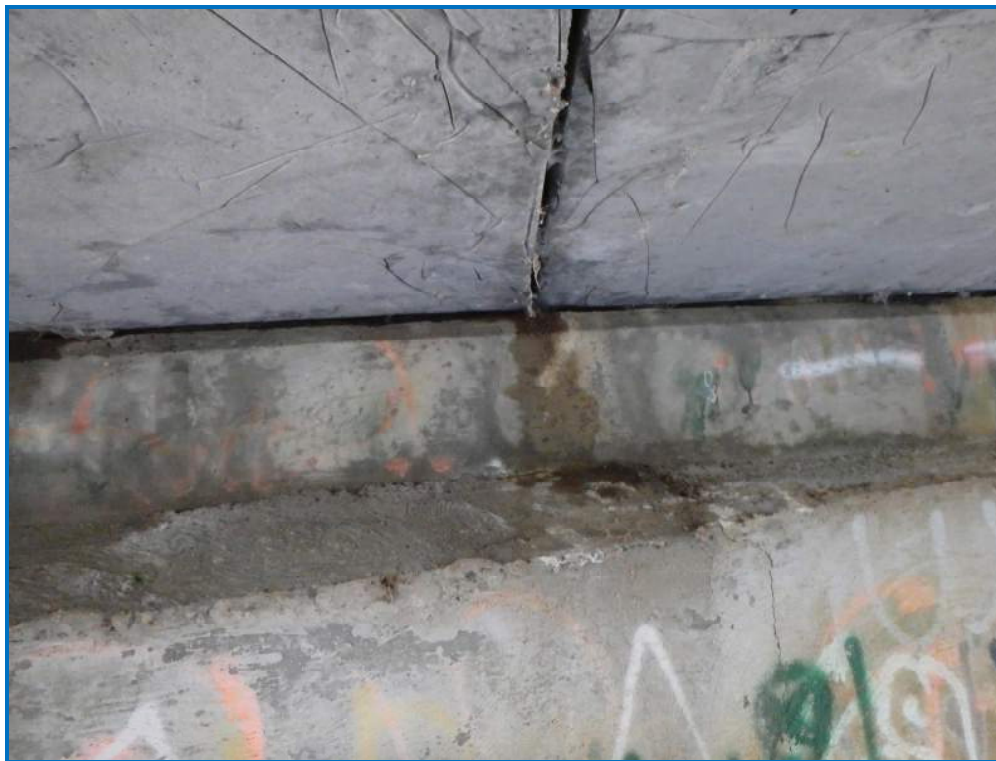
*Photo 22: Abutment #2 (north) leaking underside of deck at joint. Hairline cracking at abutment*

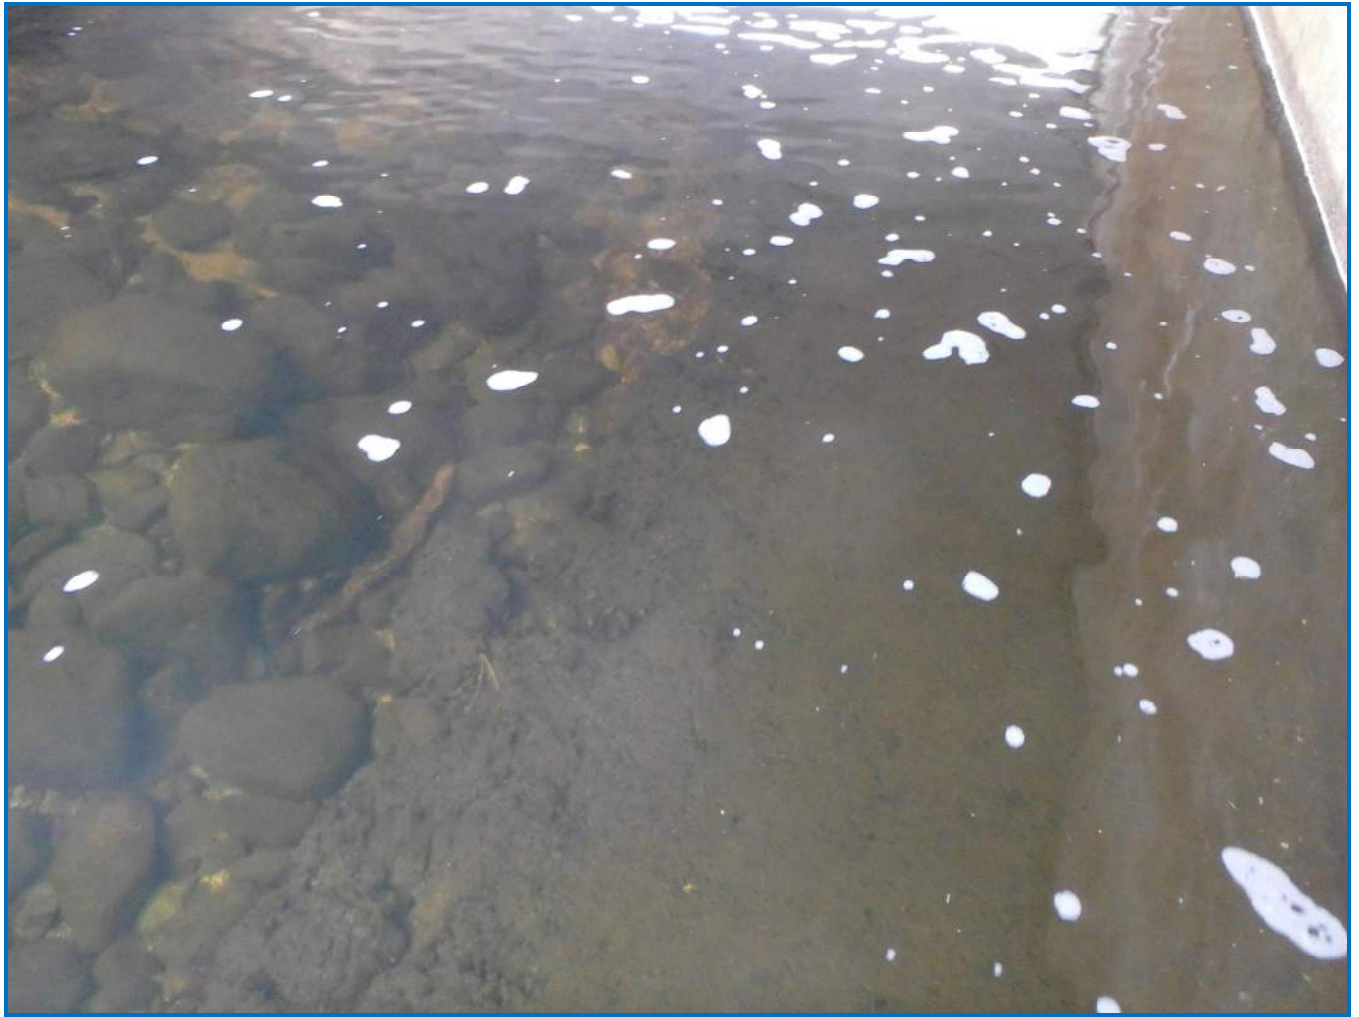
**Erosion and scour** – Erosion and scour of the structure remains in poor condition. The overall substructure rating is driven by the erosion and undermining that is evident. The south abutment footing, including its overpour, is exposed full length. The area of a concrete over pour at the south abutment is undermined for the full length of up to 16” penetration at the time of field inspection. Our observations match those of the recent inspection report suggesting that the conditions are serious but not rapidly progressing.

*Photo 23: Abutment #1 (South) Exposed footing and overpour*

Based on the findings from the field inspection, CHA is offering recommendations to preserve the structural integrity of the bridge as well as improve roadside safety at the site in the short term. It is apparent this bridge exhibits a high vulnerability to scour due to the geometry and the extreme turn the channel takes at the bridge. Action should be taken to prevent further scour to the south abutment and the southeast wingwall. The scour countermeasure should be designed to re-align the channel towards the center of the bridge span and be installed to protect the substructure from further scour which eventually will lead to undermining and ultimately structural instability. Measures should be taken to repair the northwest and northeast wingwalls mortar voids and deterioration, as well as addressing the fall hazard at the southeast wingwall by installing a fence. Additionally, a proper approach guiderail system should be installed at each corner of the bridge to provide safety to drivers by shielding them from a blunt end and redirecting vehicles to the roadway. Potential construction cost estimate: \$100,000 (see Appendix B: Cost Estimate for the estimate breakdown).
