Bridge Conditional Assessment

**Bridge No. 04770 in Scotland, CT
Brook Road #2 over Merrick Brook**

Town of Scotland
Scotland, Connecticut

Issued: January 29, 2021

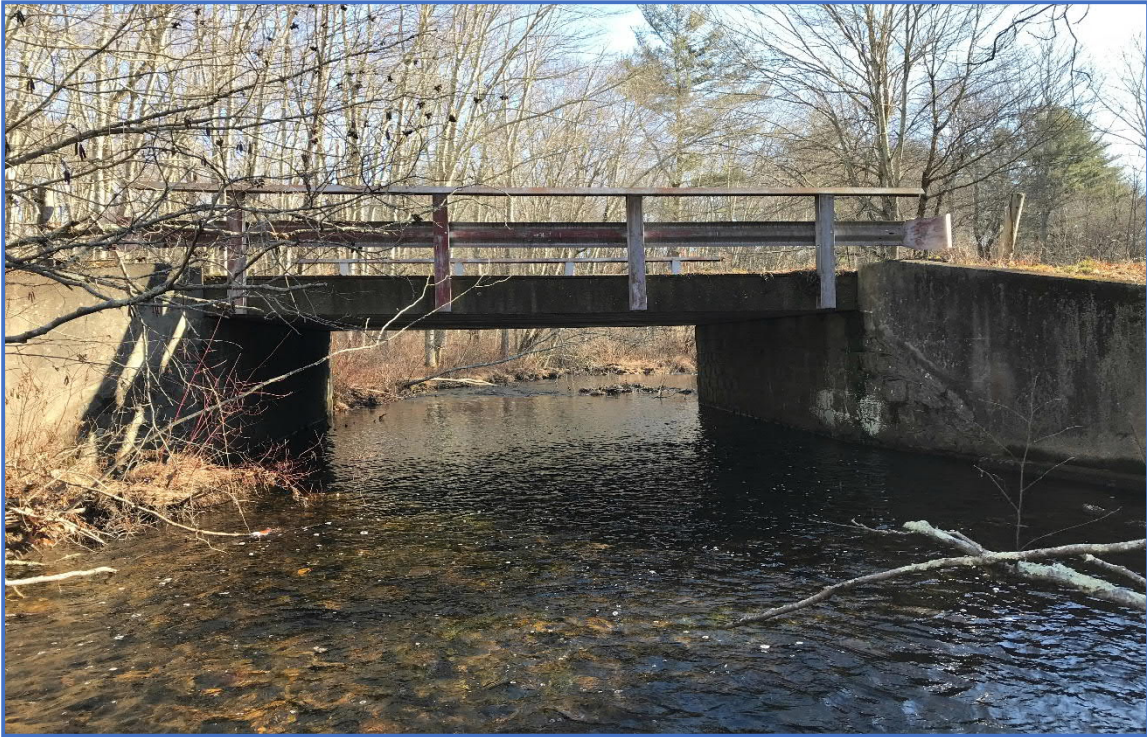
Photo 1: West Elevation

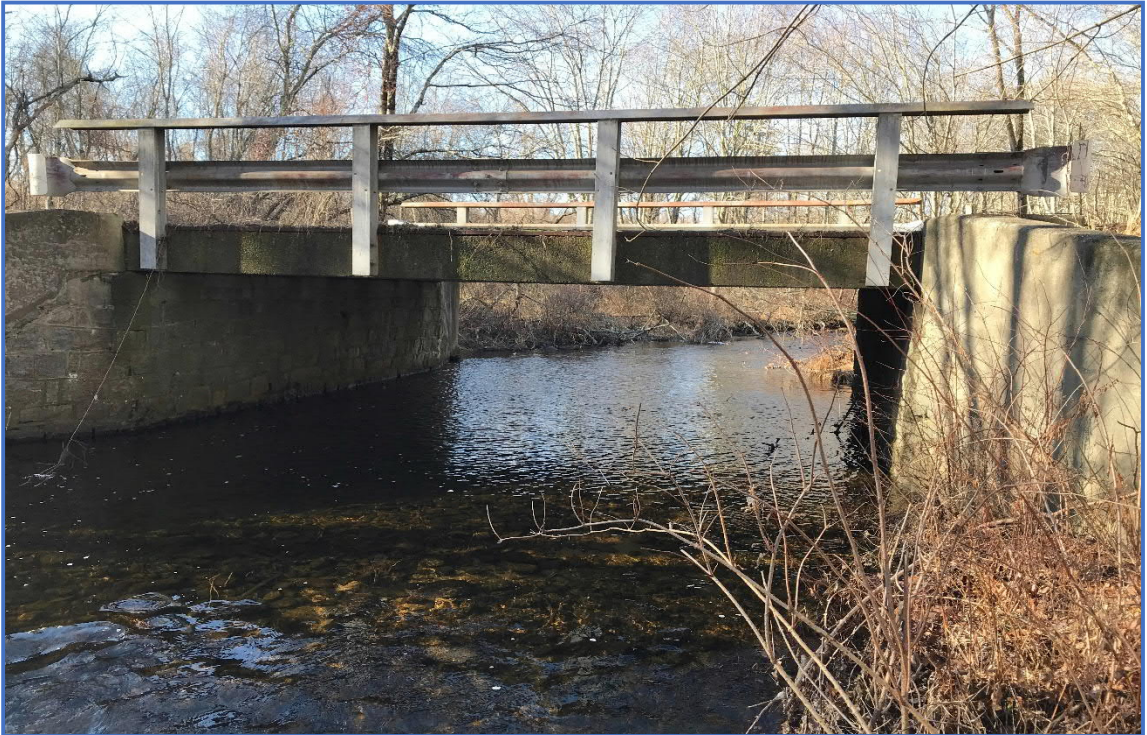
Photo 2: East Elevation

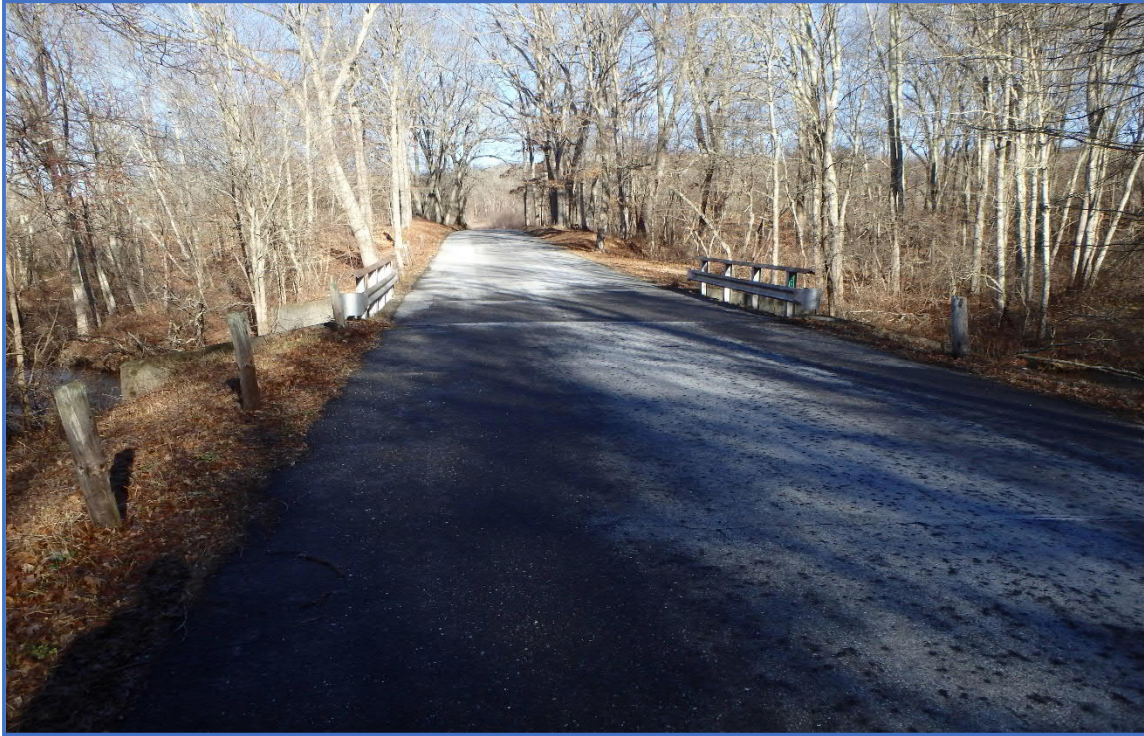
Photo 3: Bridge from South Approach (Looking North)

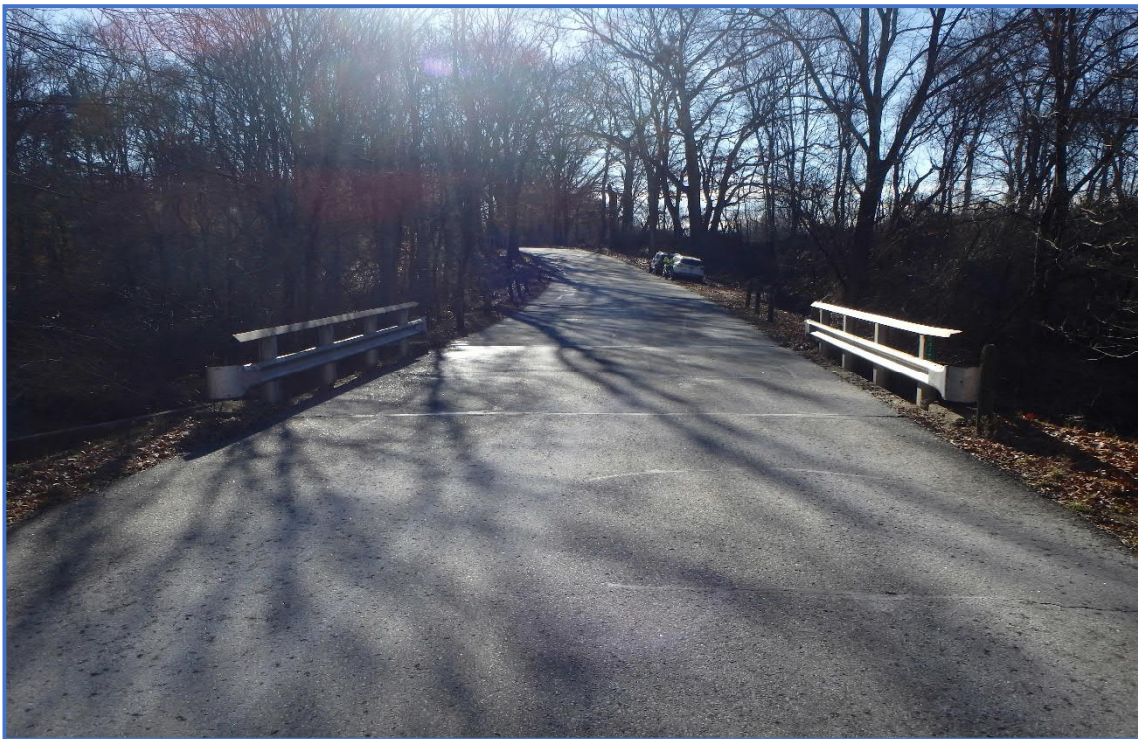
Photo 4: Bridge from North Approach (Looking South)

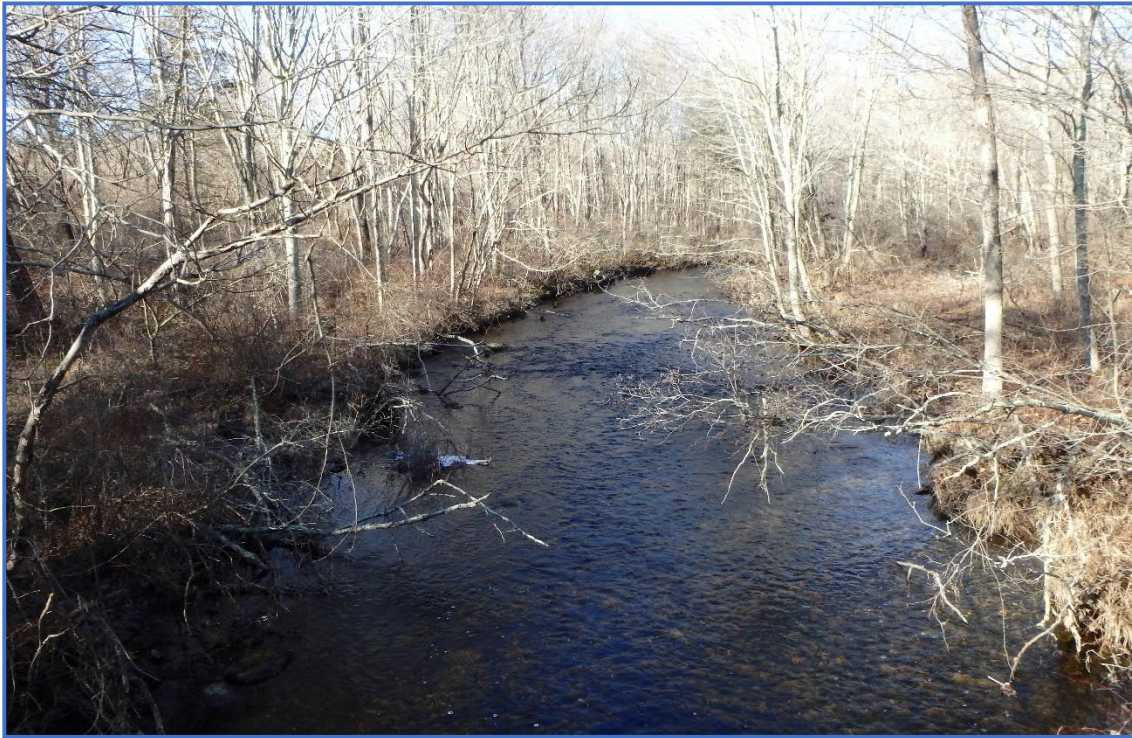
Photo 5: Channel looking upstream from bridge

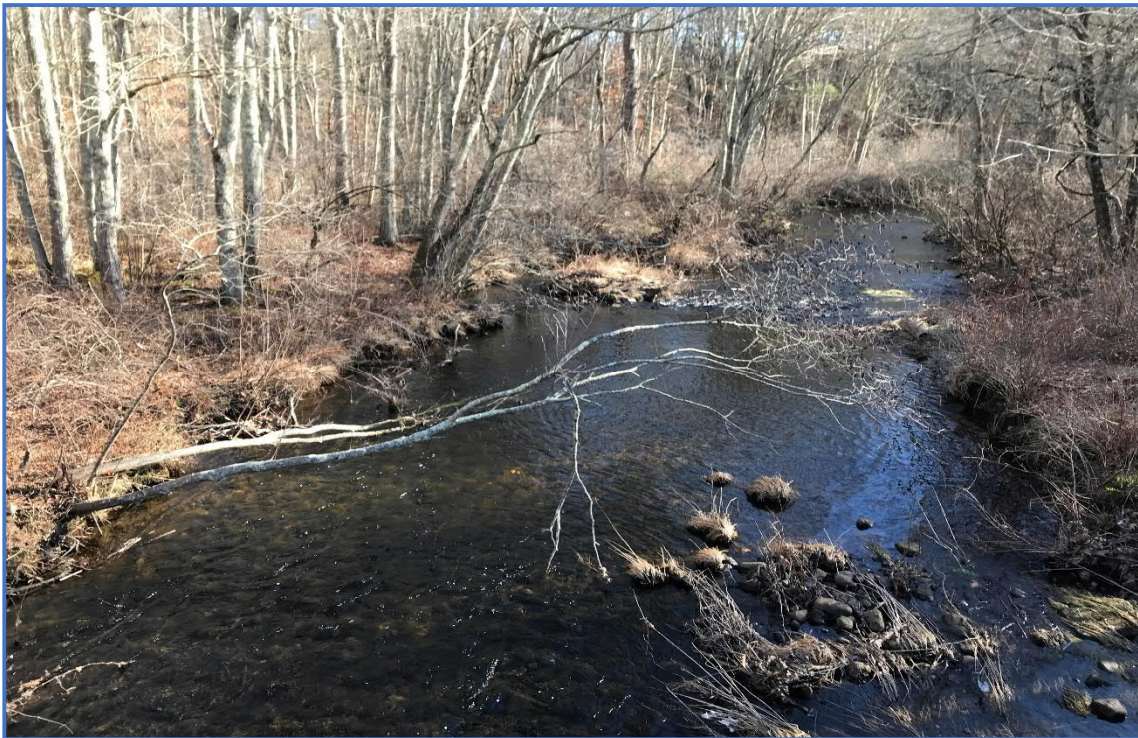
Photo 6: Channel looking downstream from bridge

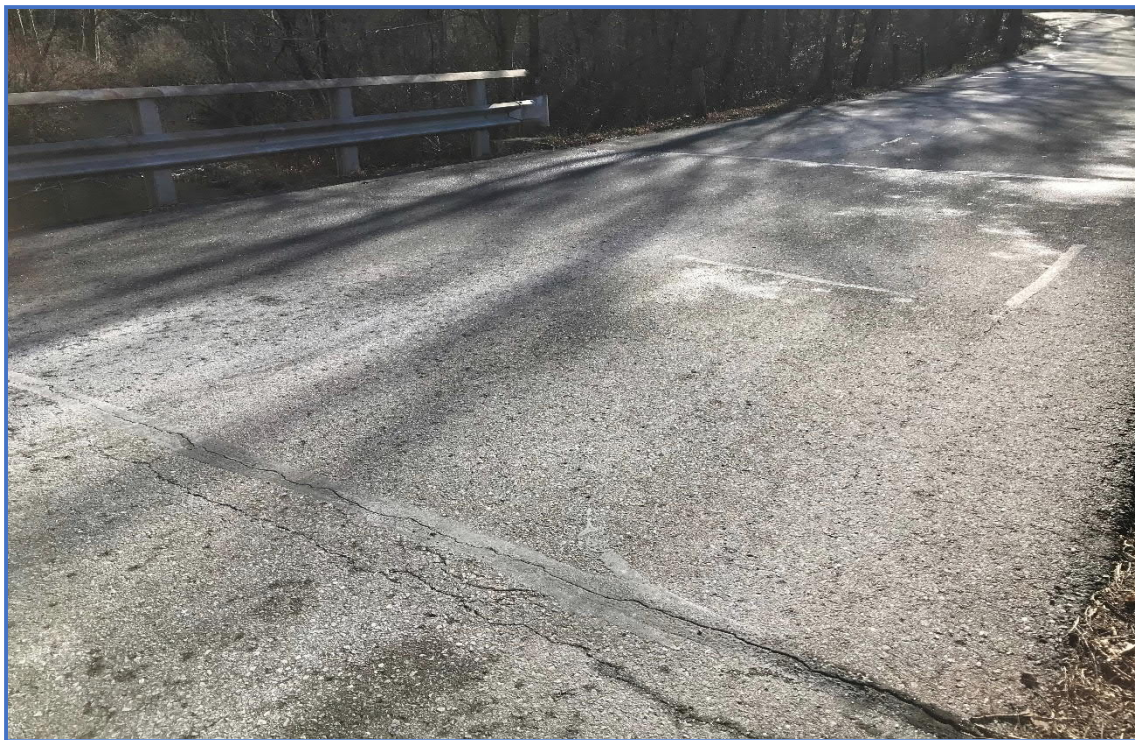
Overlay - The overlay is in fair condition having areas with minor map cracking. Full length transverse cracks are visible at both ends of the deck at the interface with the roadway. Longitudinal and transverse cracks, up to 3' long each, exist and have been sealed up in the southbound lane of the deck, near mid-span. (See photo 7).

Photo 7: Typical wearing surface (Note longitudinal cracking on deck, and full width transverse cracks at deck ends)

Additional signage should be posted to warn motorists of the potential blunt end hazard condition of the bridge railing. Measures should also be taken to crack seal the transvers crack at the bridge limits as well as re-point the cracked stone masonry in the abutment stems. A scour countermeasure should be installed to mitigate the observed scour previously noted at the south abutment and southwest wingwall. The scour countermeasure should be designed to retain the streambed material during extreme storm events and also armor the abutments for continued service. As part of the scour countermeasure, the location of the channel centerline should be adjusted to promote flow towards the center of the bridge span. The Town should also consider updating the bridge railing and approach traffic railing at the site. Both systems are substandard and showing signs of deterioration. Potential construction estimate: \$100,000 (see Appendix B: Cost Estimate for the estimate breakdown).

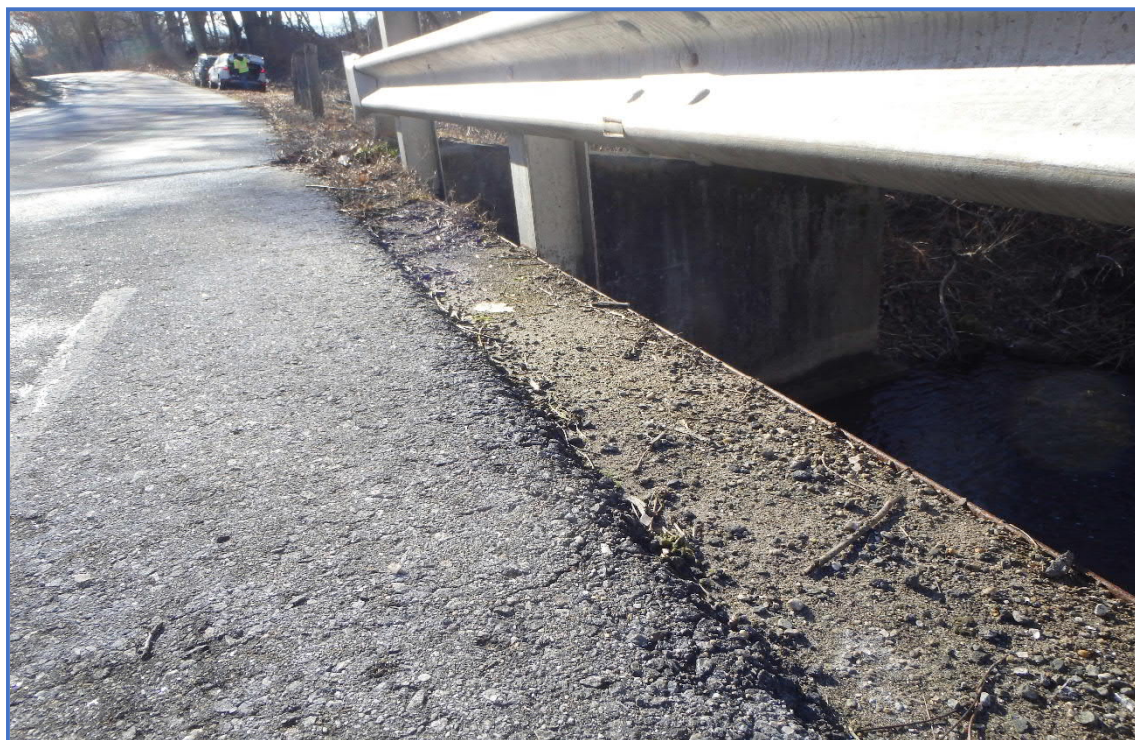
Curbs –No curbs are present at this structure. The edge of the deck overlay ends approximately 10" from the fascia, leaving the concrete deck unprotected at the gutterline (see photo 8).

Photo 8: Typical edge of deck overlay with missing curbs

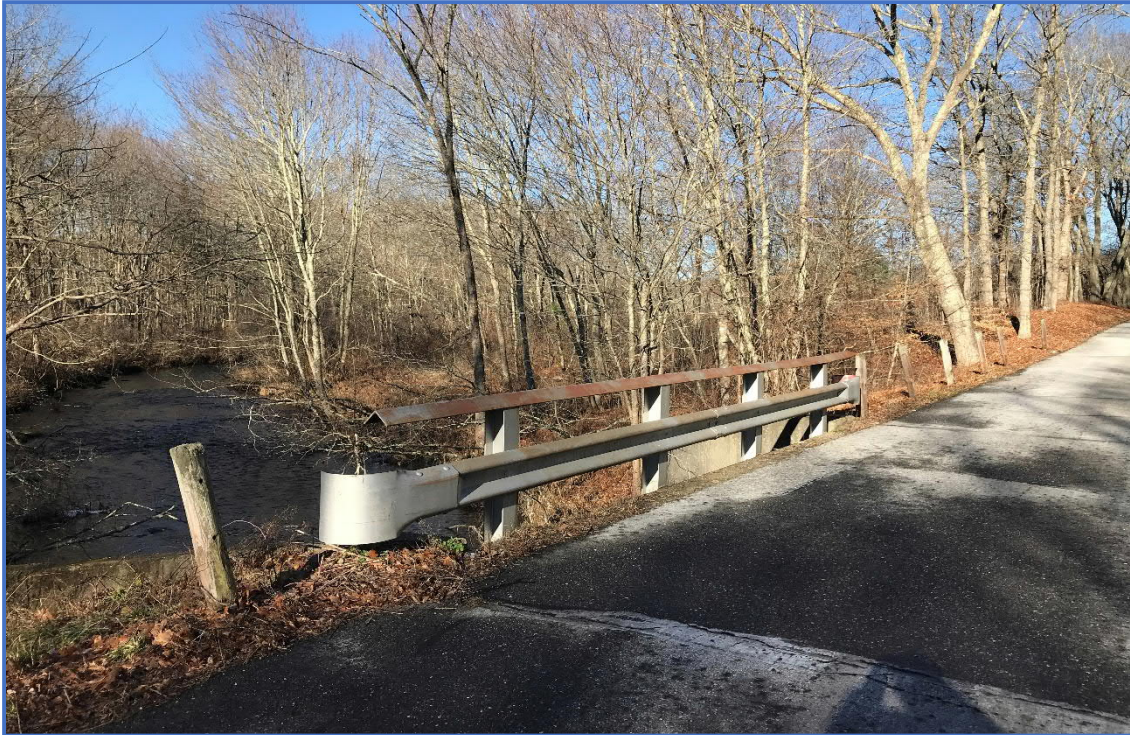
Railing – The railing is in fair condition. The coating system has reached the end of its useful service life and is flaking or missing coating (paint) throughout. A significant amount of exposed area has visible surface corrosion with some areas exhibiting minor section loss. Minor collision damage was observed at both the west and east railing. More advanced corrosion can be seen on backside of rails. The railing does not transition off the bridge or extend far enough clear zone, creating a hazard due to blunt end fixed condition. The railing did not exhibit the capacity to withstand a vehicle collision or prevent an errant vehicle from falling off the bridge.

Photo 9: Typical metal railing with H posts

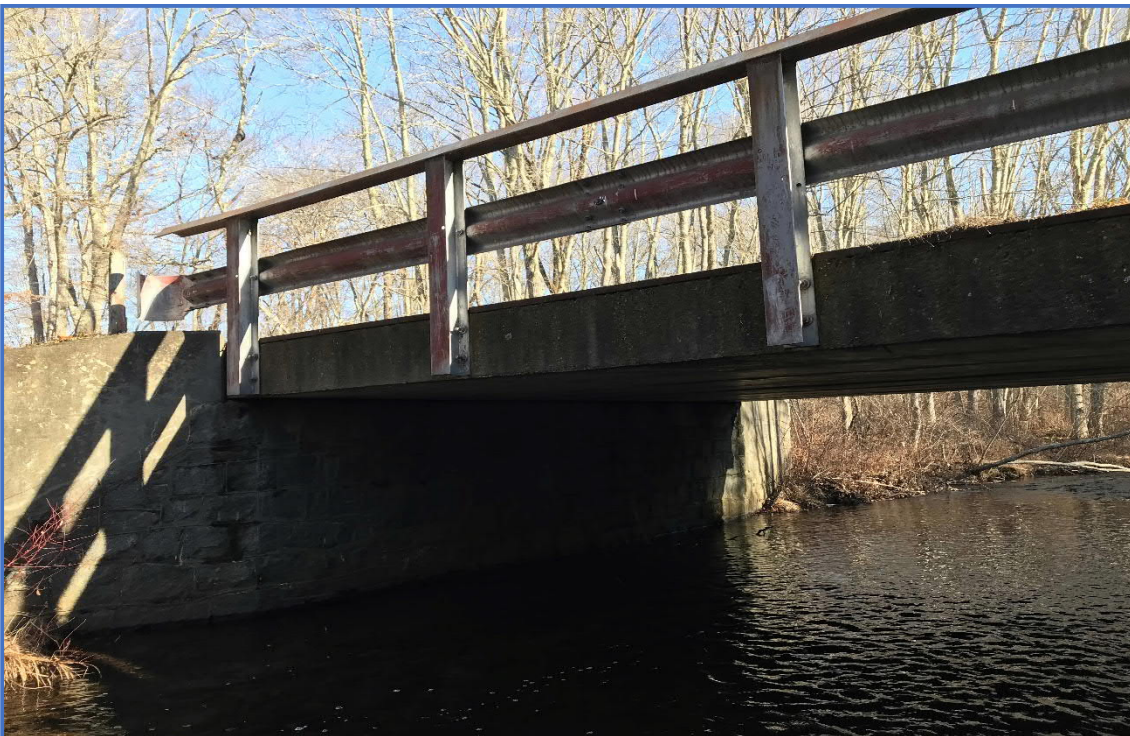
Photo 10: Typical backside of metal railing and attachment to slab

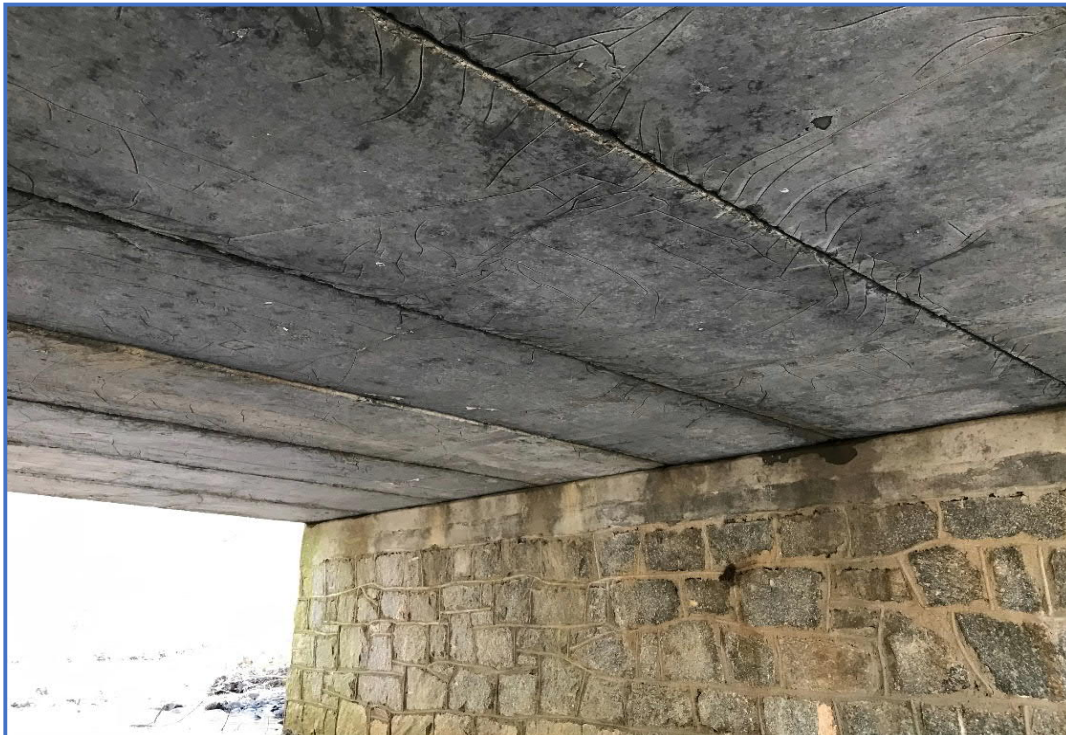
For the purpose of this inspection, the deck units are numbered 1 through 8, going from the west fascia to the east fascia. Transverse cracking and small areas of spalling were observed on the concrete units, near the joints in between adjacent units. The transverse cracking was observed near the midspan of all units, except for units #1, 2, 6, and 7, where cracking exists full-length of the span (see photos 11 & 12). A spall area 4" wide by 5" long was observed (up to $\frac{3}{4}$ " deep) at mid-span of deck unit #6, alongside the joint adjacent to unit #7. Joint spacing varied along the span-lengths for most units, ranging from $\frac{1}{8}$ " spacing between units to 1". Light scaling observed on both deck fasciae. It appears the shear keys have failed on these deck units allowing for rotation causing the cracking at near the abutments and allowing moisture between the deck panels. These deck panels are designed to act as a single unit and if the bond at the shear keys has failed the units will not be able to transfer (share) the loads amongst the system. This is a common issue with these types of deck systems and eventually will show signs of "piano keying". Tell tales consist of a series of parallel longitudinal reflective cracks in the wearing surface at the deck panel joints. This evidence was not present at the time of the inspection suggesting the structure is still transferring and sharing the loads between the units.

Photo 11: Typical underside of concrete deck (note cracking and spalling between joints on of prestressed concrete deck units)

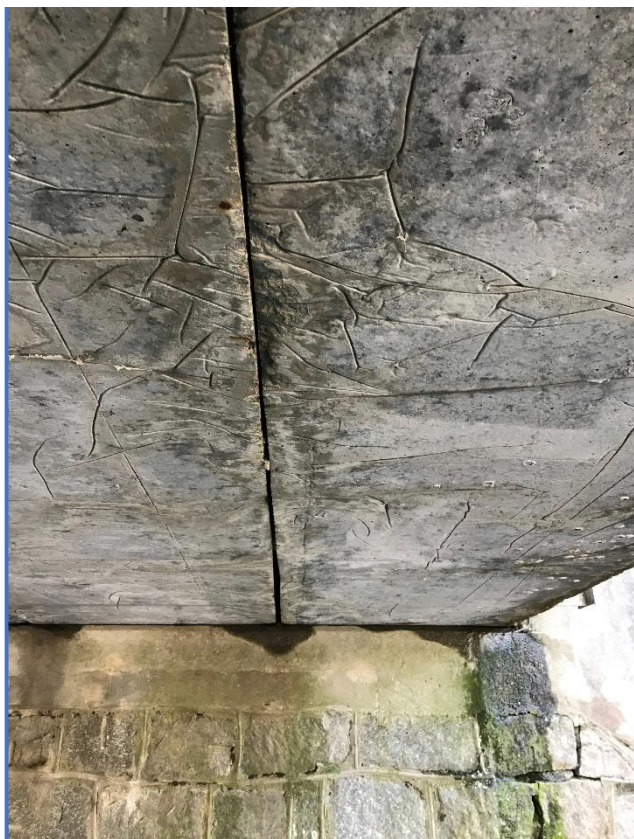
Abutments (Stem) – The stone masonry abutment stems are in fair condition having areas with cracked, loose, and missing mortar joints. The abutment stems exhibit cracks at the mortar joints with active moisture leakage. Over time, these cracks will grow as the moisture undergoes freeze/thaw cycles. There is no evidence of the cause for the cracking, such as settling or otherwise. This suggests that the cracking is a function of the age of the structure and the years exposed to water (see photos 13-15). Near the top of the abutment stems, signs of active leakage was observed on both the north and south abutment concrete caps. This moisture is most prevalent at the interface between the concrete deck units, suggesting the presence of voids between the deck units. The moisture appears to be coming from the roadway above through the cracks at the deck end (see photos 12 & 13).

Photo 12: Spalling and cracking of concrete of deck units #1 and #2 (note typical leakage at southwest abutment cap)

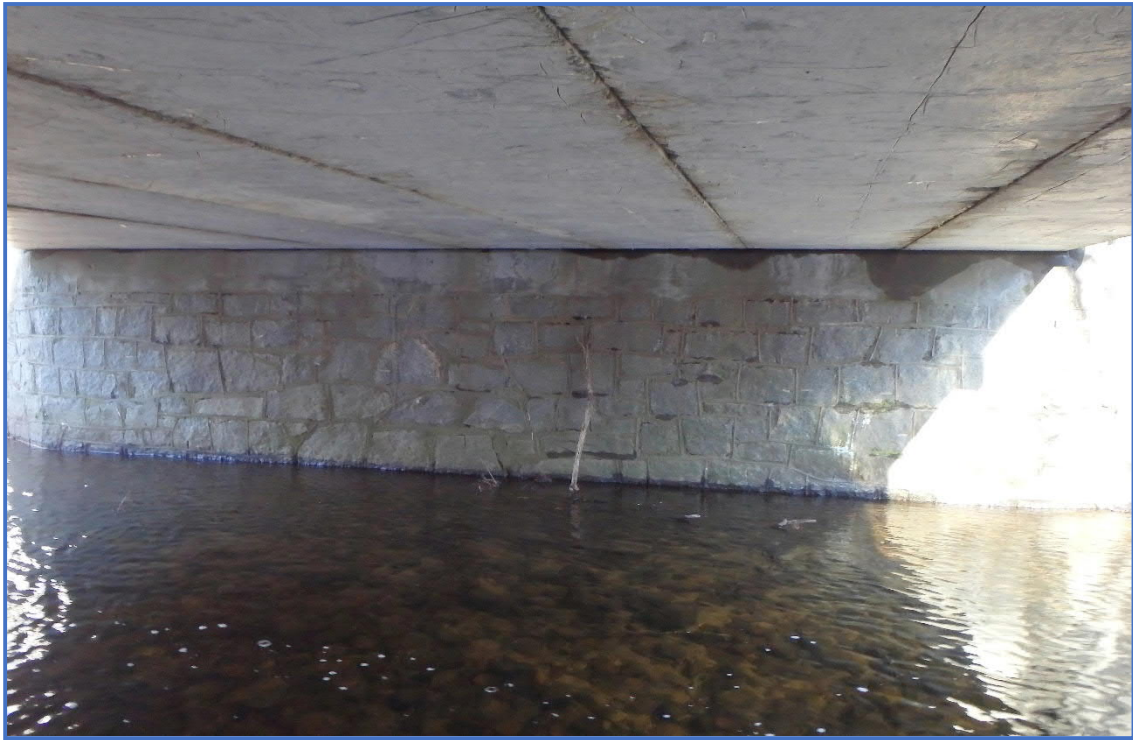
Photo 13: North abutment (note leakage at northeast abutment cap)

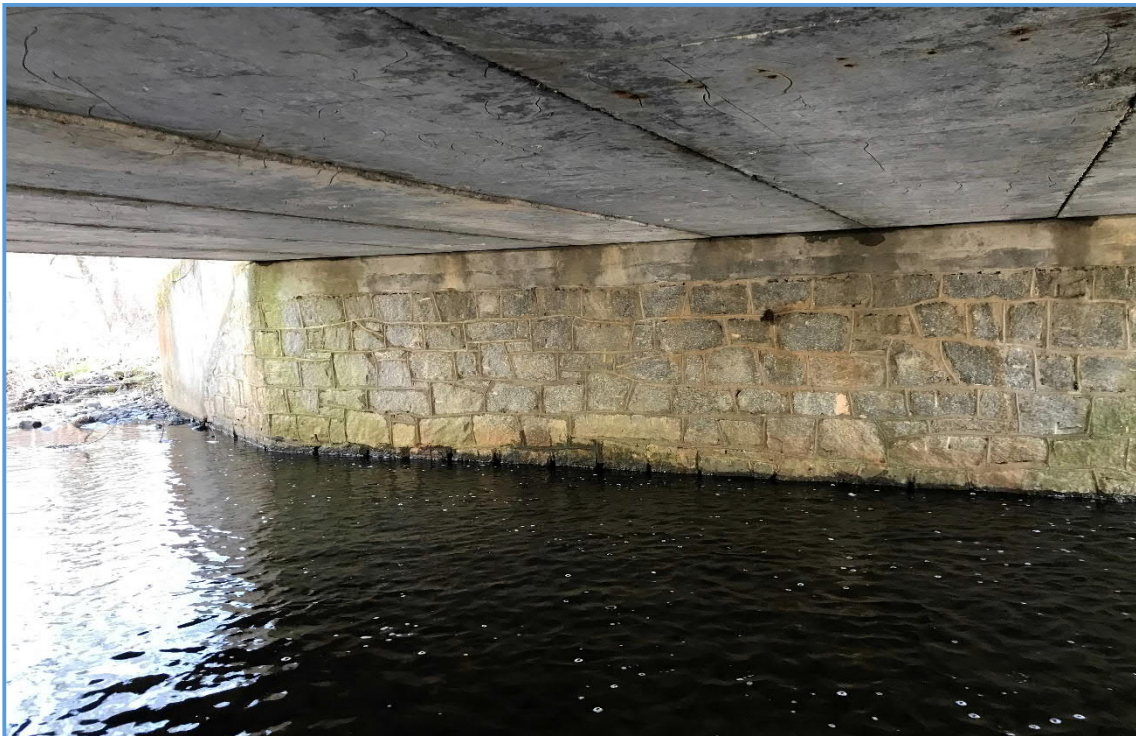
Photo 14: South abutment

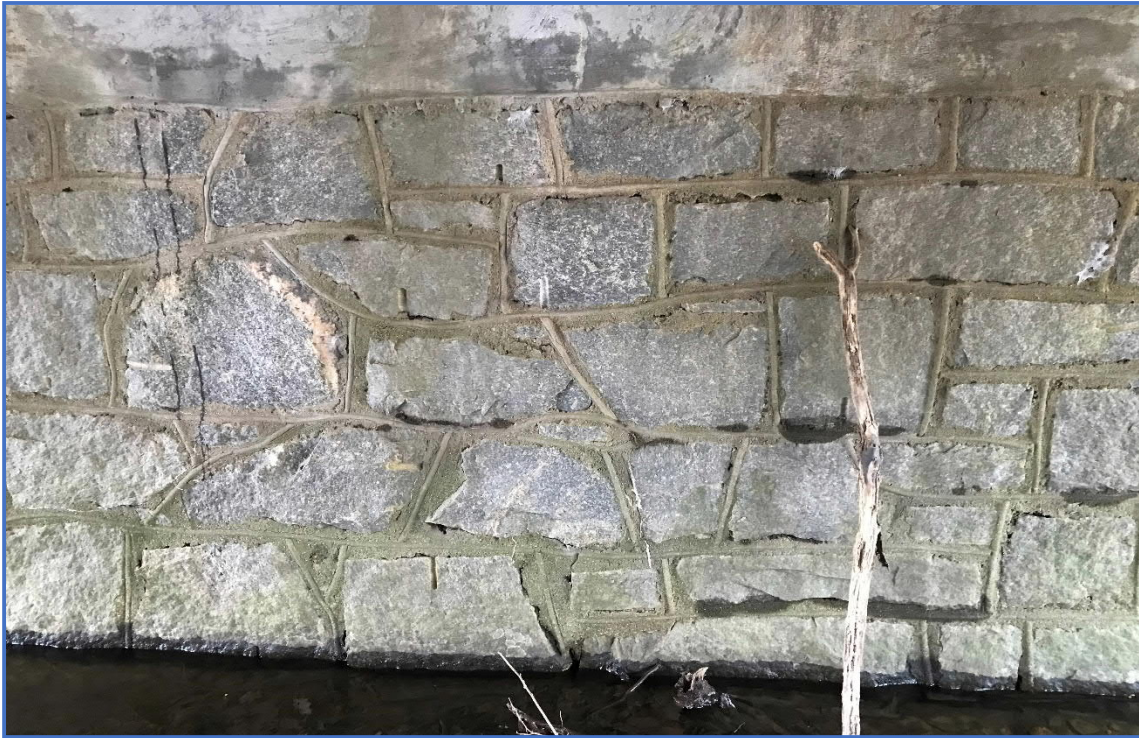
Photo 15: Typical mortar voids observed on both abutment stems (south abutment pictured)

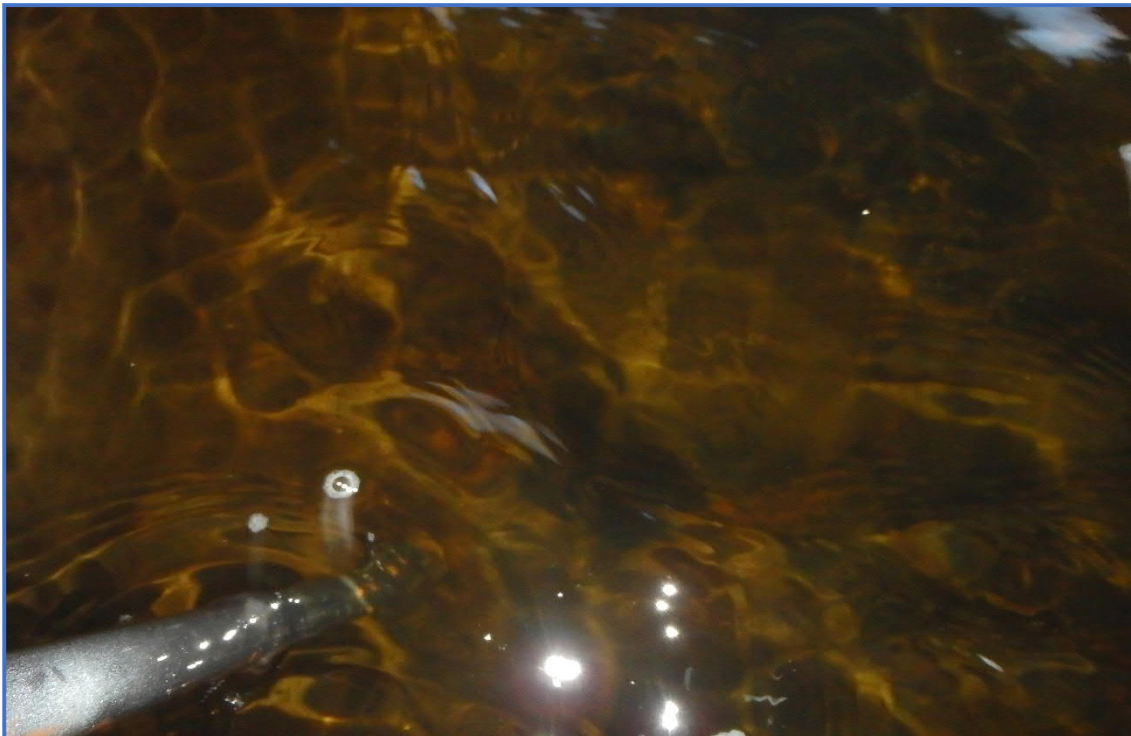
Erosion and scour – Channel erosion and scour is present primarily at the south abutments and wingwalls. A 6-foot-long portion of the south abutment footing (an 8" high vertical face) was exposed at the time of inspection (see photo 16). A 6-foot-long portion of the southwest wingwall footing was exposed at the time of inspection. The footing appears deteriorated after this 6-foot area reaches the abutment (see photo 17). No evidence of undermining was observed. The north abutment and upstream wingwall exhibits minor channel erosion/ scour estimated to be less than a foot deep.

Photo 16: Exposed footing at south abutment

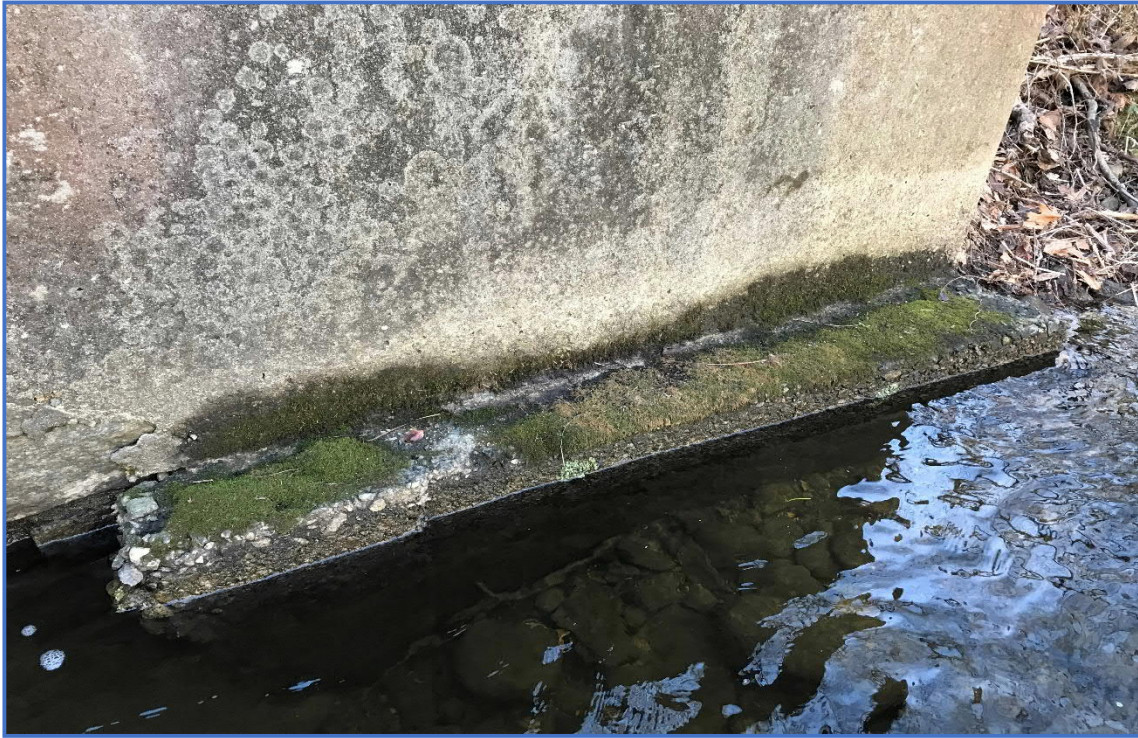
Photo 17: Exposed footing of southwest wingwall (note deterioration on eastern end)

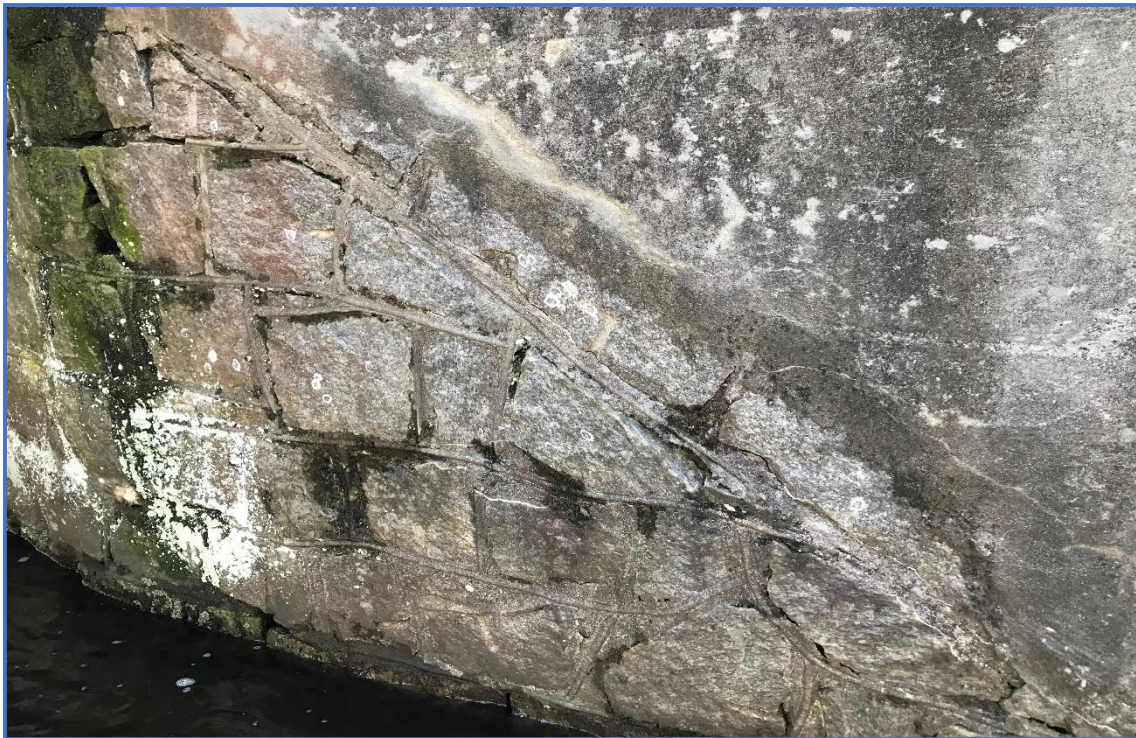
Wingwalls (Stem) – The abutment wingwalls are in fair condition with minor cracking and scaling at the waterline. Heavy efflorescence was observed at the southwest wingwall at the construction joint between the concrete wingwall portion and the stone abutment (see photo 18). Minor scaling is present on the southeast wingwall, with heavy scaling observed at the abutment (see photo 19). The stems were sounded and found to be solid. The sloping wingwalls are lacking protective fences.

Photo 18: Heavy efflorescence and cracking on southwest wingwall at connection to south abutment

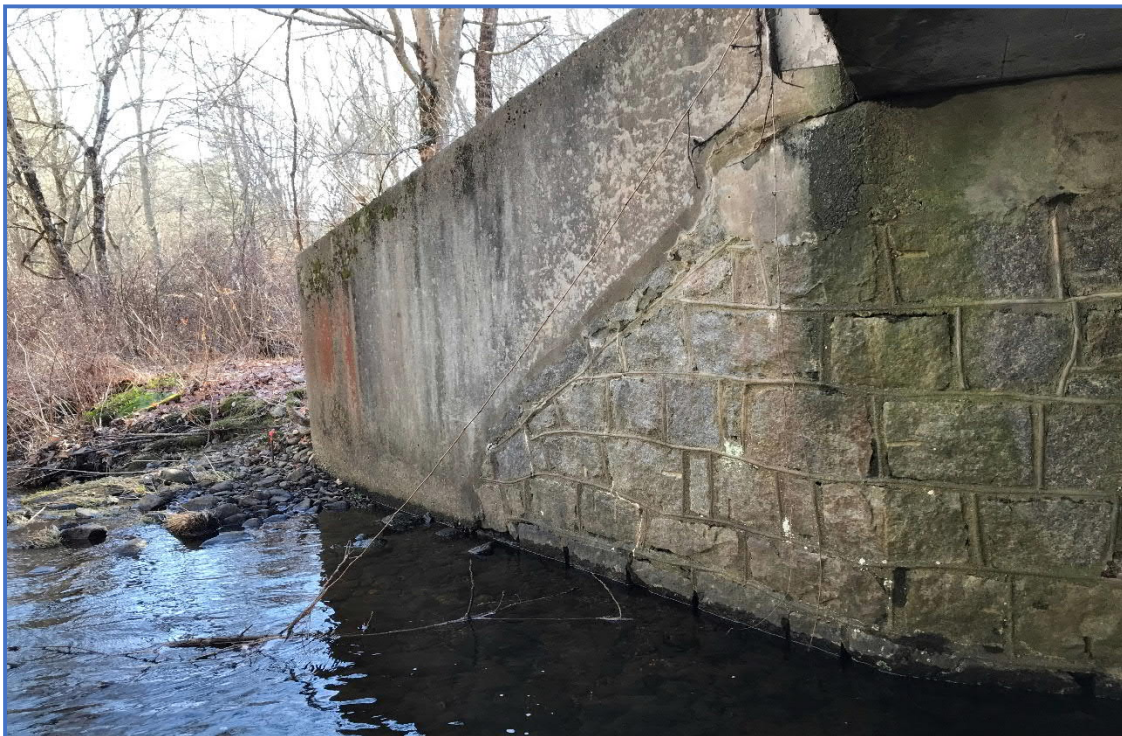
Photo 19 Southeast wingwall stem

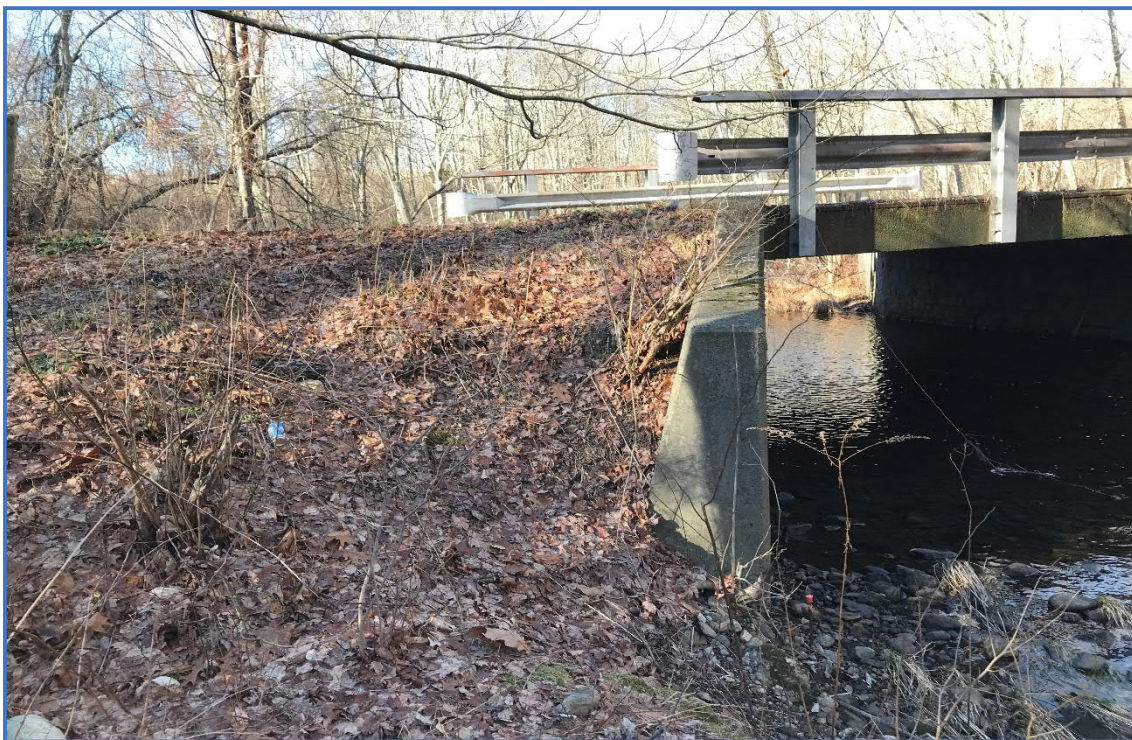
Approach embankment - The approach embankment is in fair condition with areas of erosion. Approach embankments consist of vegetation and brush. Minor erosion/loss of embankment was observed behind the stems of the southeast and northwest wingwalls (see photo 20). Brush and vegetation overgrowth was noted at the ends of both the northeast and northwest wingwalls, near the channel (see photos 21 and 22).

Photo 20: Minor erosion behind southeast wingwall stem

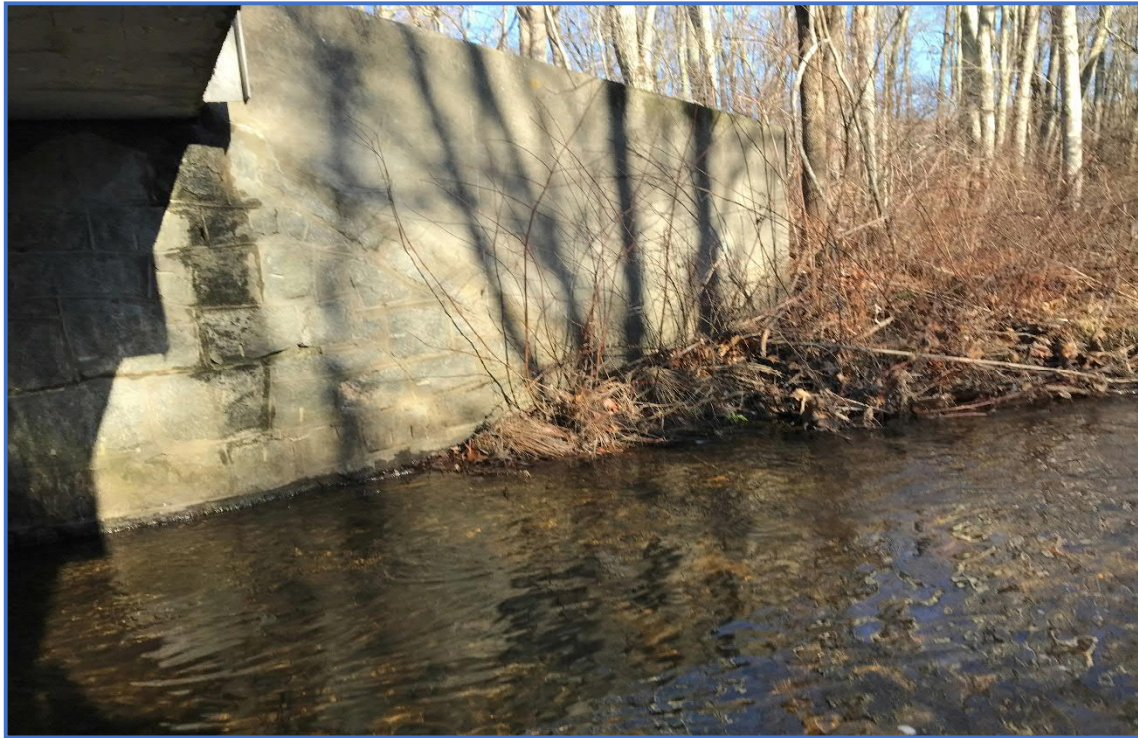
Photo 21: Brush overgrowth at northeast wingwall

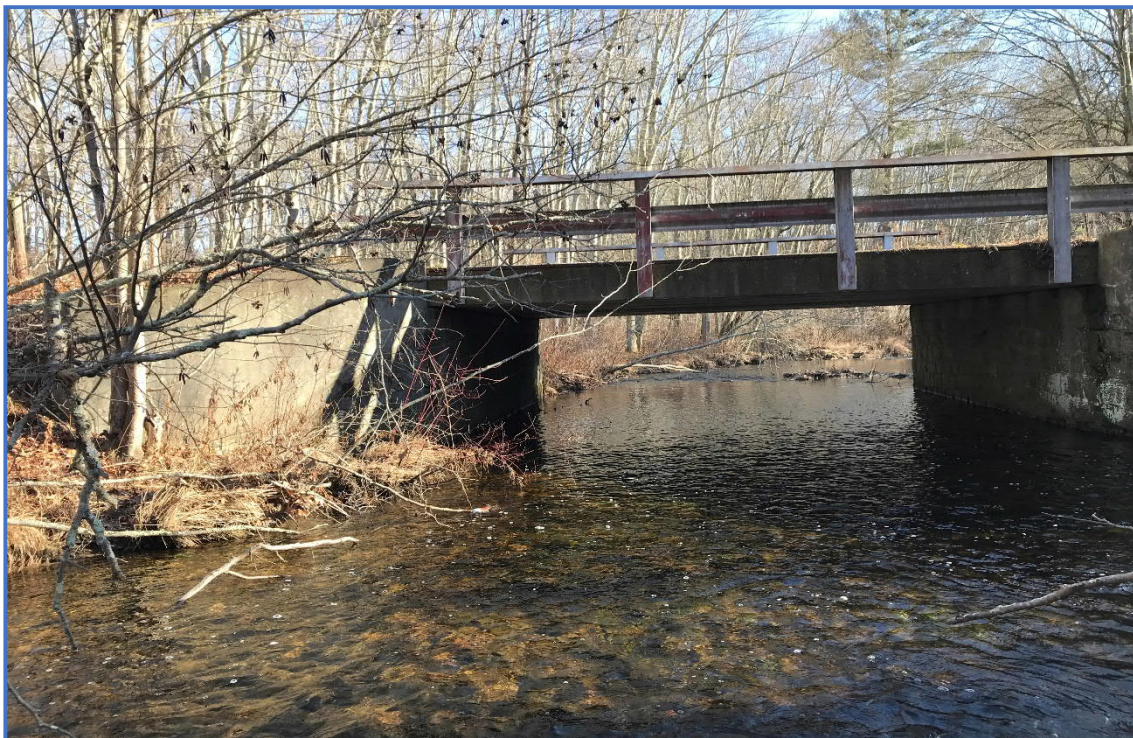
Photo 22: Brush overgrowth at northwest wingwall
