Bridge Conditional Assessment

**Bridge No. 04772 in Scotland, CT
Bass Rd over Merrick Brook**

Town of Scotland
Scotland, Connecticut

Issued: January 29, 2021

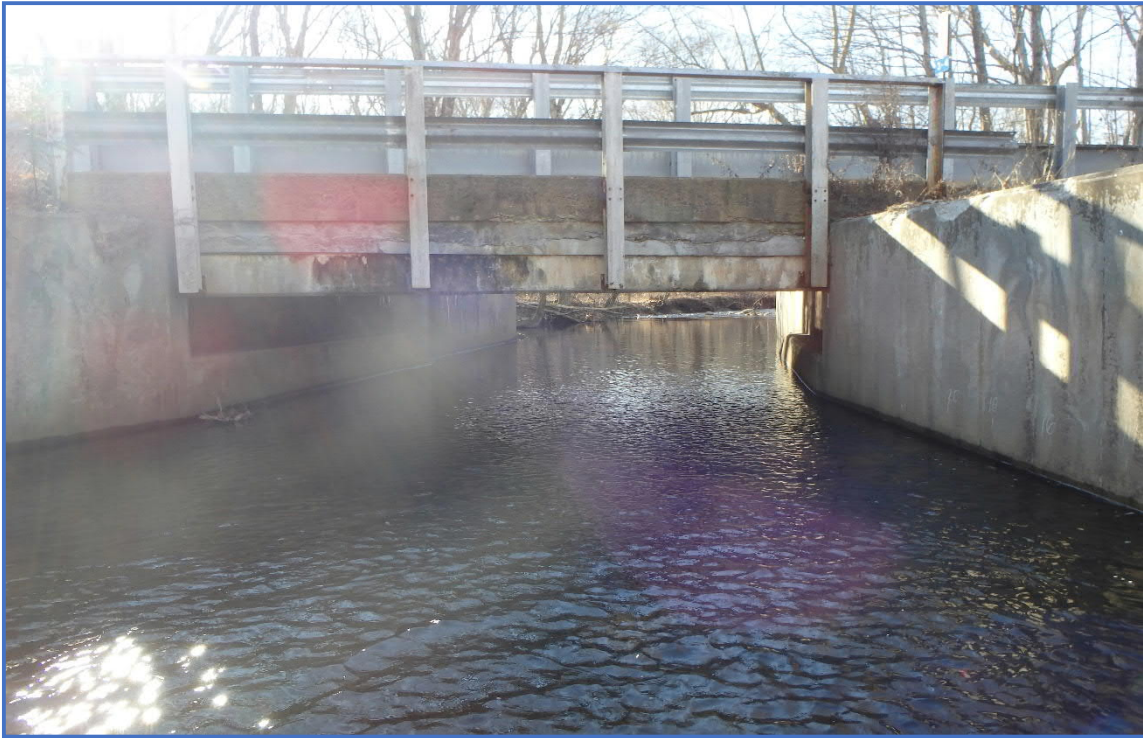
Photo 1: East Elevation

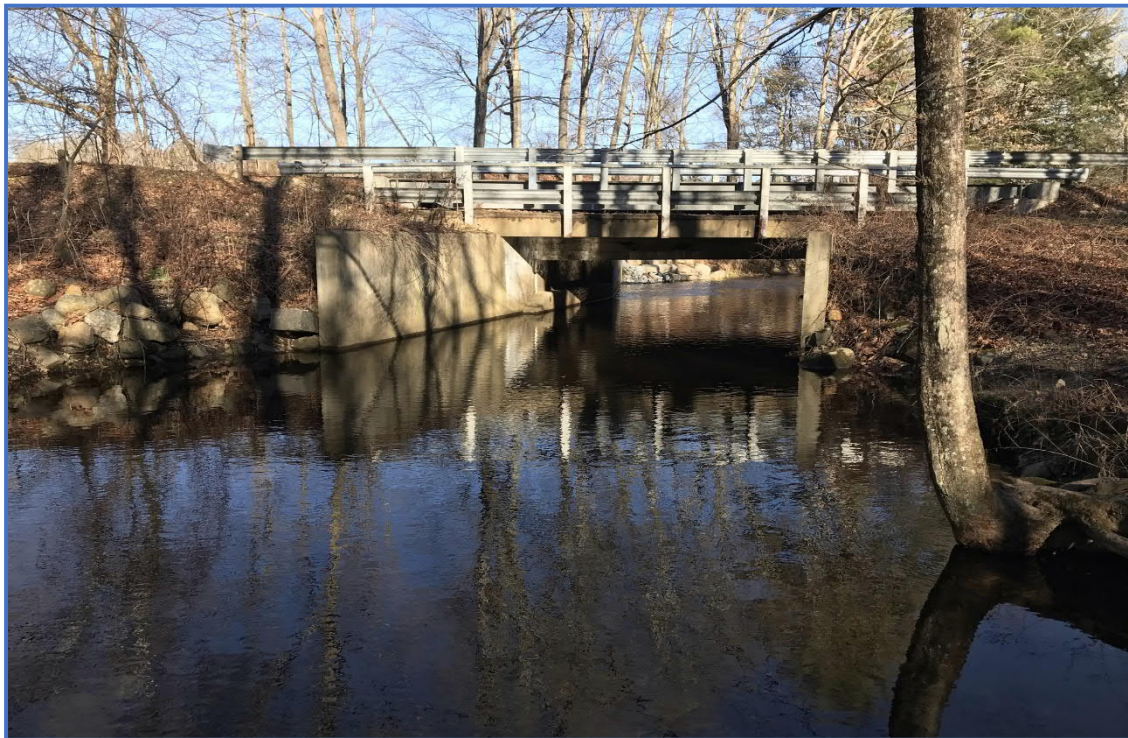
Photo 2: West Elevation

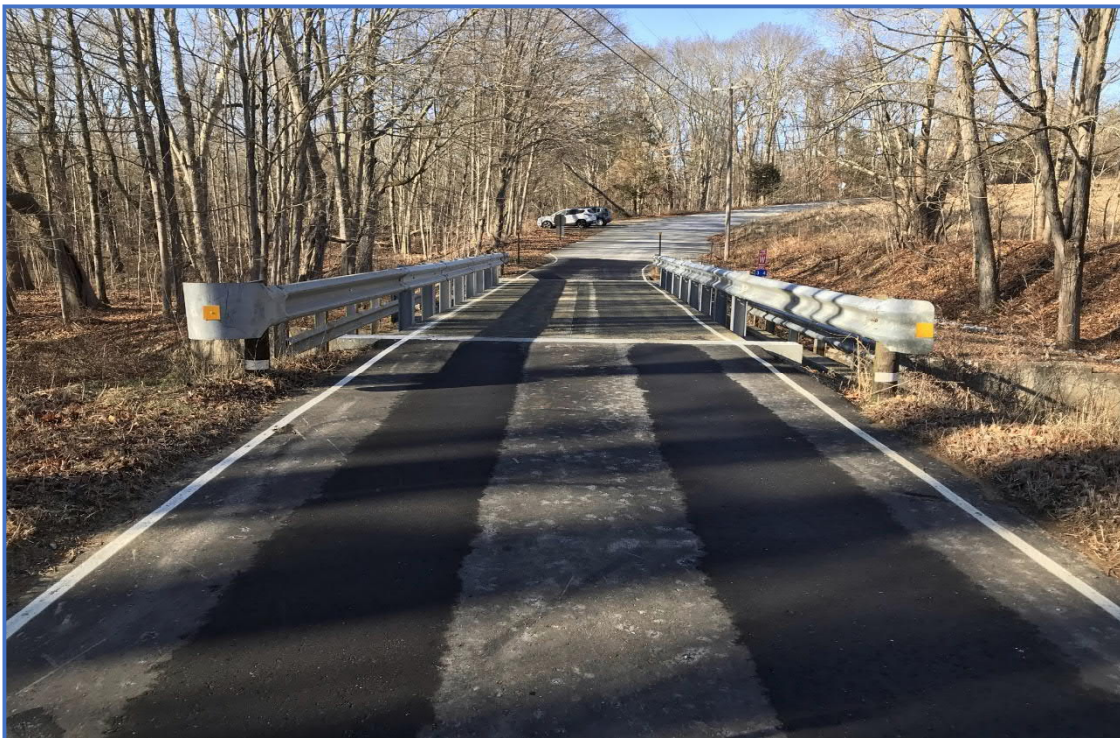
Photo 3: Bridge from South Approach (Looking North)

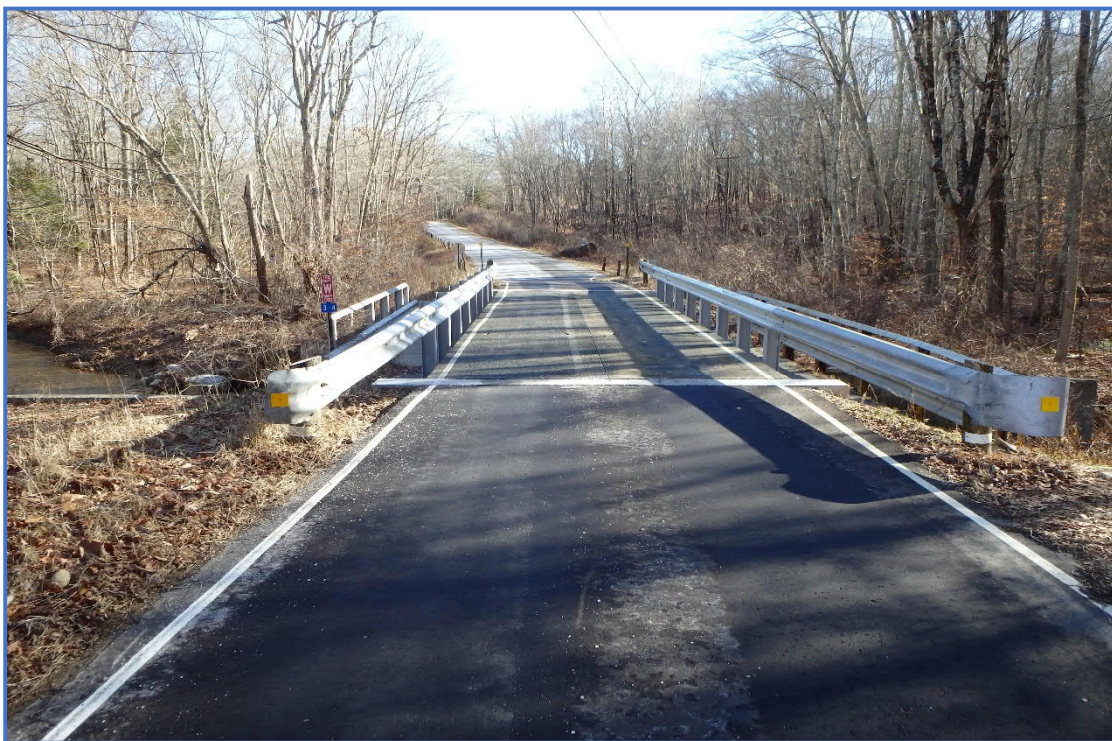
Photo 4: Bridge from North Approach (Looking South)

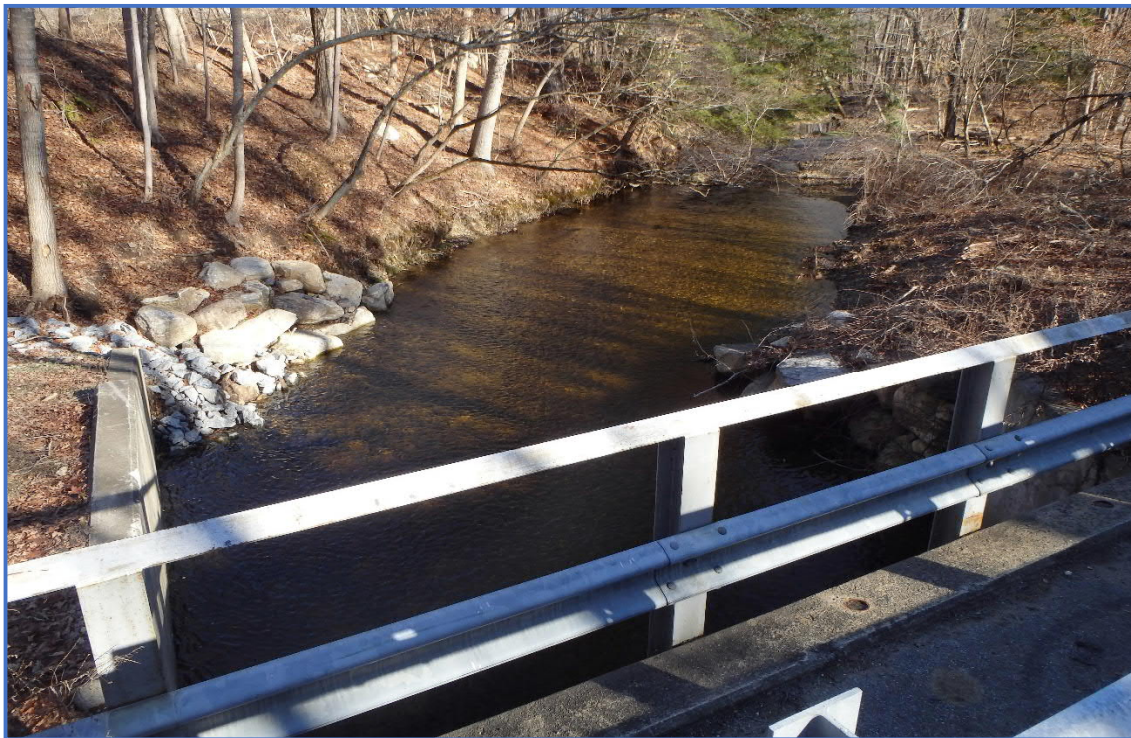
Photo 5: Channel looking upstream (East) from bridge

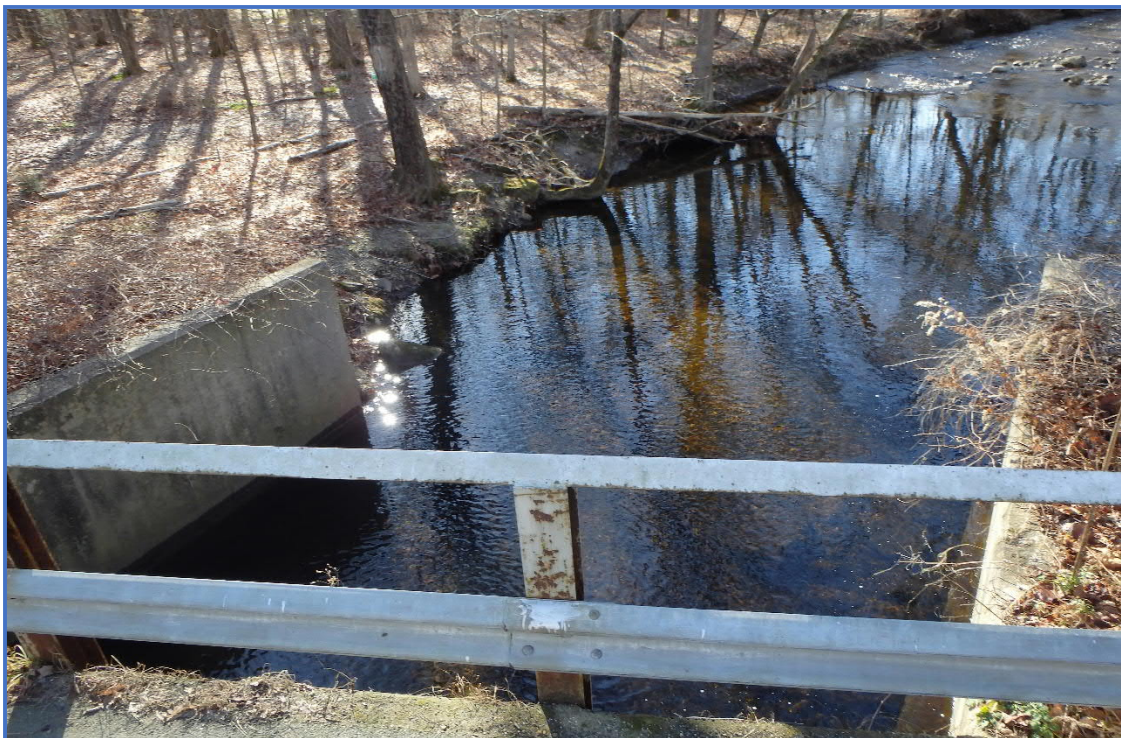
Photo 6: Channel looking downstream (West) from bridge

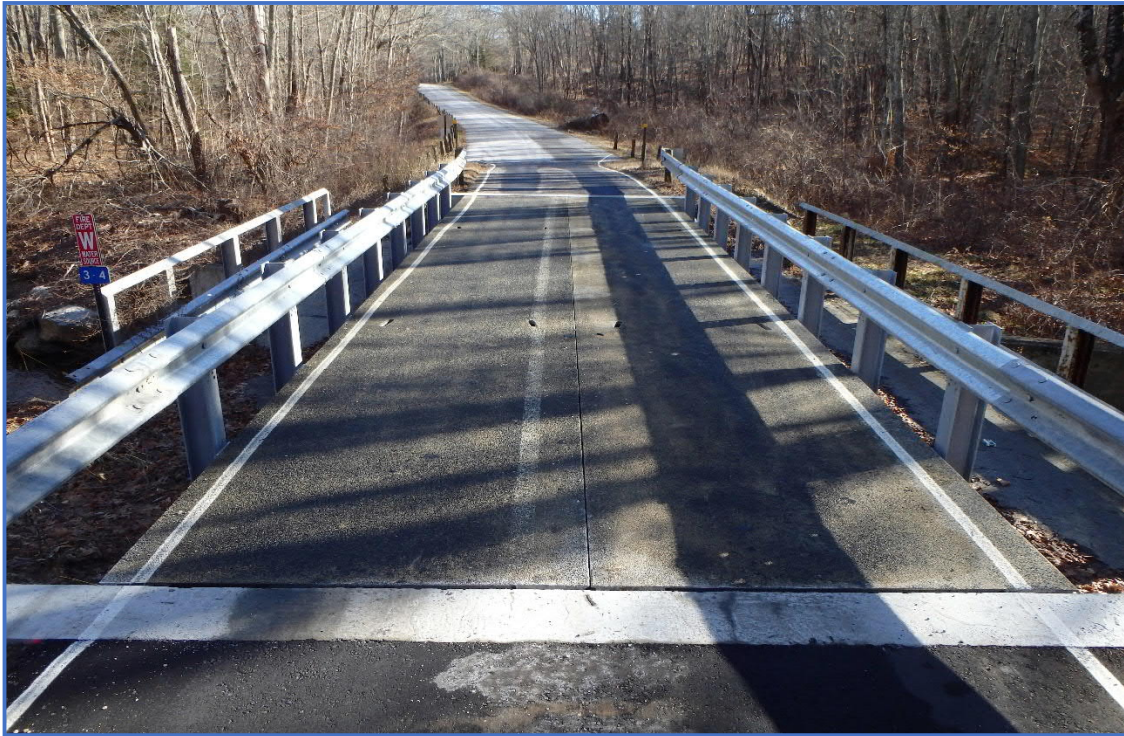
Overlay – The anti skid epoxy aggregate on the ACROW steel deck appears to be in good condition. There are no signs of deterioration or cracking of the anti skid overlay.

Deck – The ACROW steel plates act as the deck for this structure and are in good condition. The underside was inspected and there was no notable deterioration at the time of inspection. The top of the plates are covered by the anti skid overlay.

Photo 7: Typical steel deck with anti skid coating (Note two separate steel plates with longitudinal joint)

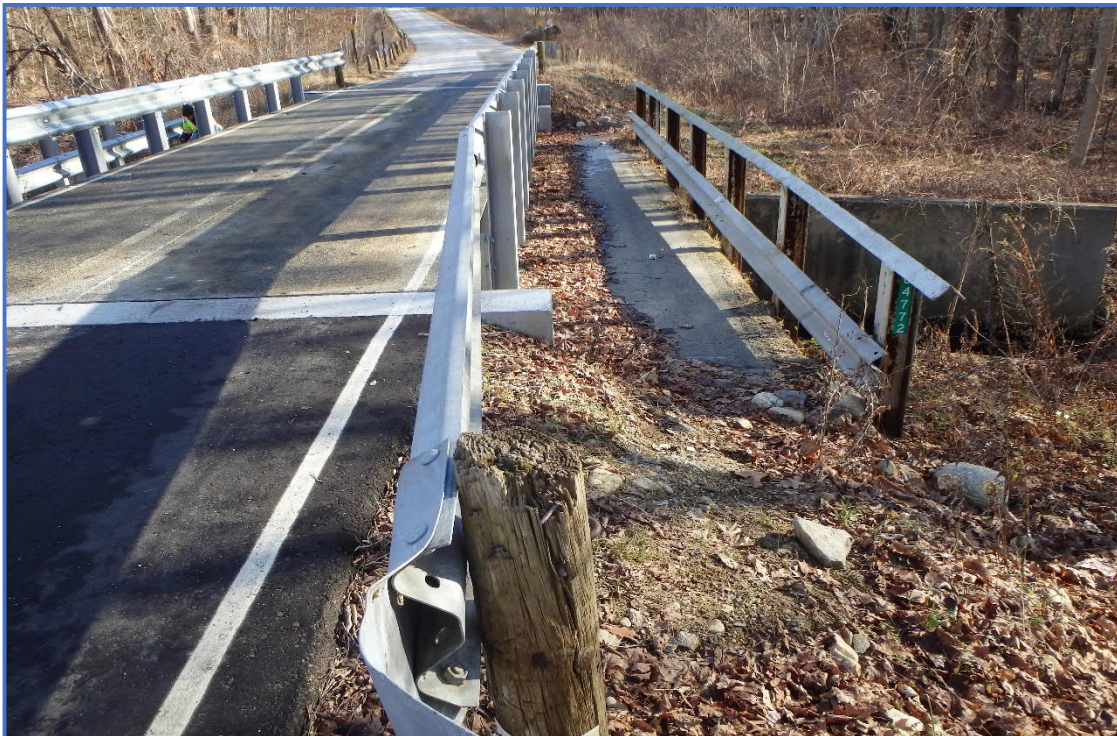
Photo 8: North bridge railing connected to wooden approach post. (Typical all corners)

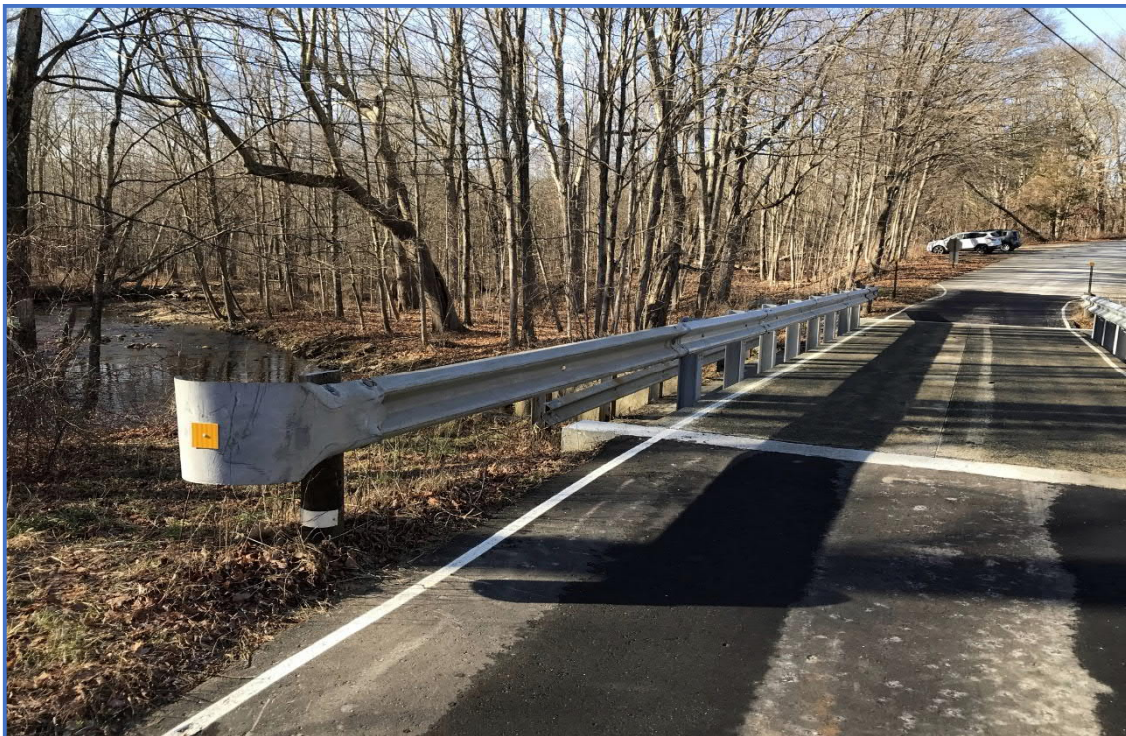
Approach guiderail – Metal beam attached to timber post at each corner (see photo 9). Guiderail system appears to be in good condition. Note: the speed limit over this bridge is posted for 10mph, and stop signs are evident on both approaches.

Photo 9: Typical approach and bridge railing. 10 mph area and stop signs on both approaches

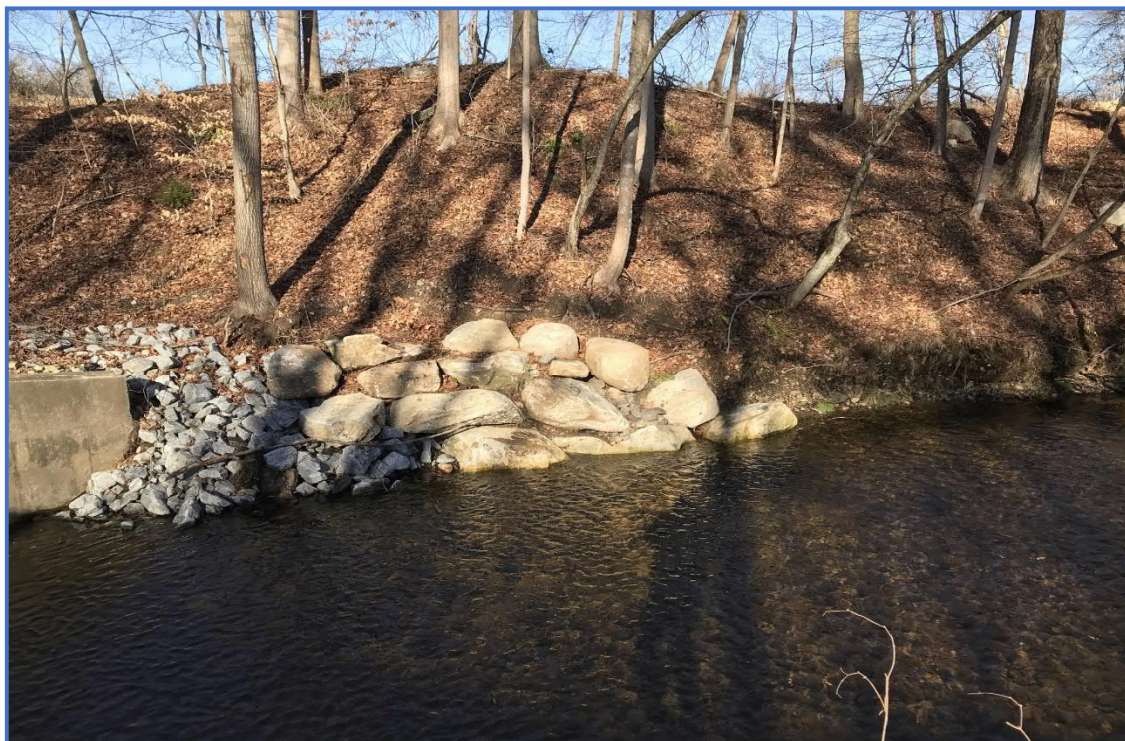
Erosion and scour – Erosion and scour of the original structure remains in poor to serious condition. The overall substructure rating of the original structure is driven by the severe erosion and undermining that is evident. The north abutment and wingwalls, along with the southwest wingwall and the south abutment, experience moderate to severe scour and undermining. The west side of the north abutment and the northwest wingwall have completely exposed footings with up to 12” of undermining measured at the time of field inspection. The northeast wingwall and east side of the north abutment also appear to be exposed and severely undermined which was also noted in the underwater inspection report dated 2/27/2020. Our observations match those of the recent underwater inspection suggesting that the conditions are serious but not rapidly progressing. The footings exhibit full height exposure and undermining up to 2.7ft high and 5ft penetration, up to 3ft behind the footing. The south abutment is exposed full length but is not currently undermined. See photos and ‘Appendix B-Notes’.

Channel Scour – The channel enters the structure at a sharp angle with flow heading west and directed towards the Northeast wingwall and the north abutment. The misalignment of the flow has contributed to the erosion and scour issues previously noted.

Approach embankment - The channel centerline makes an abrupt turn as it approaches the structure with flow directed towards the Northeast wingwall and the north abutment. This change to Merrick Brook's angle of the attack has led to embankment erosion and scouring of streambed material surrounding the nearby tree root wads. The approach embankments consist mostly of brush and vegetation.

Photo 10: End of Northeast wingwall, rip rap, erosion exposing and undermining tree roots, inlet side

Short term Recommendation: To address the immediate scour and undermining of the original bridge substructure, the Town should re-establish the existing channel section immediately upstream and at the bridge. Subsequently, a scour countermeasure should be installed and specifically designed to remain in-place during major storm events. These activities will stabilize and armor the existing abutments for continued service. To address the reduced travelway width at the bridge, object marker signs should be added at all four corners to bring attention to motorists as they approach the bridge. Potential construction cost estimate: \$300,000 (see Appendix C: Cost Estimate for the estimate breakdown).

Long Term Recommendations (Option 1): As previously noted, the Town prefers to maintain the current ACROW bridge as a permanent structure and is seeking recommendations for a long term solution. To keep this structure stable during significant storm events, it is recommended that the existing shallow temporary stub abutments be replaced with deep foundations. Design parameters and soil conditions for a permanent foundation will need to be obtained in order to design the deep foundation consisting of driven or drilled piles. In efforts of reduce construction costs, the lower portions of the original bridge substructure could be salvaged and armored to provide a low flow channel during the seasonal dry periods. Additionally, signage should be posted to warn motorists of the roadway width reduction, blunt end bridge railings, and 1- way traffic over the ACROW bridge. Action should also be taken to prevent further scour to the existing abutments. The scour countermeasure should be designed to re-align the channel towards the center of the bridge span.

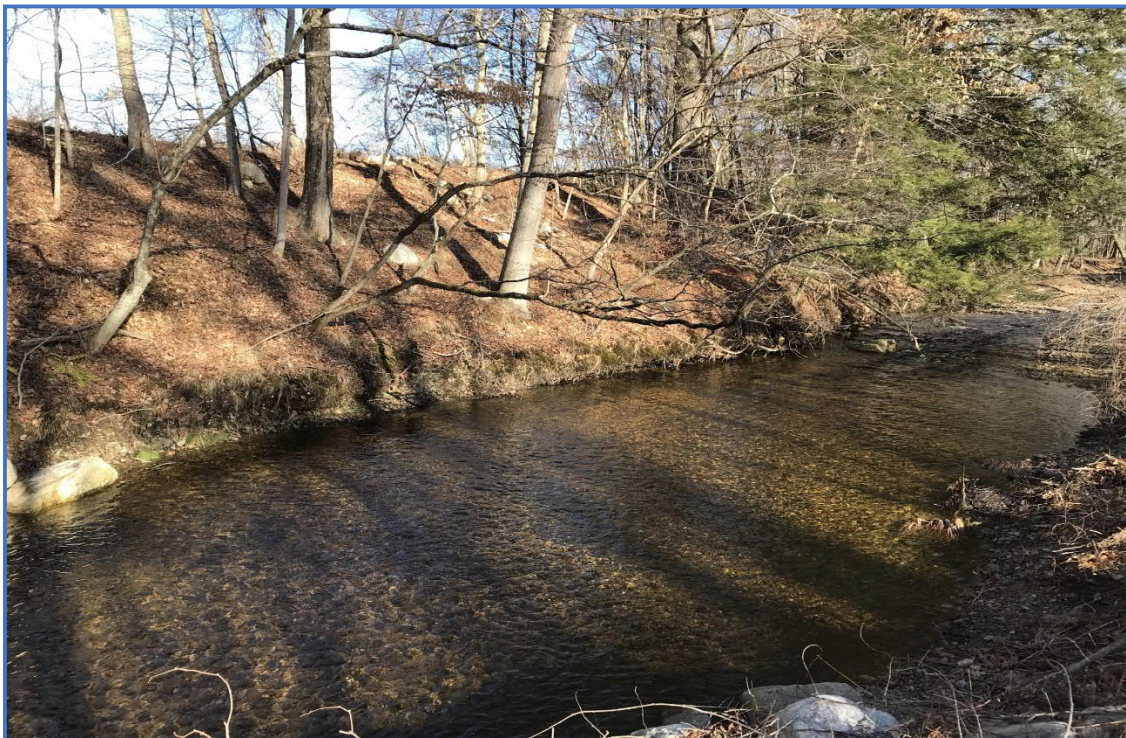
Photo 11: Erosion exposing and undermining tree roots, inlet side

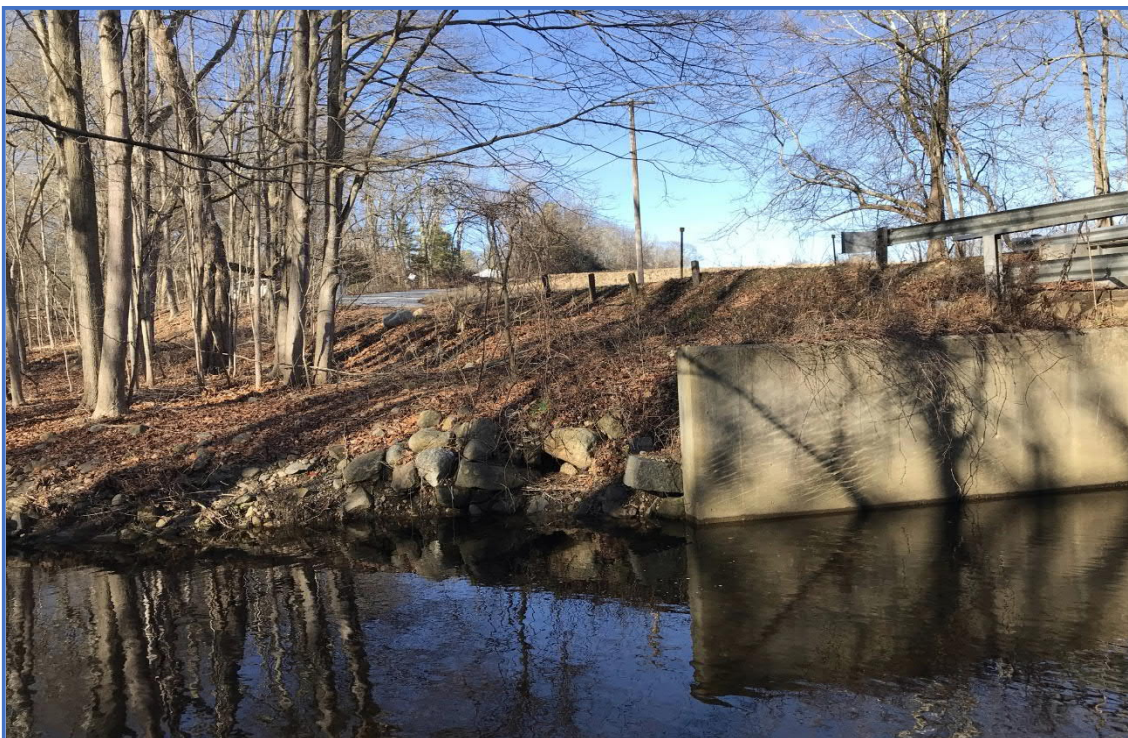
Photo 12: End of Northwest wingwall erosion, outlet side

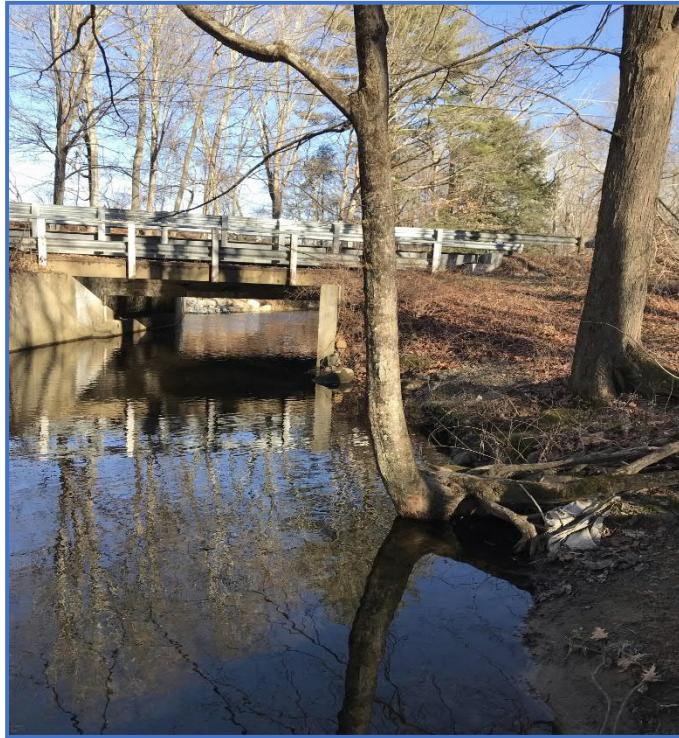
Photo 13: Southwest corner erosion, exposed and undermined tree roots, outlet side

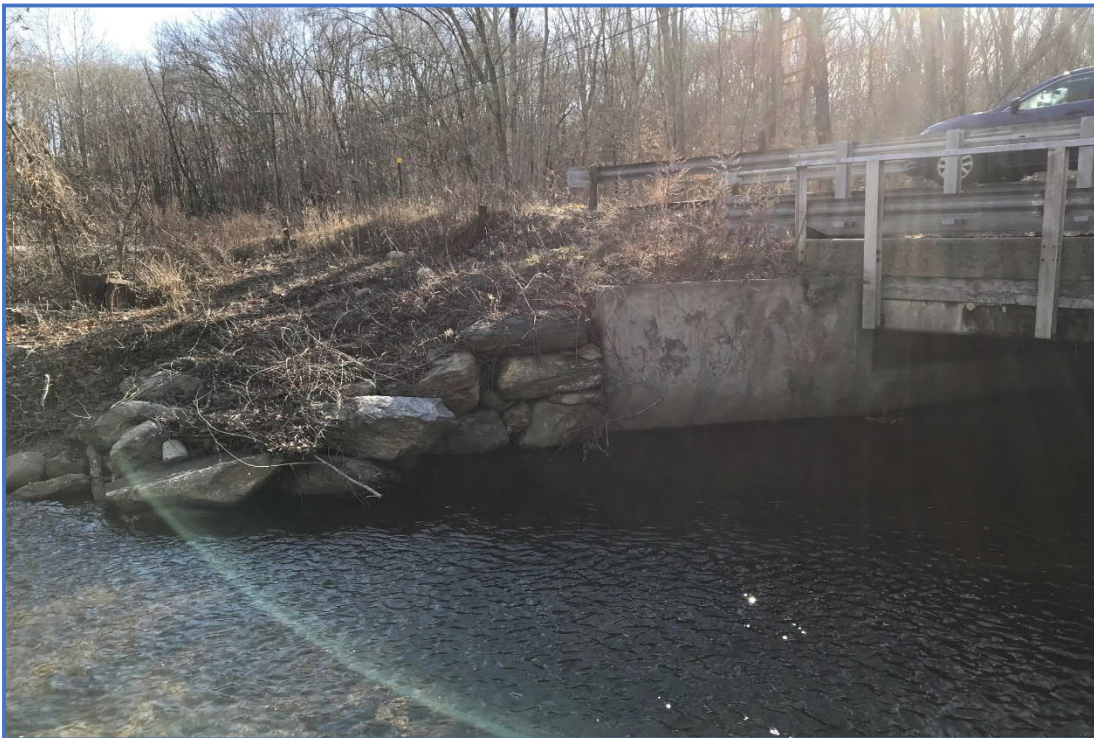
Photo 14: Southeast corner, rip rap at inlet side

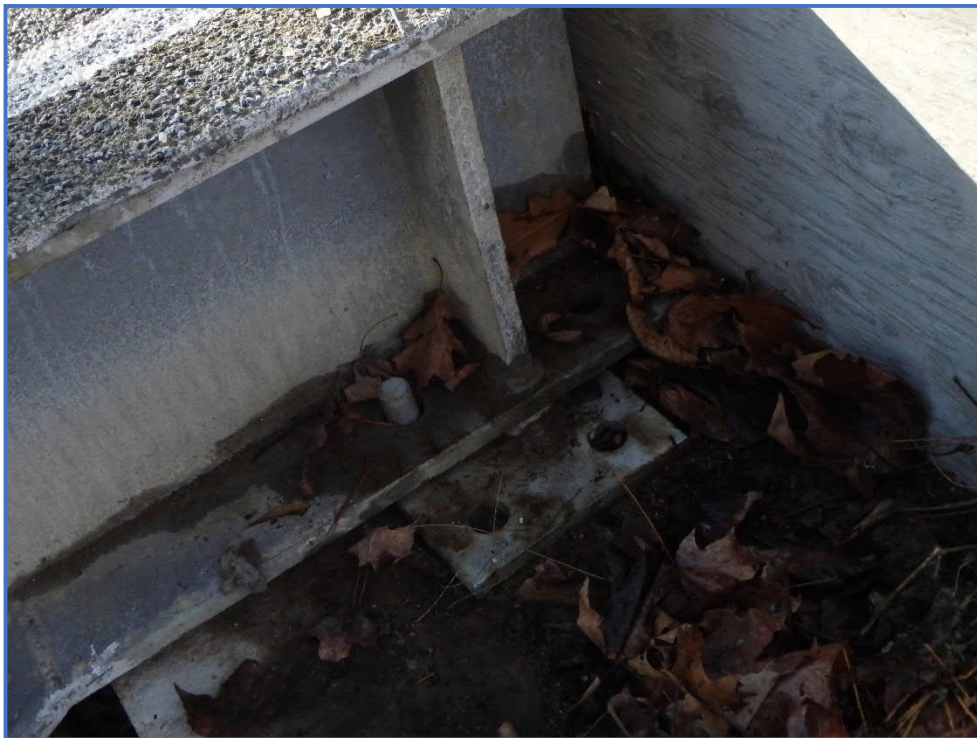
Photo 15: North expansion bearing,

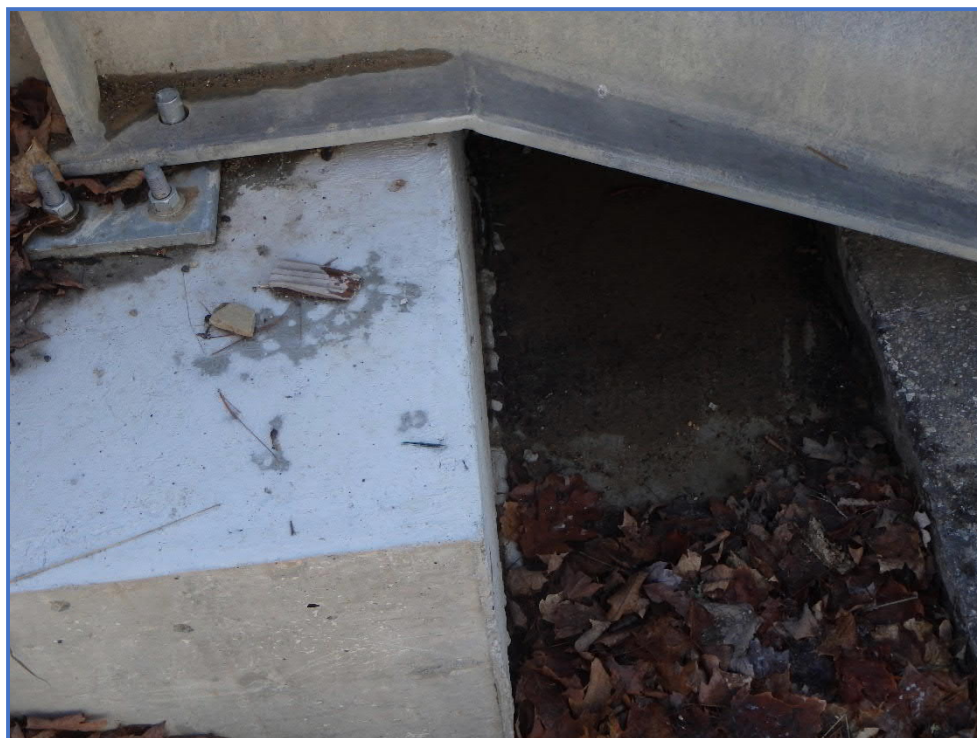
The ACROW bridge substructure is supported by reinforced concrete stub abutments and a spread footing which is in good condition. The abutments were installed perpendicular to Bass Road and 8ft to 15ft behind the original structure (which is skewed 19 degrees).

Photo 16: South fixed bearing and typical stub abutment /footing

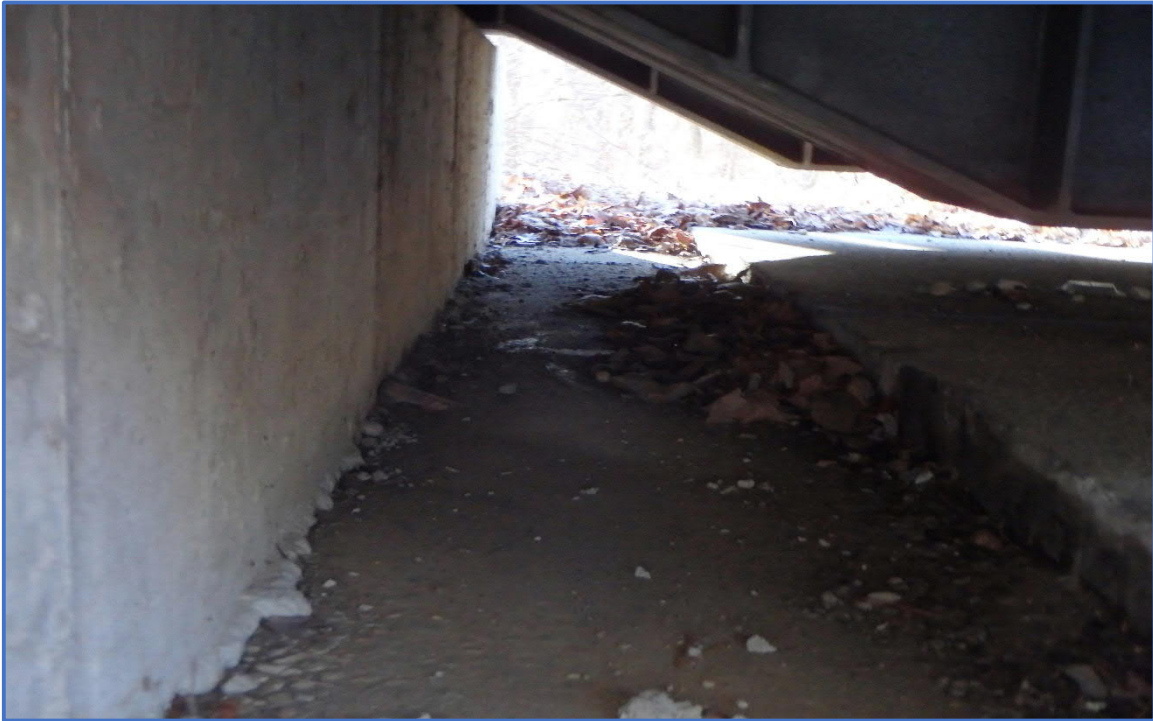
Photo 17: Typical stub abutment and footing cast against the existing roadway

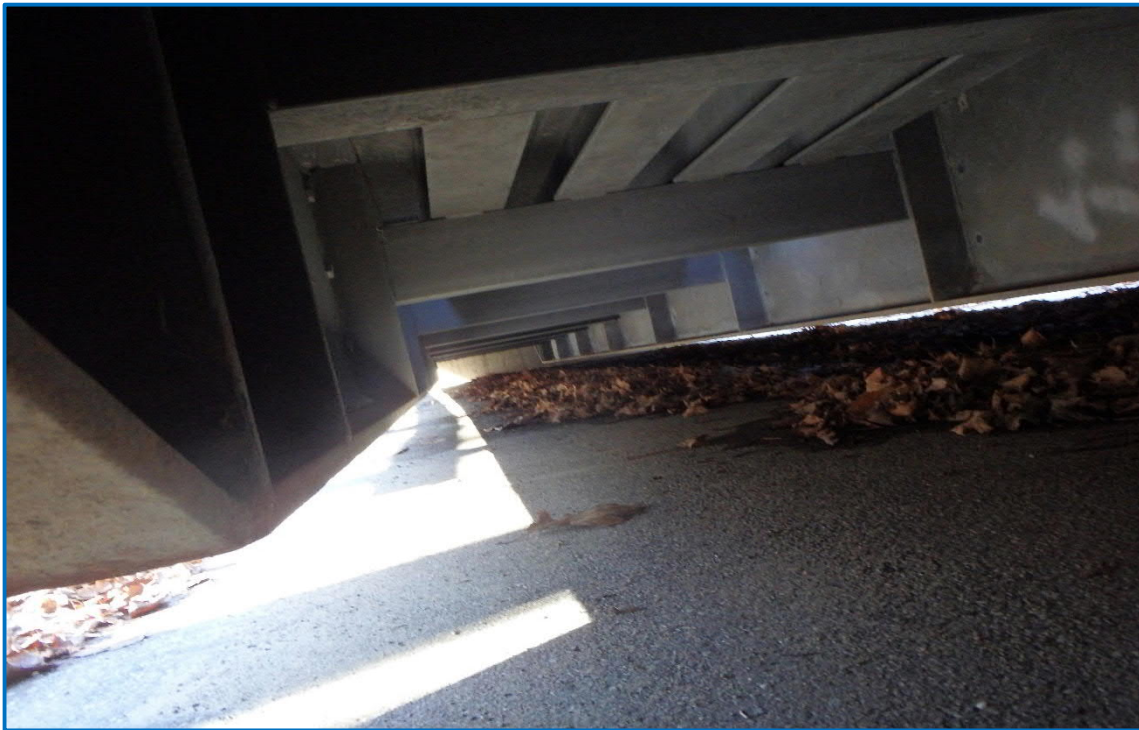
The ACROW superstructure consists of (4) main beams with diaphragms and (8) support stringers that appear to be in good condition with no deterioration.

Photo 18: Typical underside and framing.

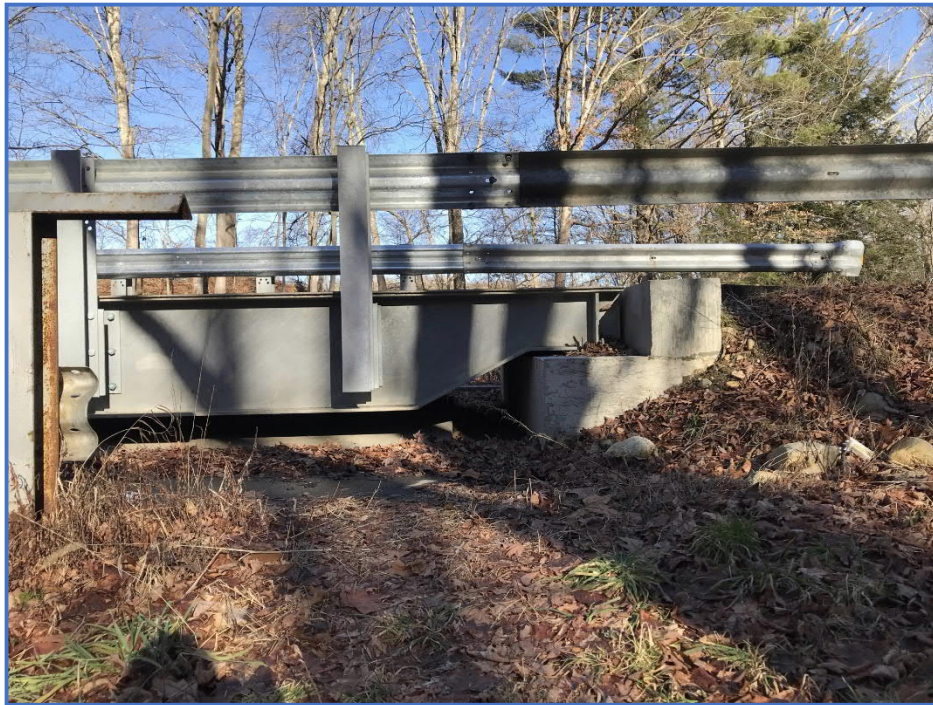
Photo 19: Typical abutment beam seat and backwall. Footing not shown

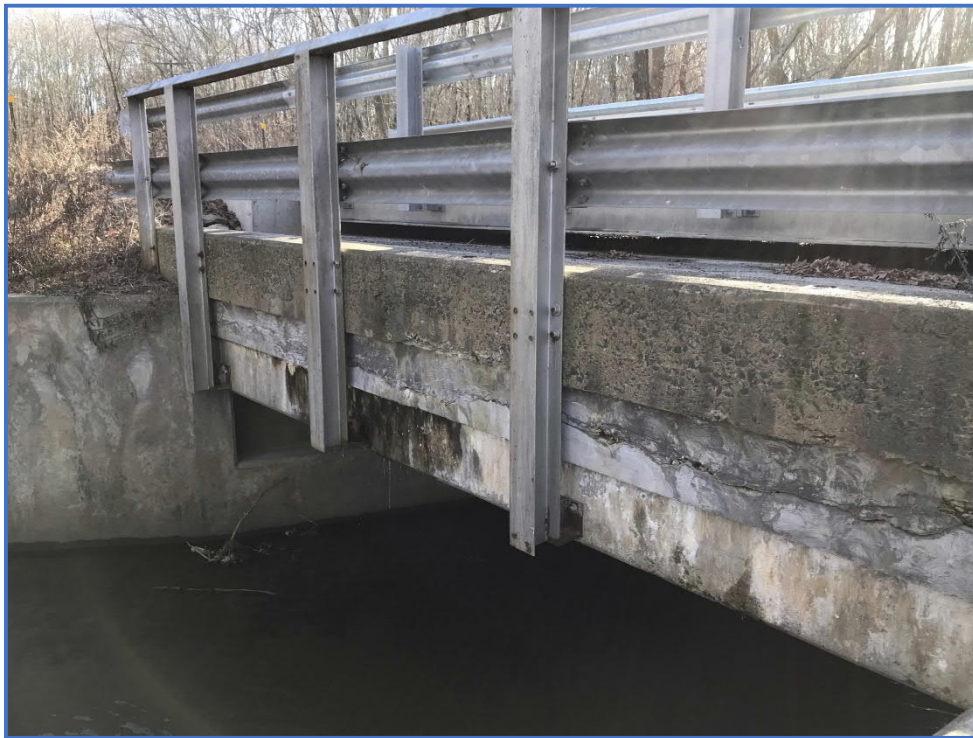
No alarming deterioration was present for the original superstructure that’s not currently in use.

Photo 20: Existing reinforced concrete deck elevation

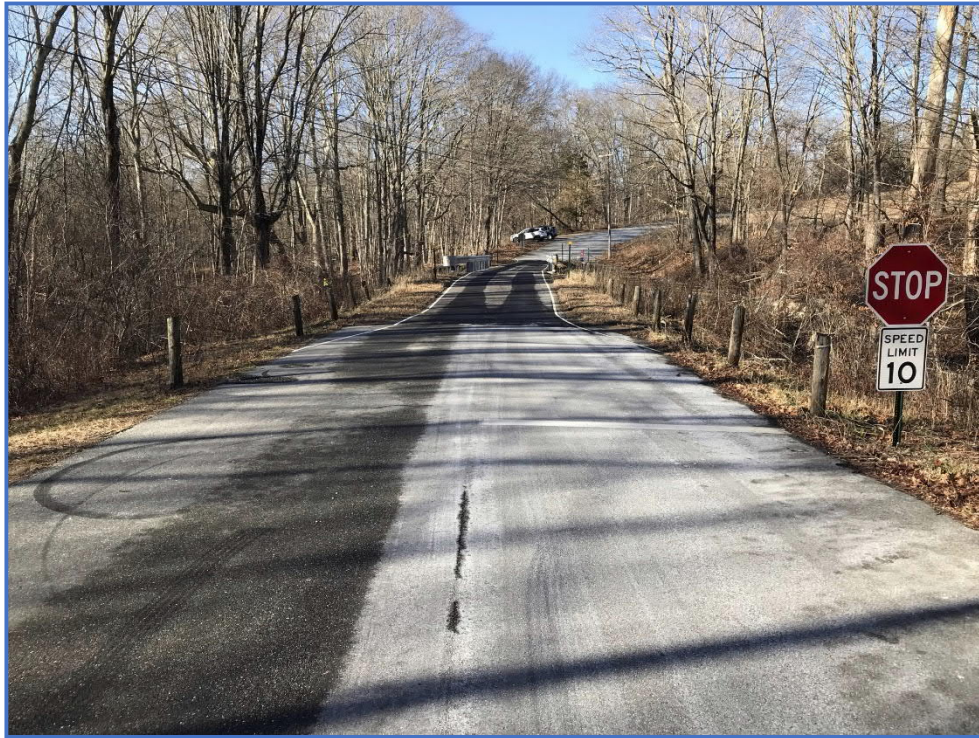
Photo 21: South approach, looking north. Compounding vertical curve changes due to the need to feather into existing grade.

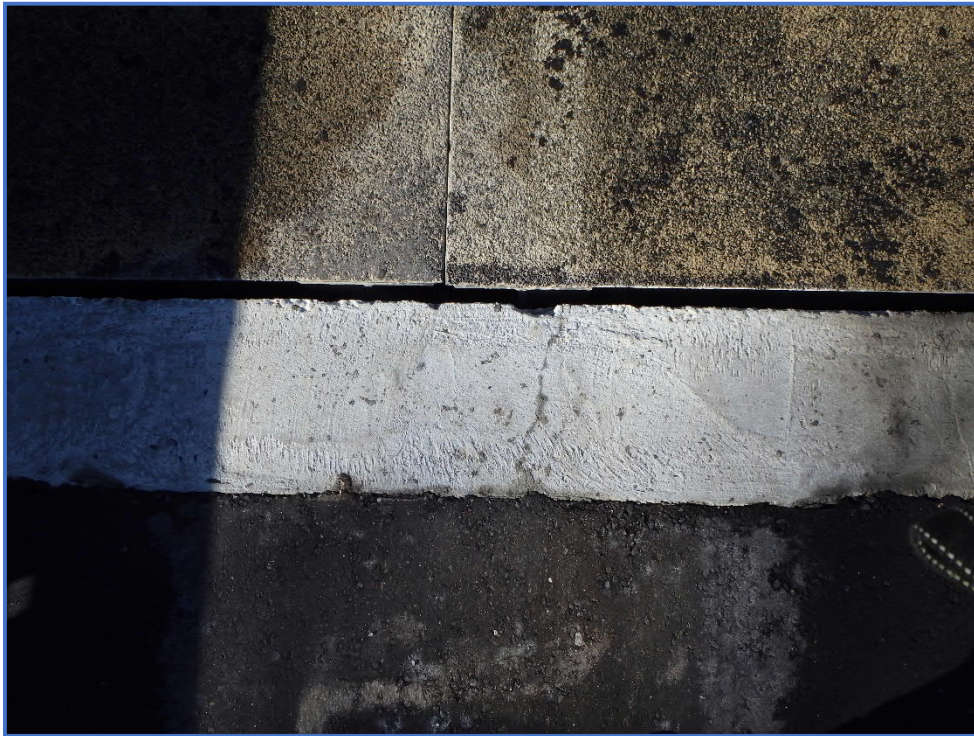
Expansion Joints – There are 1” open joints on both ends between the bridge superstructure and substructure. (See photo 22)

Photo 22: Typical joint between steel deck and backwall. Longitudinal joint also visible.
