SCOTLAND TOWN HALL

CONDITIONS ASSESSMENT STUDY

Town of Scotland

July 22, 2009

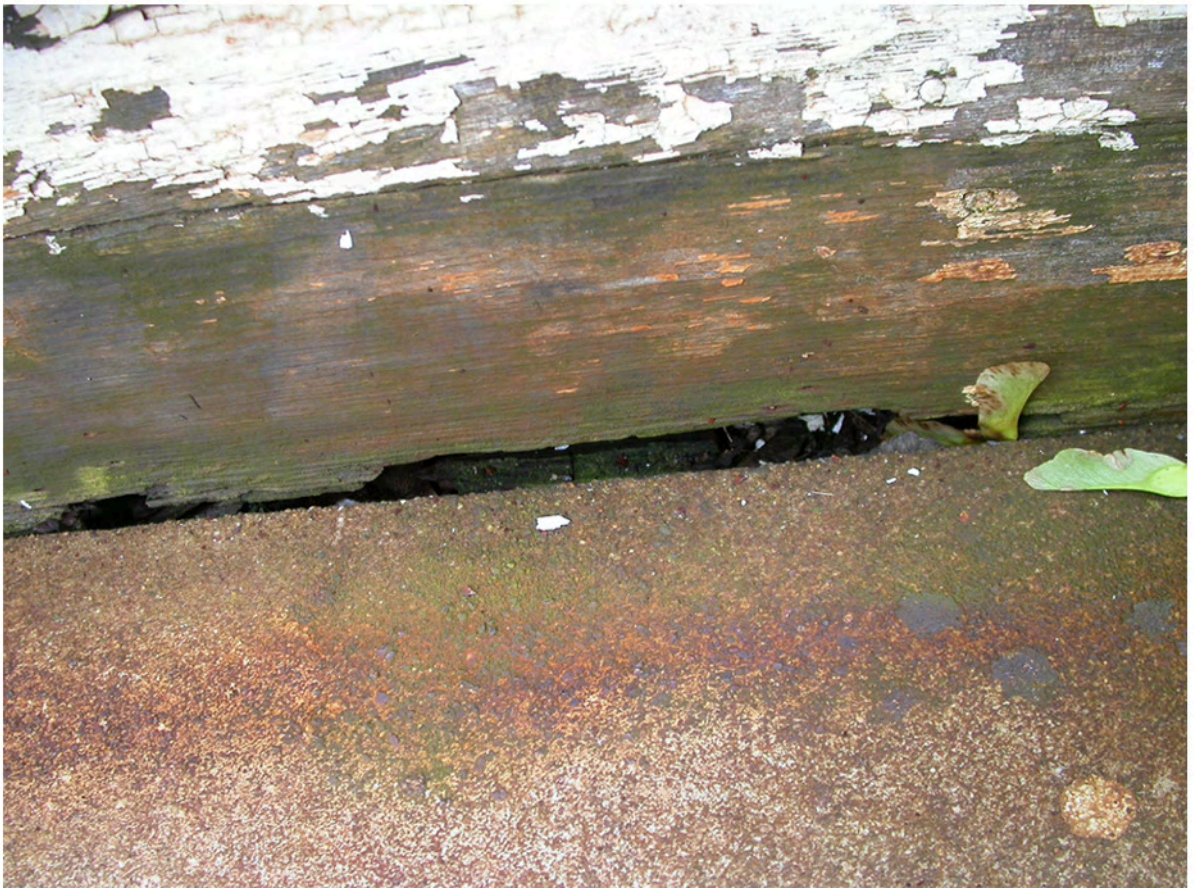
Anecdotal remembrance indicates that the wood siding was in poor condition prior to application of the vinyl siding. A small area of wood siding is visible under the south exterior doors in the Town Clerk's and First Selectman's office. The exposed wood shows evidence of rot along the sill line (photo 1, 2, and 3). If deteriorated wood was covered by artificial siding it will continue to deteriorate with time. The danger is that deterioration is not longer visible. Deterioration of sill plates will often happen from the outside (area of water infiltration) to the inside. The fact that a visual inspection of the first floor framing does not indicate damaged sills does not necessarily mean that the sills are in good condition. It just means that any damage is not yet visible to the interior. This represents a very real and unquantifiable hazard to the integrity of the building. We cannot ascertain the extent of prior and current damage, and we cannot make any guarantees for timeline.

**Photo 1** Sill and watertable at south exterior door in Town Clerk's office

The deteriorated siding on the north, south and west sides must be replaced. This requires complete removal of vinyl siding and aluminum trim in order to determine extent of repairs and to actually make the repairs. We understand that the Town may not be in a financial position to do routine siding repair. Rather than cover the siding with artificial siding consideration should be given to replacing the siding with one of composite siding materials currently available.

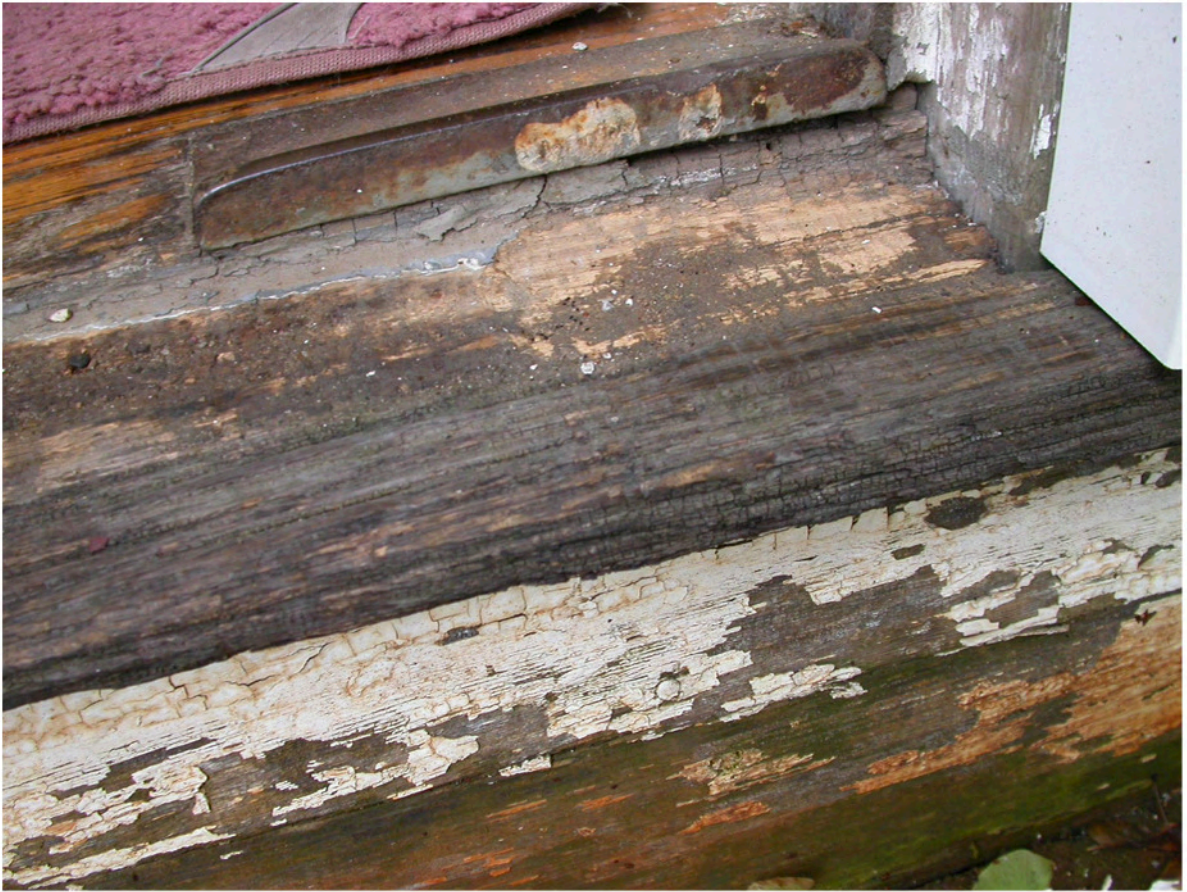
**Photo 2** Detail of watertable at south door from Town Clerk's office

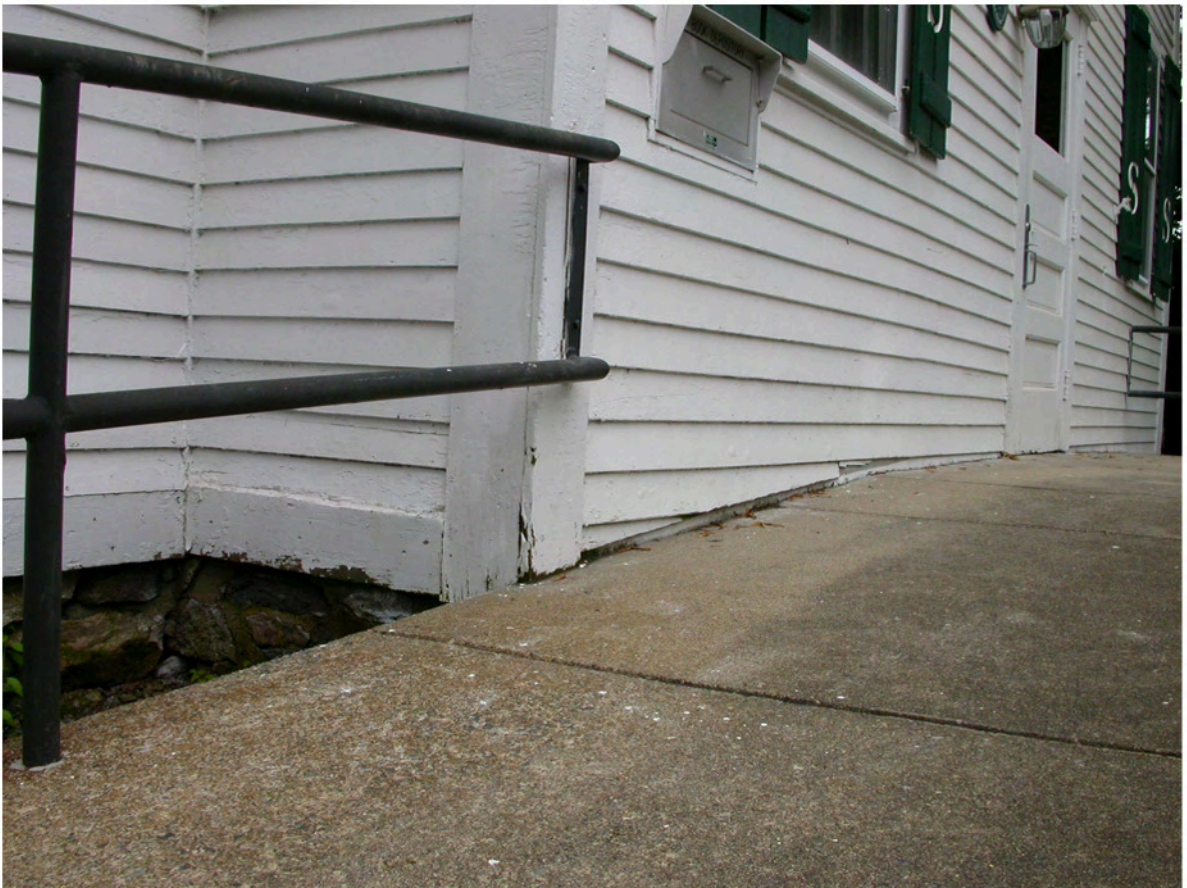
**Photo 3** Detail of sill at south door from Town Clerk's office

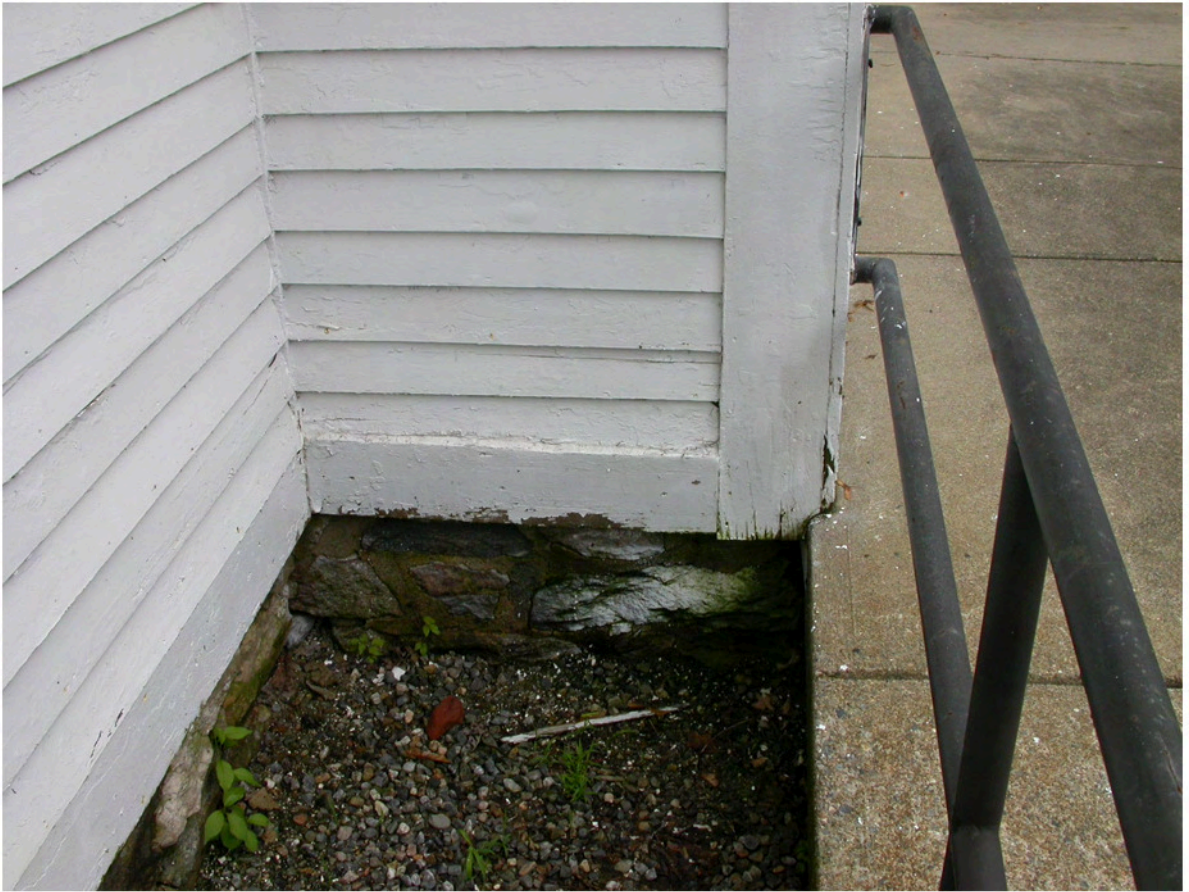
The siding on the front (east) façade of the building is exposed wood clapboard siding. A portion of the siding and watertable boards on this side are concealed behind the concrete platform at the top of the entry door steps and ramp (photo 4). We cannot determine the condition of the boards but note that the existing detailing allows water to get between the siding and concrete (photo 5). This type of detail accelerates deterioration along the sill line.

**Photo 4** Detail of ramp siding connection along east façade.

When the Town replaces the front stairs and ramp the detailing between the building face and should be changed to minimize damage to the wood sills.

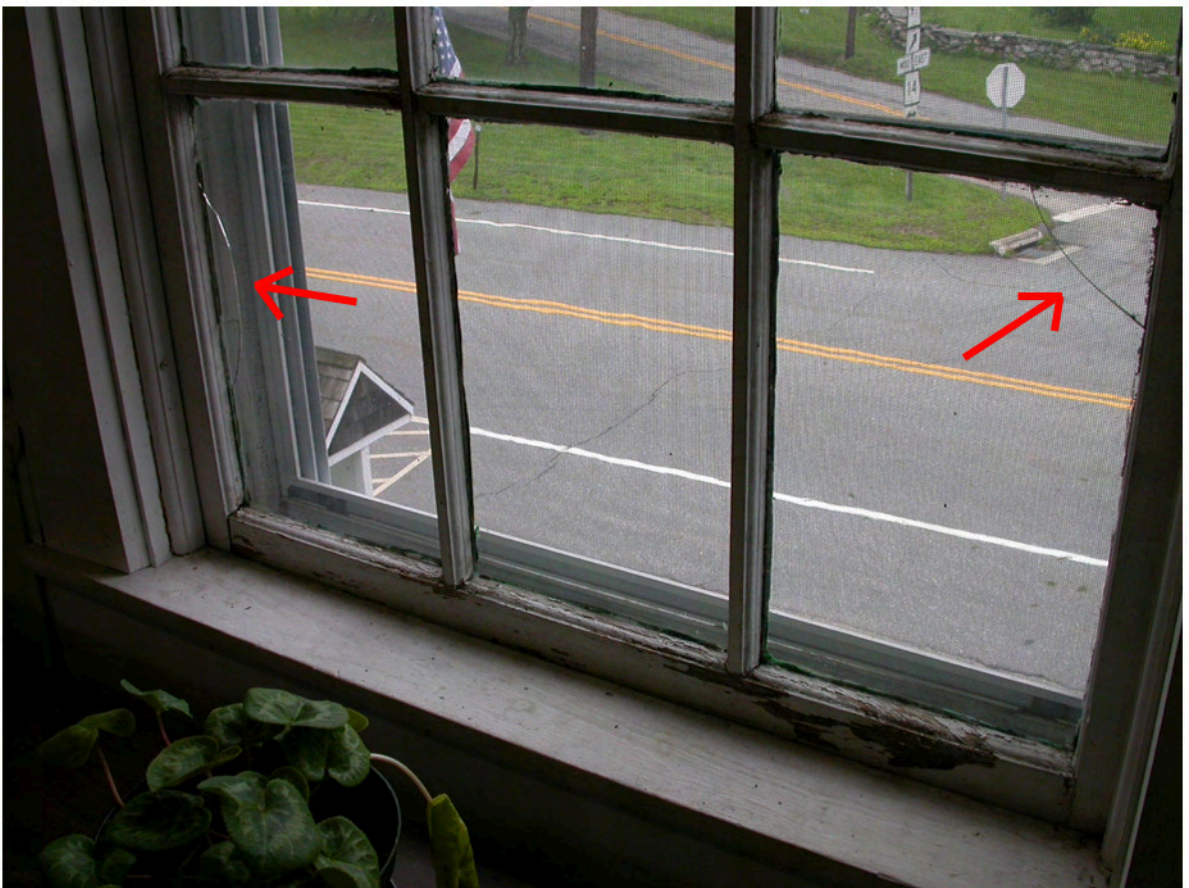
- Of the 154 individual panes of glass, 53 panes, or 34%, are broken. The breaks typically occur in the corners of the glass panes and are caused by a buildup of paint along with muntin and glazing putty lines which prevents the glass from moving in response to thermal expansion and contraction (Photo 7 and 8).
- Sashes are hard to operate which presents a problem as the windows are the only source of ventilation for the building. Some windows have sashes that have been painted shut, some windows have so many layers of paint on the frame that the sash can no longer move freely, some windows with sash weights have broken sash cords, and some windows have racked.

**Photo 7** Example of missing glass

From our experience with historic buildings we recommend that capital outlay be first placed towards building insulation and doors, and that existing windows be properly repaired. The issue regarding window replacement can and should be revisited as the scope of the Town Hall refurbishment is defined.

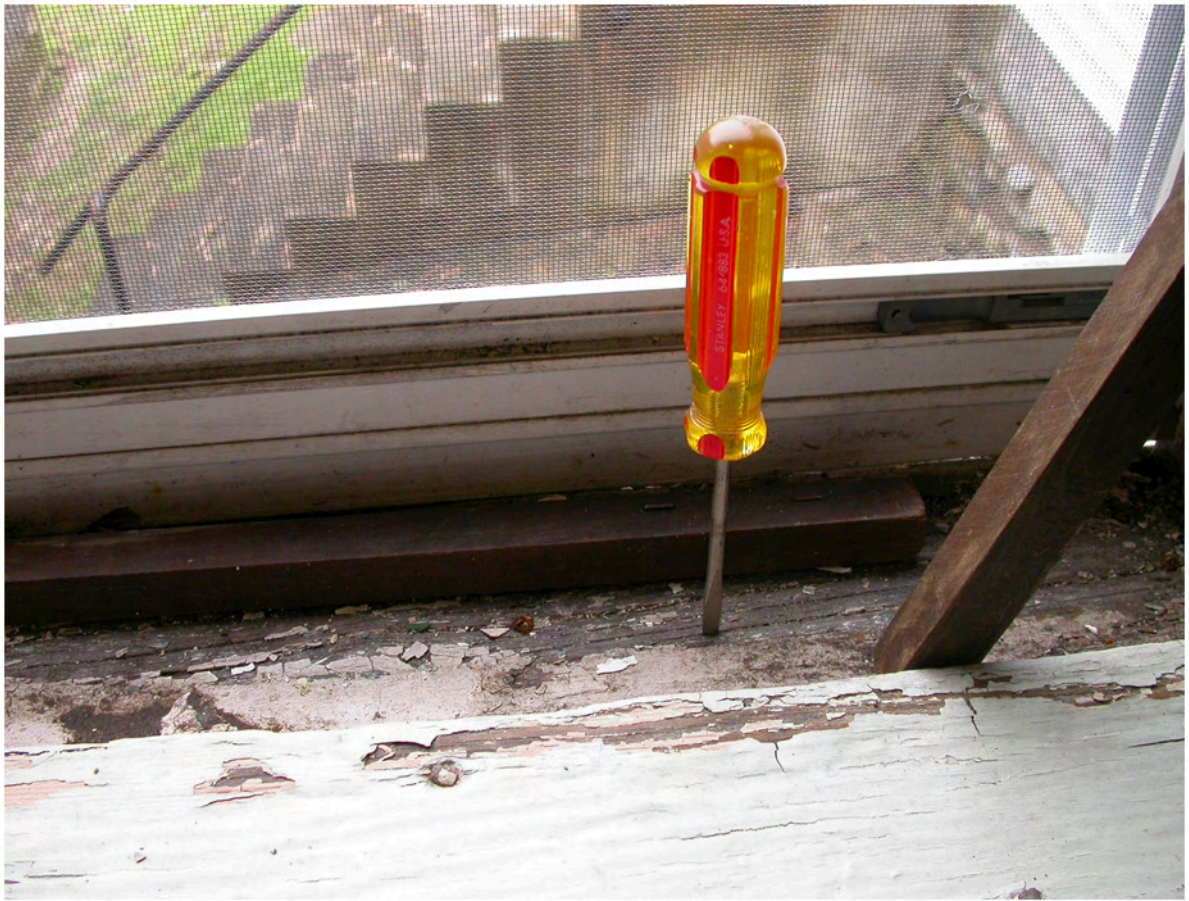
**Photo 8** Example of broken glazing (second floor office)

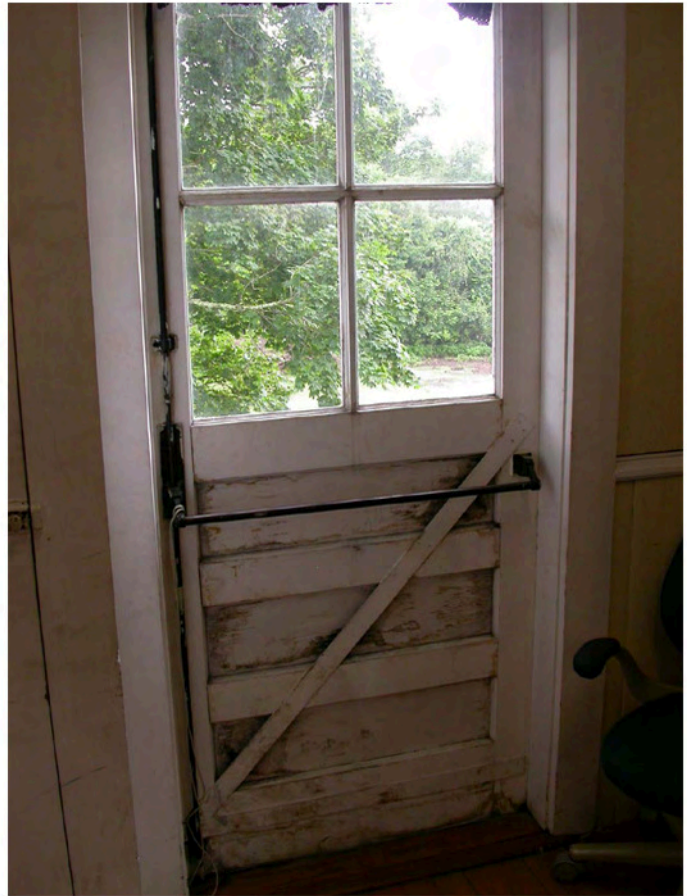
All of the doors are judged to be in poor condition and need replacement (photo 10, 11, 12).

**Photo 10** Detail of exterior door at First Selectmen office

To strengthen the historic appearance of the building we strongly suggest that the design of the replacement exterior doors match the four and six panel style of the original doors. Dimensions for the door panels can be taken from the interior doors that are original to the Consolidated School Building.

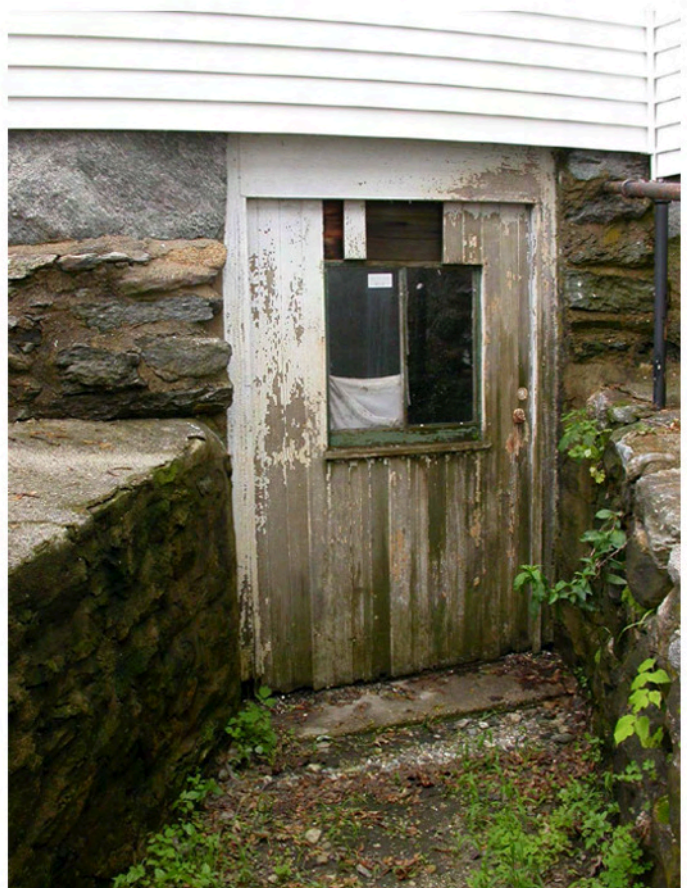
**Photo 11** Example of exterior door condition

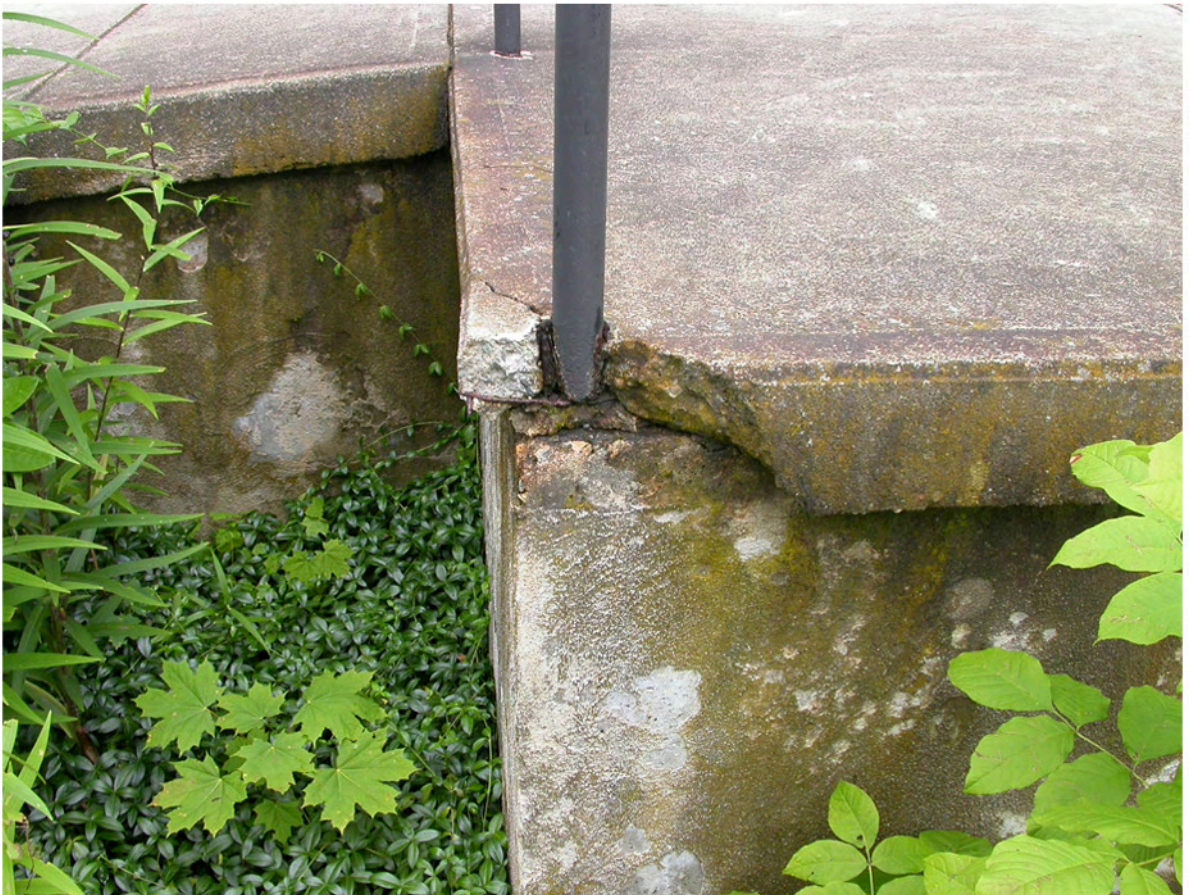
- Use of chloride based de-icing products in the winter (photo 13)
- Poor initial concrete mix
- Rusting of embedded metal causing fractures in the concrete (photo 14, 15, 17)

**Photo 13** Spalling at front steps

Recommendation Concrete work needs to be replaced. The condition shown in photo 14 presents a safety hazard.

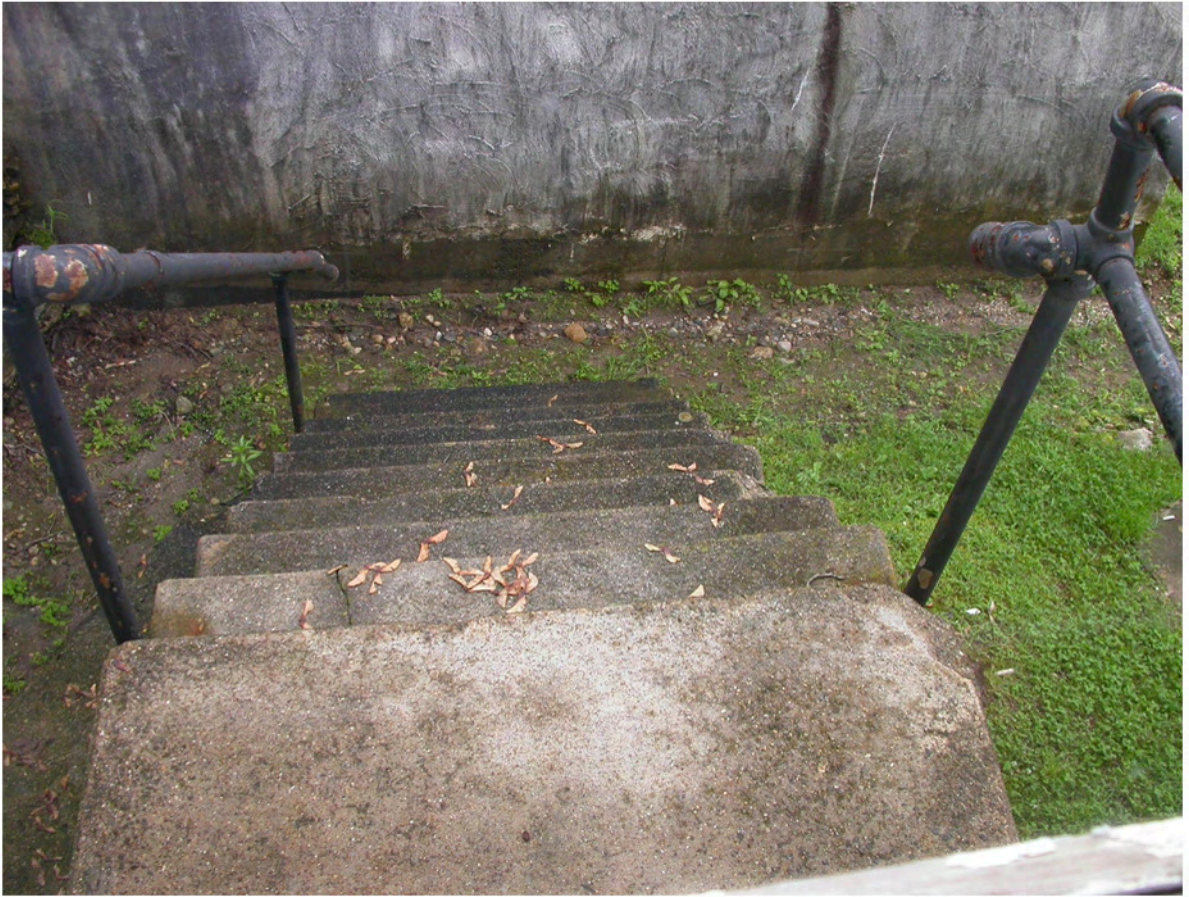
**Photo 14** Concrete damage due to rust

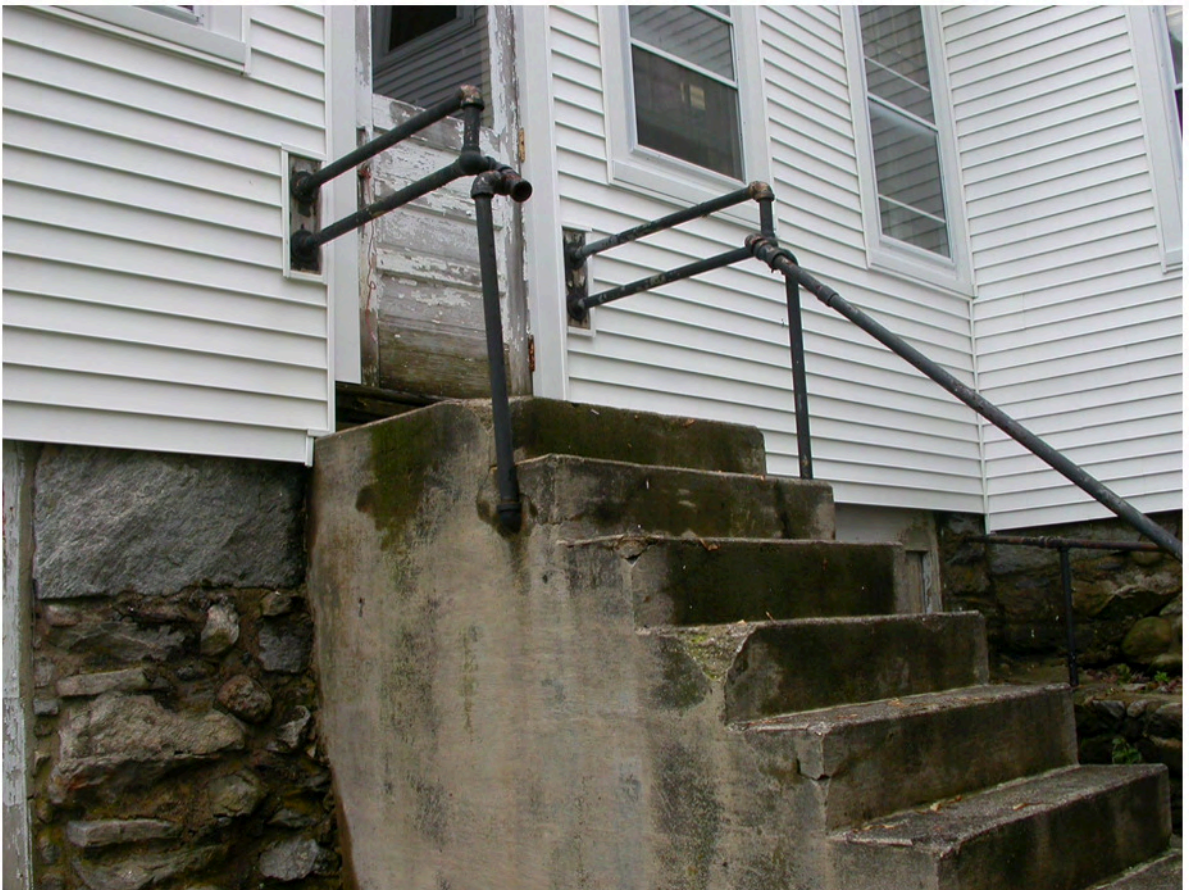
**Photo 15** Steps from First Selectman's office

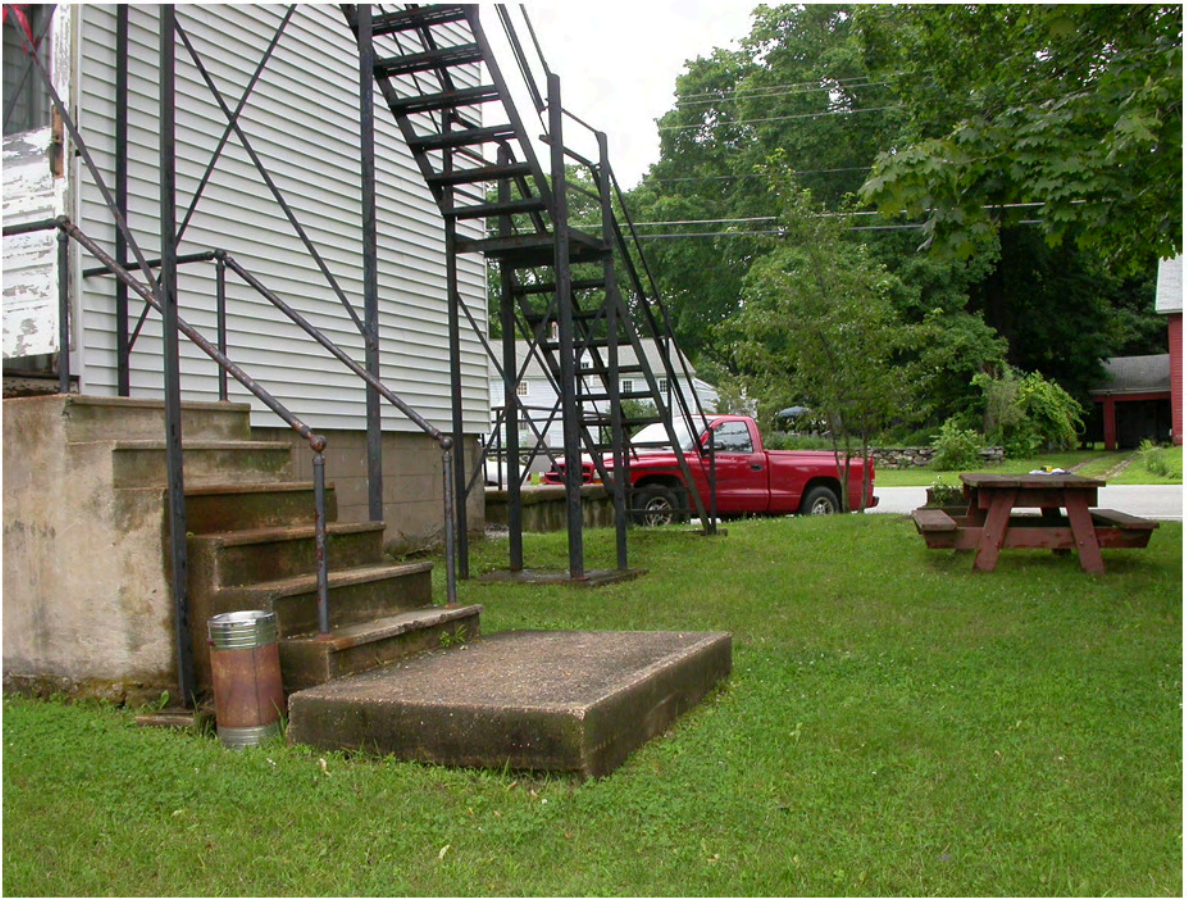
Additionally, portions of handrails are missing (in addition to being non-code compliant). See Photo 16.

**Photo 16** Steps from First Selectman's office

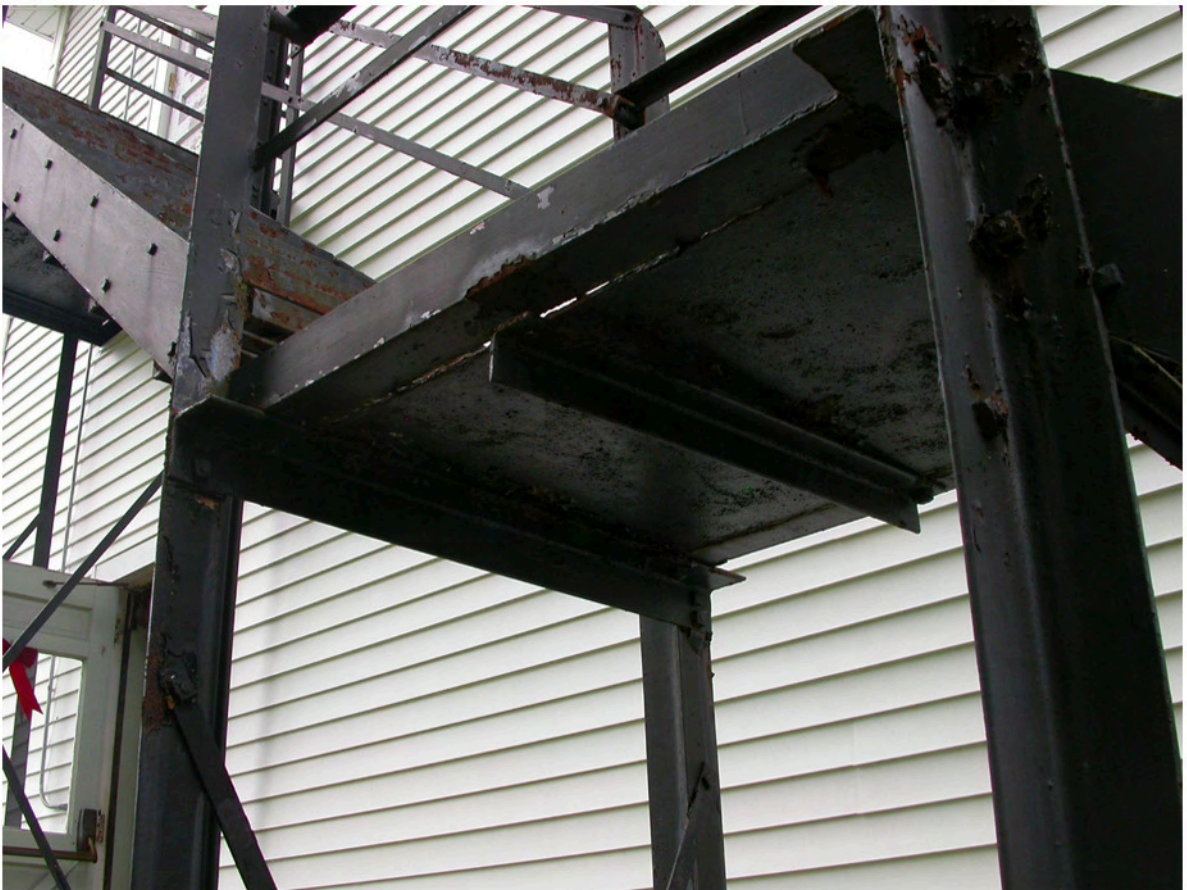
**Photo 17** Steps from Town Clerk's office

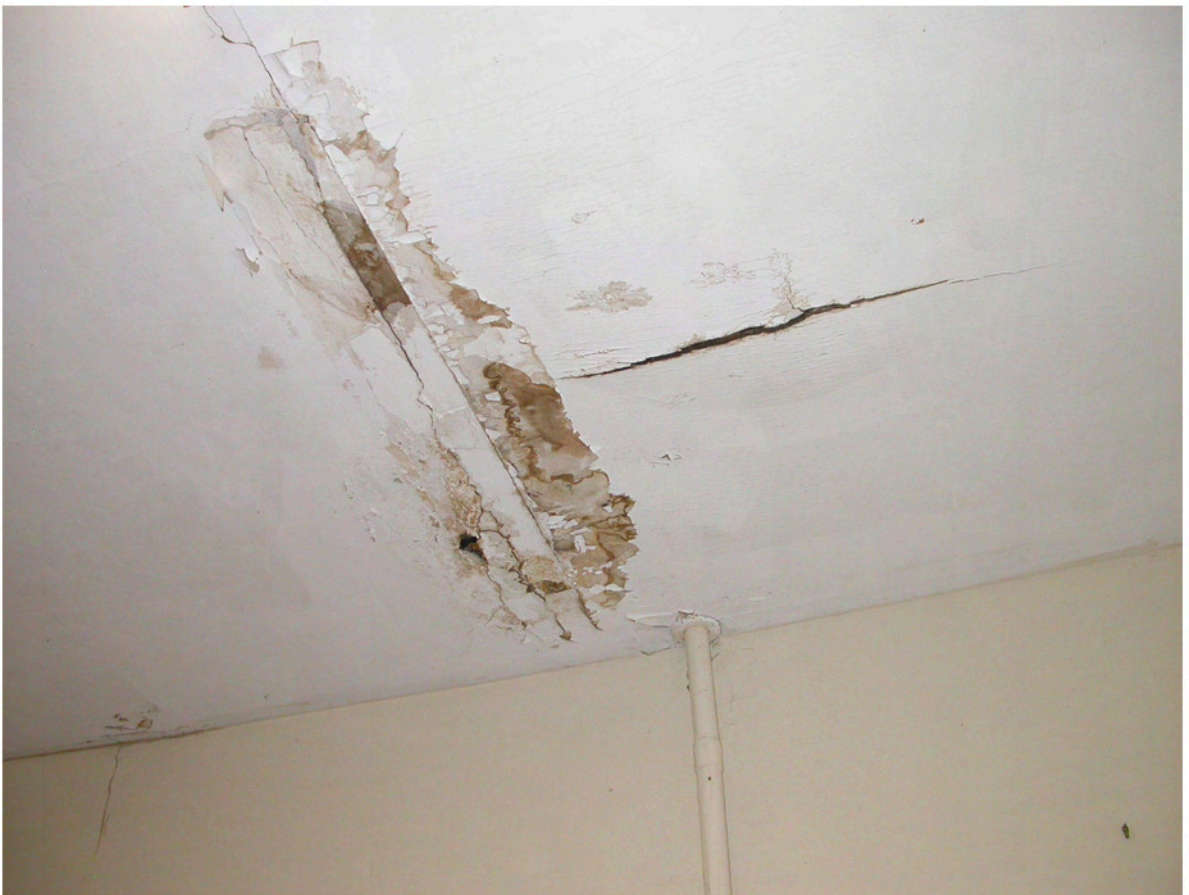
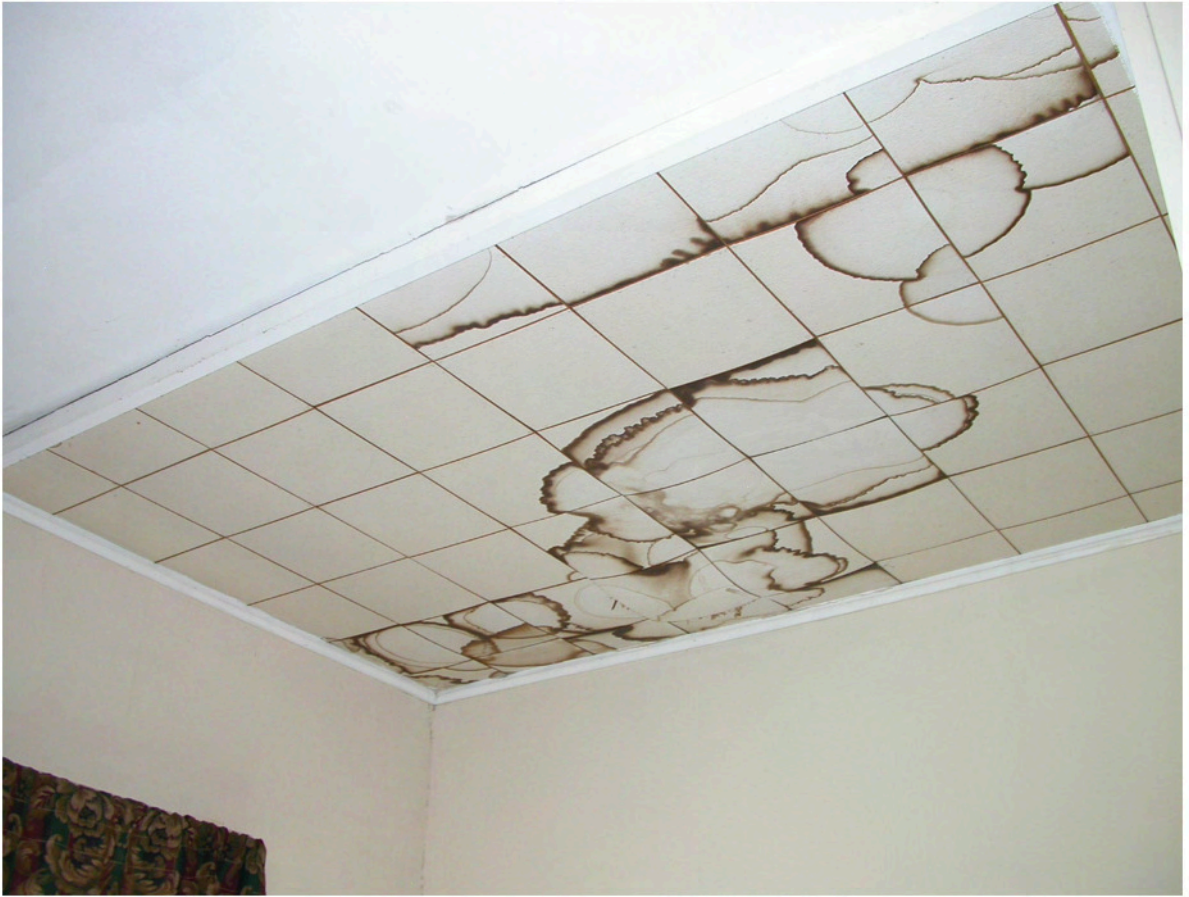
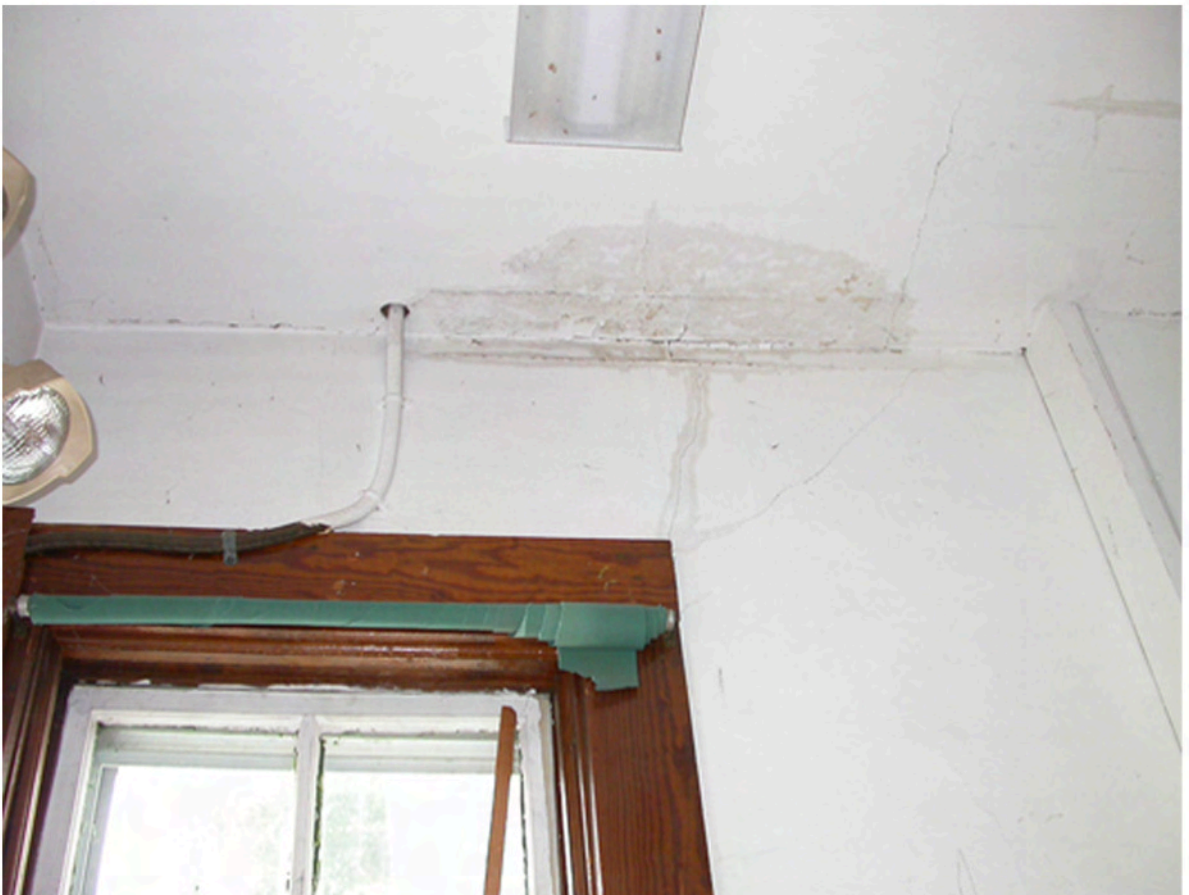
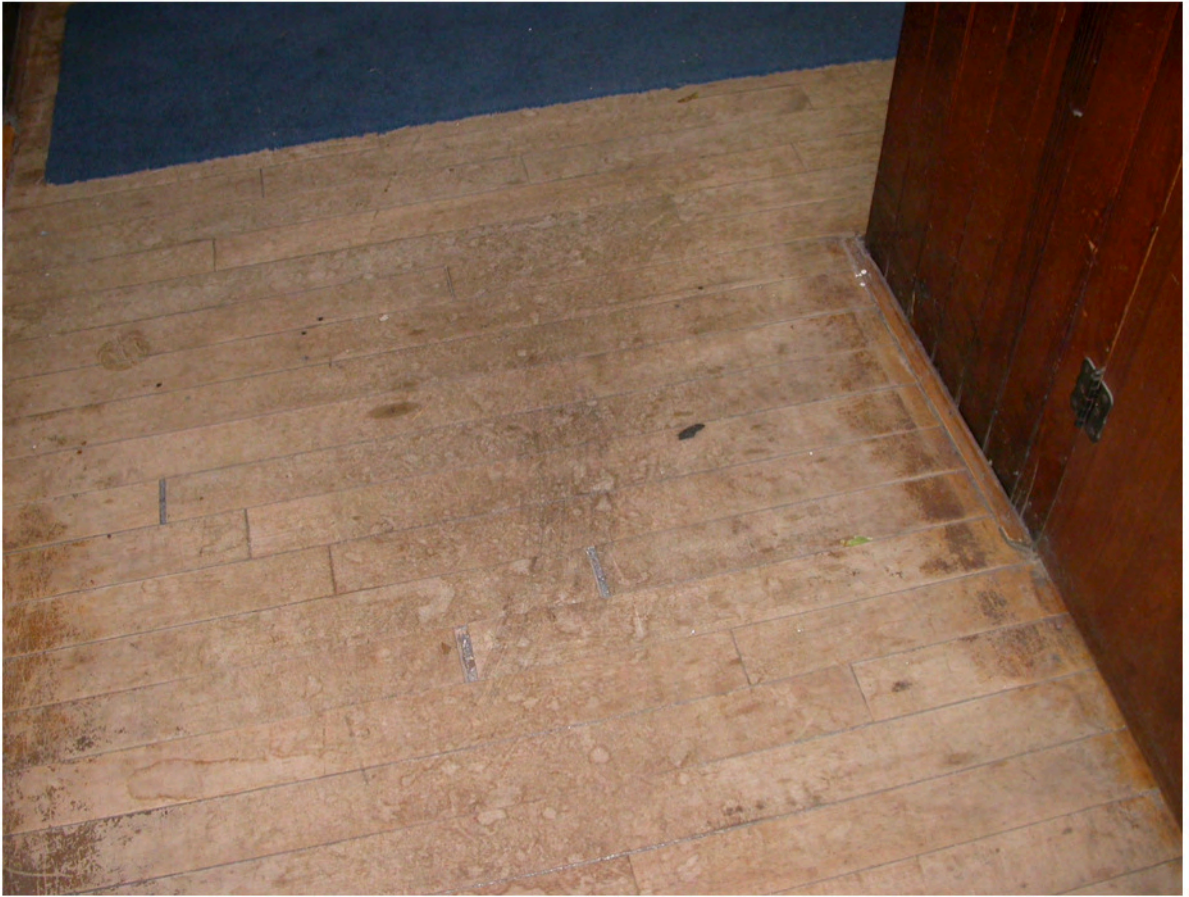
Condition All of the interior finishes are tired and in need of refinishing. Ceiling areas in the first and second floor that show extensive evidence of water damage from prior roofing issues need to be repaired / replaced and repainted (photo 19, 20, 21, 22). Wood floors have lost their protective finishes and are susceptible to increased damage (photo 23, 24). Wall areas in various state of condition.

**Photo 19** Water damage at 2nd floor ceiling

**Photo 20** Water damage at 2nd floor ceiling

**Photo 21** Water damage at 2nd floor ceiling

**Photo 22** Water damage at first floor ceiling

We recommend that the Town of Scotland develop an overall plan for building repair and refurbishment and that new finishes be integrated into the overall plan.

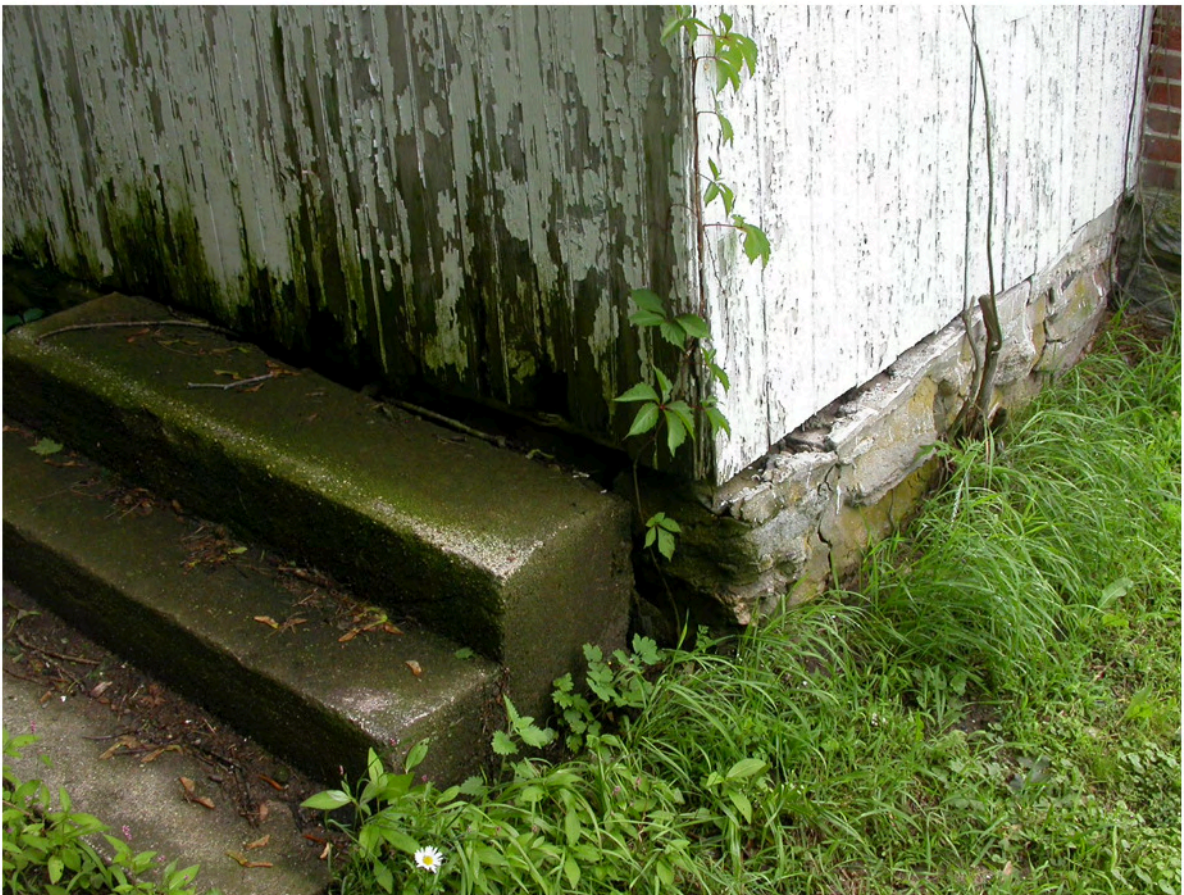
The Town Hall complex has a building to the west and rear of the Town Hall building which was not included in this study. Though the project team did not review the building we enclose photos of the south and north sides. The building shows evidence of significant deterioration of the building envelope (Photo 25, 26).

**Photo 25** South side, rear shed

**Photo 26** North west corner, rear shed
