Mountainside Drive Infrastructure Assessment Report

November 2025

Town of Winchester 338 Main Street Winchester, CT 06098

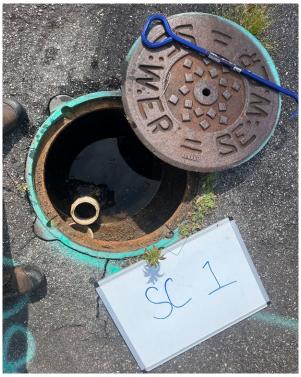
Photo 3: General water level in sewer manholes

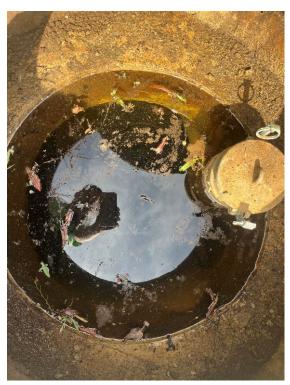
Photo 4: Dust cap intact in SC 2

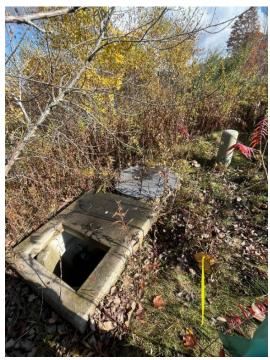
Photo 5: E1 Transformer Vault, E-Vault, Comms Equipment

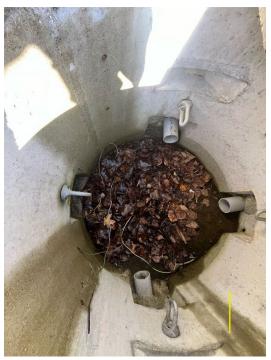
Photo 6: General appearance inside of vaults

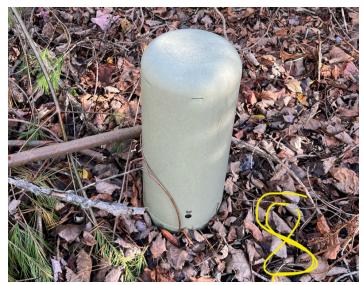
Photo E8-A

Date	45952				
Staff Initials	LT			Covers	
				E-Vault Cover Buried?	NA
ID, Location & Photos		E-Vault and	d Xfmr Walls	E- Vault Cover Material	NA
ID#	E8	Type	NA	Cover Condition	NA
E-Vault?	No			Is Cover Solid?	NA
Transformer Vault?	No	Condition	NA	Transformer Cover	NA
Comms Equipment?	Yes	1/1?	NA	Comms Cover	Yes
Accessible?	Yes	Comments		Comms Cover Material	Plastic
Street	Mountainside Dr			Cover Condition	Good
Exterior Photo#	E8-A				
Interior Photo #	NA	Steps/Lade	der		
E-Vault # of Conduits	NA	Type	NA		
Transformer # of Conduits	NA	Condition			
		Comments			
Vault Location					
Street?					
Other?	SE side of street				
Subject to Flooding?	No

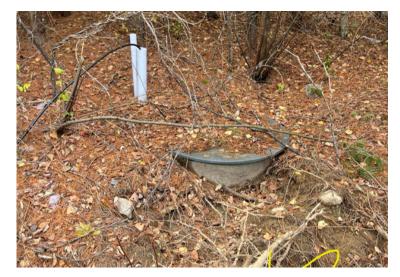
Photo E12-A

Other? W side of street
Subject to Flooding? No - raised

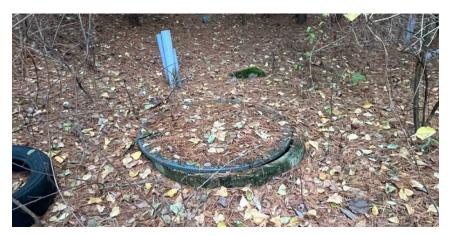
Photo E15-A

Ottone Town of Willong	Stoi				
Date	45952				
Staff Initials	LT			Covers	
				E-Vault Cover Buried?	No
ID, Location & Photos		E-Vault an	d Xfmr Walls	E- Vault Cover Material	Plastic
ID#	E15	Type	Concrete	Cover Condition	Good
E-Vault?	Yes			Is Cover Solid?	Yes
Transformer Vault?	No	Condition	UNK	Transformer Cover	NA
Comms Equipment?	No	I/I?	UNK	Comms Cover	NA
Accessible?	OK - could not open	Comments	S	Comms Cover Material	NA
Street	Mountainside Dr			Cover Condition	NA
Exterior Photo#	E15-A				
Interior Photo #	NA	Steps/Lad	der		
E-Vault # of Conduits	UNK	Type	NA		
Transformer # of Conduits	NA	Condition			
		Comments	S		
Vault Location					
Street?					
Other?	W side of street				
Subject to Flooding?

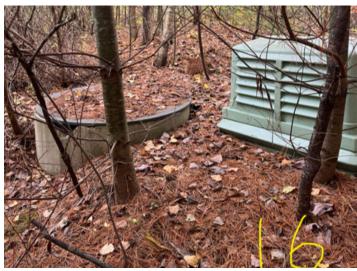
Photo E16-A

E-Vault Cover Buried? No E- Vault Cover Material Plastic **Cover Condition** Good Is Cover Solid? Yes **Transformer Cover** NA Comms Cover Yes Plastic Comms Cover Material **Cover Condition** Good
