# **Comprehensive Asbestos Survey**

**Residential Structure  
220 North 5th Street  
Easley, South Carolina 29640  
September 8, 2025**

**Prepared for:  
Mr. Tor Ellstrom  
The City of Easley**

This pre-demolition comprehensive asbestos survey has been prepared by Upstate Environmental LLC (Upstate) of Easley, South Carolina for the residential structure located at 220 North 5th Street in Easley, South Carolina. Demolition by a contractor is being considered, so it is subject to inspection and abatement (if necessary) by the requirements of the South Carolina Department of Environmental Services (SCDES) regulation R.61-86.1.

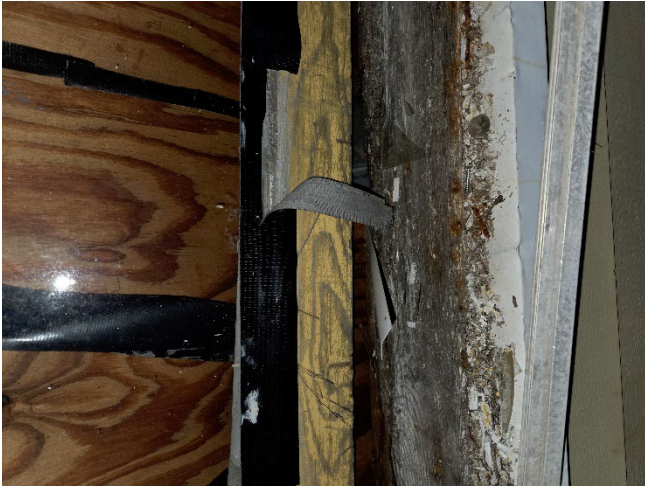
1

| Sample Number | Sample Description and type (TSI, Miscellaneous, Surfacing) | Location | Analytical Results | Friable / Non-Friable | Current Condition | Potential for Disturbance | Estimated Quantity |
|---|---|---|---|---|---|---|---|
| A01-A03 | Window glazing<br>Miscellaneous material | Exterior windows | NAD | Friable | Damaged | HPD | 200 LF |

Homogeneous Area "A":  
Window glazing

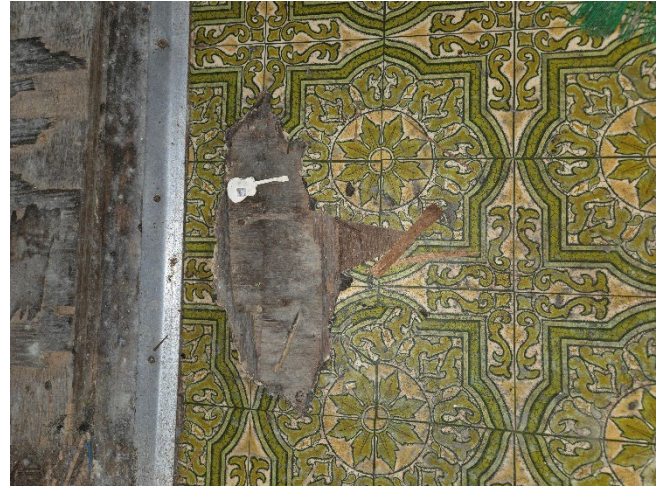
2

*Homogeneous area "B"- Green sheet flooring. 15% Chrysotile. Approximately 155 Square Feet*

| Sample Number | Sample Description and type (TSI, Miscellaneous, Surfacing) | Location | Analytical Results | Friable / Non-Friable | Current Condition | Potential for Disturbance | Estimated Quantity |
|---|---|---|---|---|---|---|---|
| B01-B03 | Green sheet flooring<br>Miscellaneous material | Kitchen | <b>15% Chrysotile</b> | Friable | Damaged | HPD | 155 SF |

Homogeneous Area "B":  
Green sheet flooring

Every attempt has been made to sample all the suspect ACMs in/on the building that are in the work area scope. However, if suspect material that has not been analyzed previously is encountered during demolition activities, the suspect ACM should be sampled prior to disturbance. The area of asbestos containing material shall be abated before any work being performed that could cause disturbance. This abatement should be performed by persons licensed by South Carolina Department of Environmental Services (SCDES).

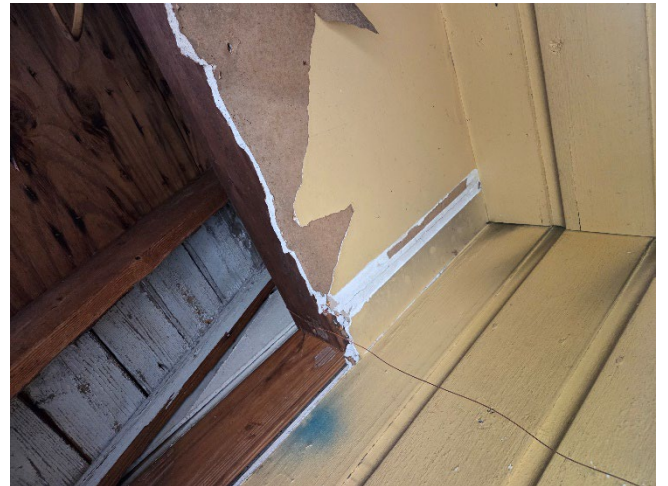
4

| Sample Number | Sample Description and type (TSI, Miscellaneous, Surfacing) | Location | Analytical Results | Friable / Non-Friable | Current Condition | Potential for Disturbance | Estimated Quantity |
|---|---|---|---|---|---|---|---|
| D01-D07 | Drywall and joint compound<br>Surfacing materials | Throughout | NAD | Non-friable | Good | HPD | 3120 SF |

Homogeneous Area "D":  
Drywall and joint compound

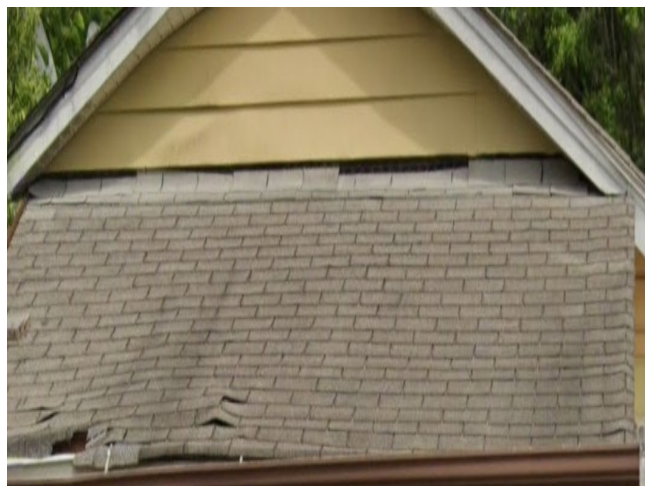
6

| Sample Number | Sample Description and type (TSI, Miscellaneous, Surfacing) | Location | Analytical Results | Friable / Non-Friable | Current Condition | Potential for Disturbance | Estimated Quantity |
|---|---|---|---|---|---|---|---|
| F01-F03 | Roofing layers<br>Surfacing material | Roof | NAD | Non-friable | Good | HPD | 2000 SF |

Homogeneous Area "F":  
Roofing layers

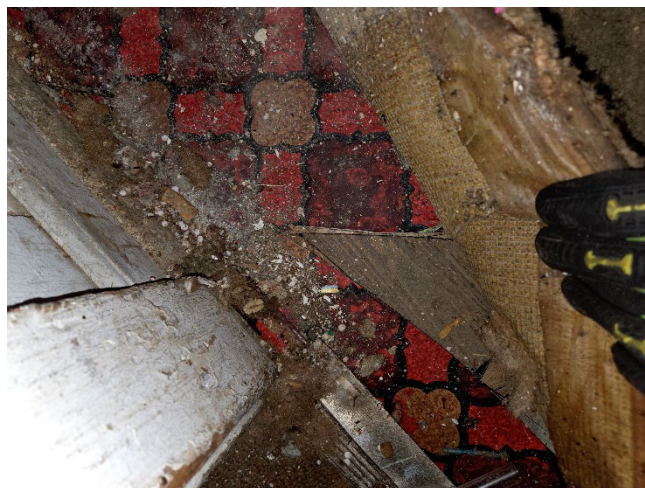
8

*Homogeneous area "H"- Red/ Multiple layers sheet flooring. 15% Chrysotile. Approximately 155 Square Feet*

| Sample Number | Sample Description and type (TSI, Miscellaneous, Surfacing) | Location | Analytical Results | Friable / Non-Friable | Current Condition | Potential for Disturbance | Estimated Quantity |
|---|---|---|---|---|---|---|---|
| H01-H03 | Bedroom sheet flooring<br>Miscellaneous material | Front right bedroom facing house | <b>15% Chrysotile</b> | Friable | Damaged | HPD | 155 SF |

Homogeneous Area "H":  
Red multicolored sheet flooring

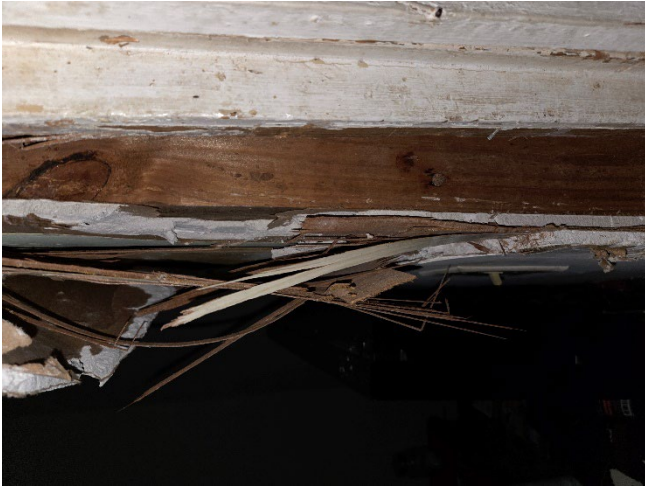
9

| Sample Number | Sample Description and type (TSI, Miscellaneous, Surfacing) | Location | Analytical Results | Friable / Non-Friable | Current Condition | Potential for Disturbance | Estimated Quantity |
|---|---|---|---|---|---|---|---|
| I01-I03 | Drywall under wood panel<br>Miscellaneous material | Middle bedroom on driveway side | NAD | Friable | Good | HPD | 350 SF |

Homogeneous Area "I":  
Drywall under wood paneling

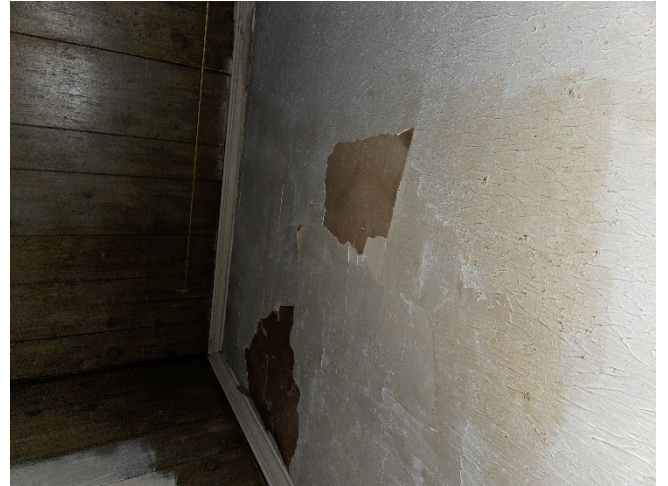
10

| Sample Number | Sample Description and type (TSI, Miscellaneous, Surfacing) | Location | Analytical Results | Friable / Non-Friable | Current Condition | Potential for Disturbance | Estimated Quantity |
|---|---|---|---|---|---|---|---|
| J01-J03 | Ceiling texture<br>Miscellaneous material | Bedrooms | NAD | Friable | Significantly Damaged | HPD | 475 SF |

Homogeneous Area "J":  
Ceiling texture in bedrooms
