# **Comprehensive Asbestos Survey**

**Residential Structure  
143 West C Avenue Extension  
Easley, South Carolina 29640  
October 8, 2025**

143 West C Avenue Extension  
Mobile Home in Easley, South Carolina

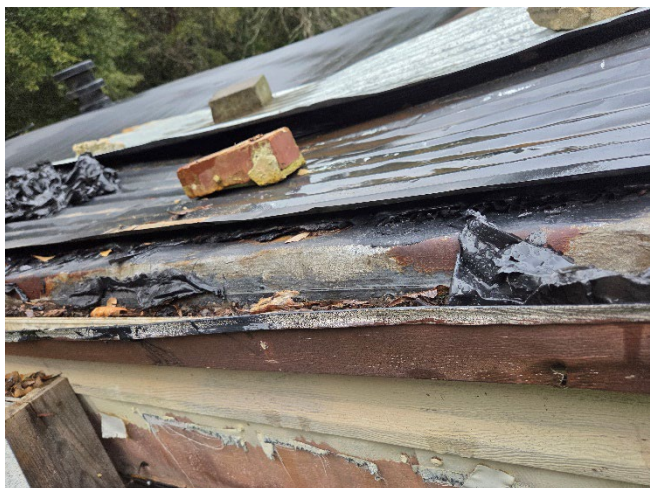
| Sample Number | Sample Description and type (TSI, Miscellaneous, Surfacing) | Location | Analytical Results | Friable / Non-Friable | Current Condition | Potential for Disturbance | Estimated Quantity |
|---|---|---|---|---|---|---|---|
| A1-A3 | Silver paint and flashing<br>Miscellaneous material | Roof | <b>2% Chrysotile</b> | Non-friable | Damaged | PD | 900 SF |

**1** Homogeneous Area "A":  
Roofing paint and flashing

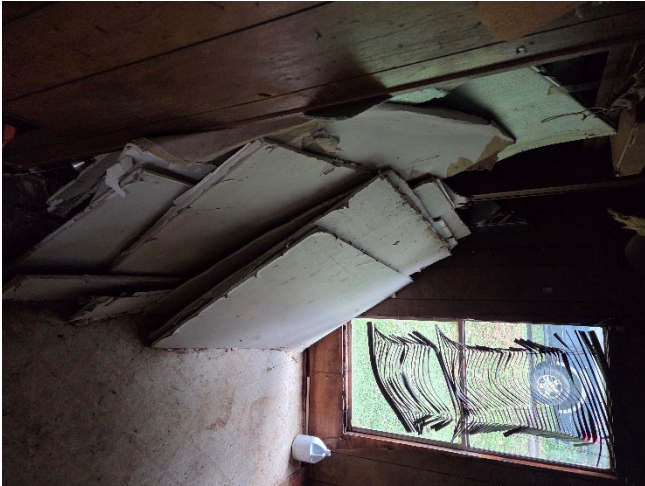
5

| Sample Number | Sample Description and type (TSI, Miscellaneous, Surfacing) | Location | Analytical Results | Friable / Non-Friable | Current Condition | Potential for Disturbance | Estimated Quantity |
|---|---|---|---|---|---|---|---|
| E1-E3 | Drywall and joint compound<br>Surfacing material | Stack in storage | NAD | Friable | Significantly Damaged | PD | 2 Piles |

Homogeneous Area "E":  
Drywall and joint compound

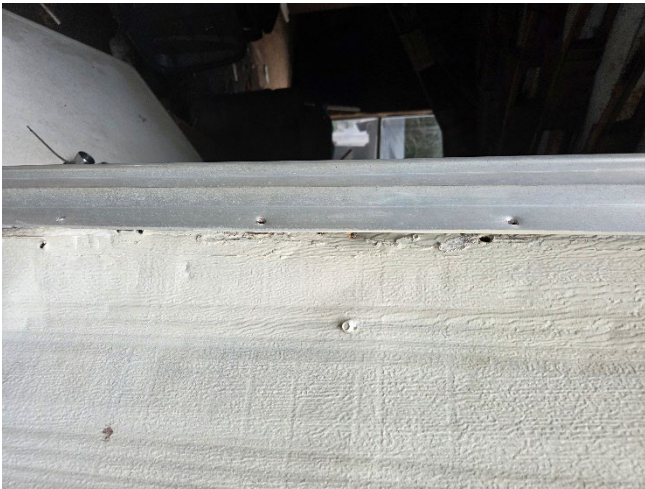
7

| Sample Number | Sample Description and type (TSI, Miscellaneous, Surfacing) | Location | Analytical Results | Friable / Non-Friable | Current Condition | Potential for Disturbance | Estimated Quantity |
|---|---|---|---|---|---|---|---|
| G1-G3 | Door and window caulk<br>Miscellaneous material | Exterior | <b>2% Chrysotile</b> | Non-friable | Damaged | PD | 300 LF |

Homogeneous Area "G":  
Window and door caulking
