SCOTLAND TOWN HALL

CONDITIONS ASSESSMENT STUDY

Town of Scotland

July 22, 2009

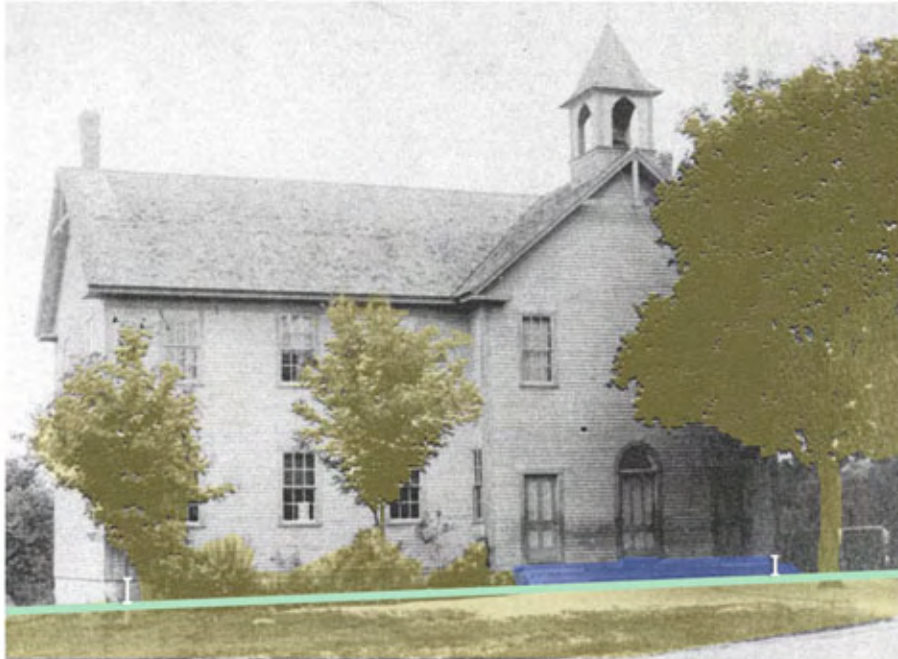
#### GROUND PLANE

Grade at the front (east side) of the Consolidated School Building in the early 20th century was much higher than presently exists. The lowering of grade is presumed to be the result of re-grading for roadway work along Rt. 97. The lowered grade relative to the first floor of the building increases the number of steps required to get into the building and distorts the relationship the 19th-Century building had to the site.

#### ENTRY STAIR

The width of the original entry stair spanned most of the width of the east facing gable end façade. Currently the stair and landing are much narrower. As a result the entry facade does not have the same sense of scale and monumentality.

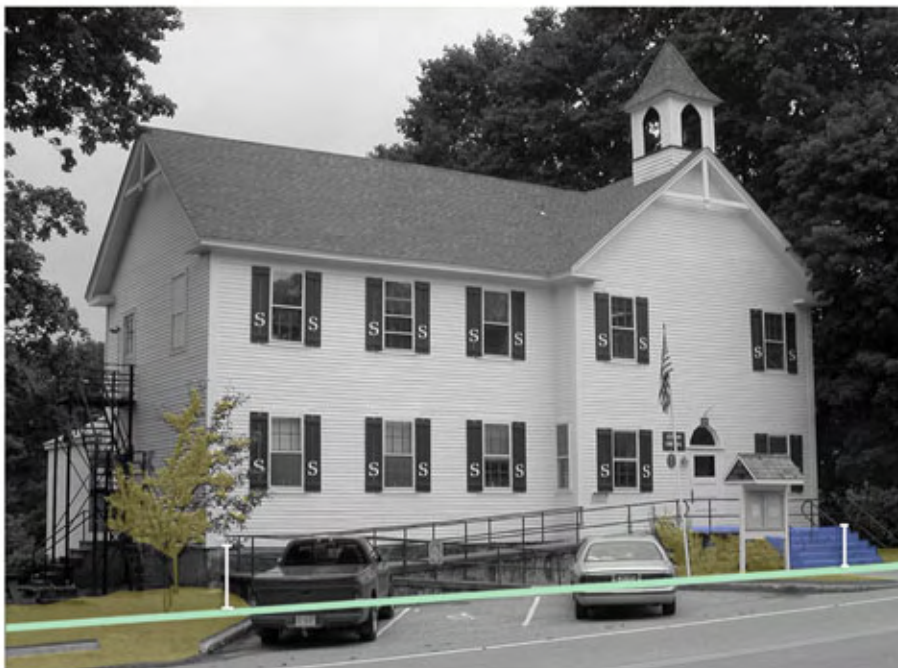
#### FRONT YARD VEGETATION

Plantings softened the read of the Consolidated School Building's façade and integrated the building with the rural landscape. While plantings are not possible given the current ramp and stair arrangement development of sympathetic landscape design in the future would help reestablish a rural context.

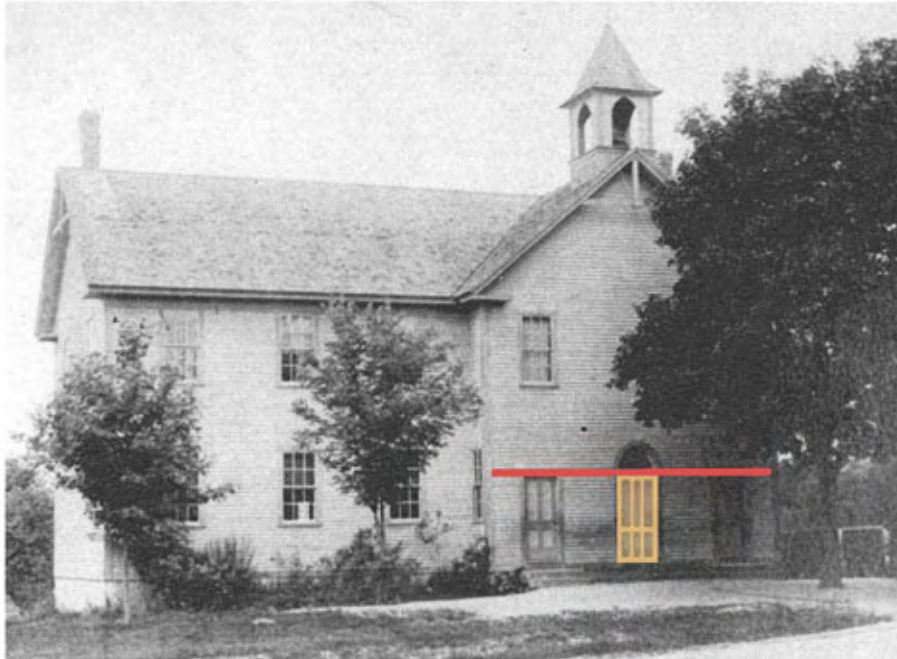
### EAST GABLE END FENESTRATION

The Consolidated School Building had 3 entry doors facing Devotion Road, 2 of which were replaced with windows in the following years. The top of the windows were set higher than the original doors but not as high as the other windows on the east façade. The lack of alignment between the top of the center door and the top of the windows is one of the greatest changes that detracts from the proportion and scale of the original façade.

### ENTRY DOOR

The entry doors facing Devotion Road were late 19th century design. The center door was a six-panel door and the 2 north and south flanking doors were four-panel doors. When the center door was replaced the style of the door was changed. While it may be desirable to have glazing in the entry door when the door is replaced consideration should be given to replicating the original 6-panel design. If needed for programmatic reasons, glazing panels can be placed in the top three panels.

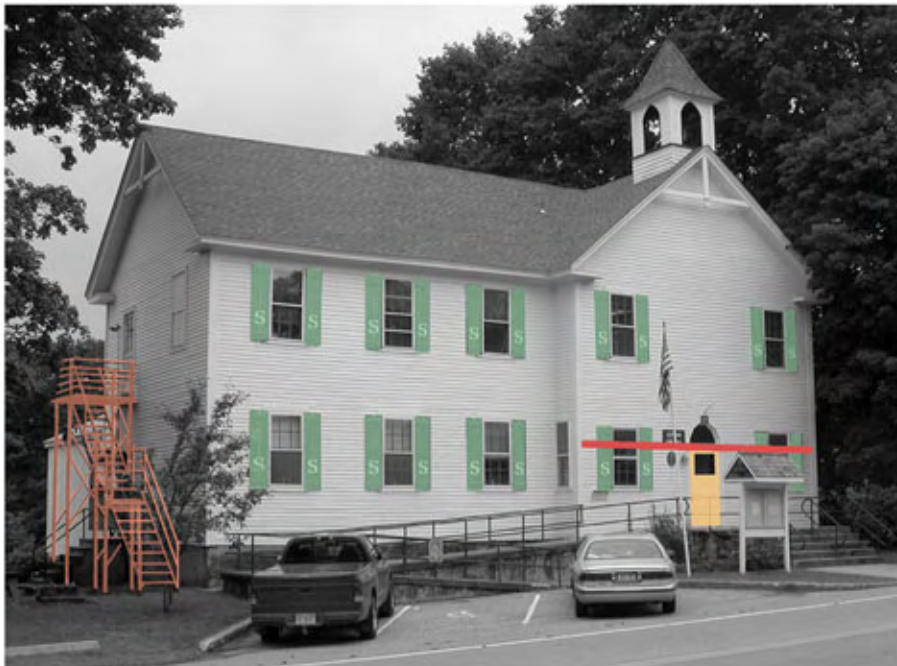
### FIRE ESCAPE

Fire escapes are needed to meet Life / Safety Codes. The south facing fire escape has significant visual impact on the south facing gable and front façade. When time to be replaced the fire escape can be alternately configured to run first to the west (towards the back of the building) and an intermediate landing and then run to the east as it currently does. This simple change would dramatically enhance the read of the front façade.
