TOWN OF WINCHESTER

2022 Road and Infrastructure Improvement Bond Road Segment Information Sheet West Wakefield Boulevard Taylor Brook Bridge

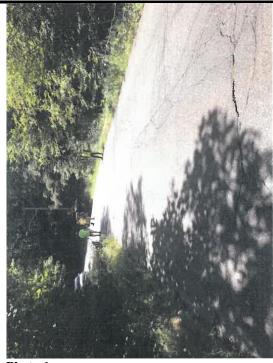
Photo 1.

Bridge – The substructure supporting the deck is in poor condition with significant corrosion. The guide rail system is substandard and is a hazard. The bridge opening is too small to pass the required storms. The bridge is too narrow to allow pedestrians to safely cross with traffic on the road.

- 1. The Bridge will be replaced with a precast concrete box culvert.
- 2. The road surface either side of the will be reconstructed.
- 3. 4" of asphalt will be added to the surface.
- 4. The shoulders will be reworked to allow pedestrians to pass over the bridge behind the guiderails.
